PARTS & SERVICE NEWS

REF NO.	AT02074
DATE	Jul. 11, 2002

SUBJECT: REPAIR PROCEDURE OF ENGINE WIRING HARNESS CLAMP ON WA1200-3

PURPOSE: To introduce modification procedure to prevent occurrence of engine harness clamp trouble on WA1200-3 wheel loaders

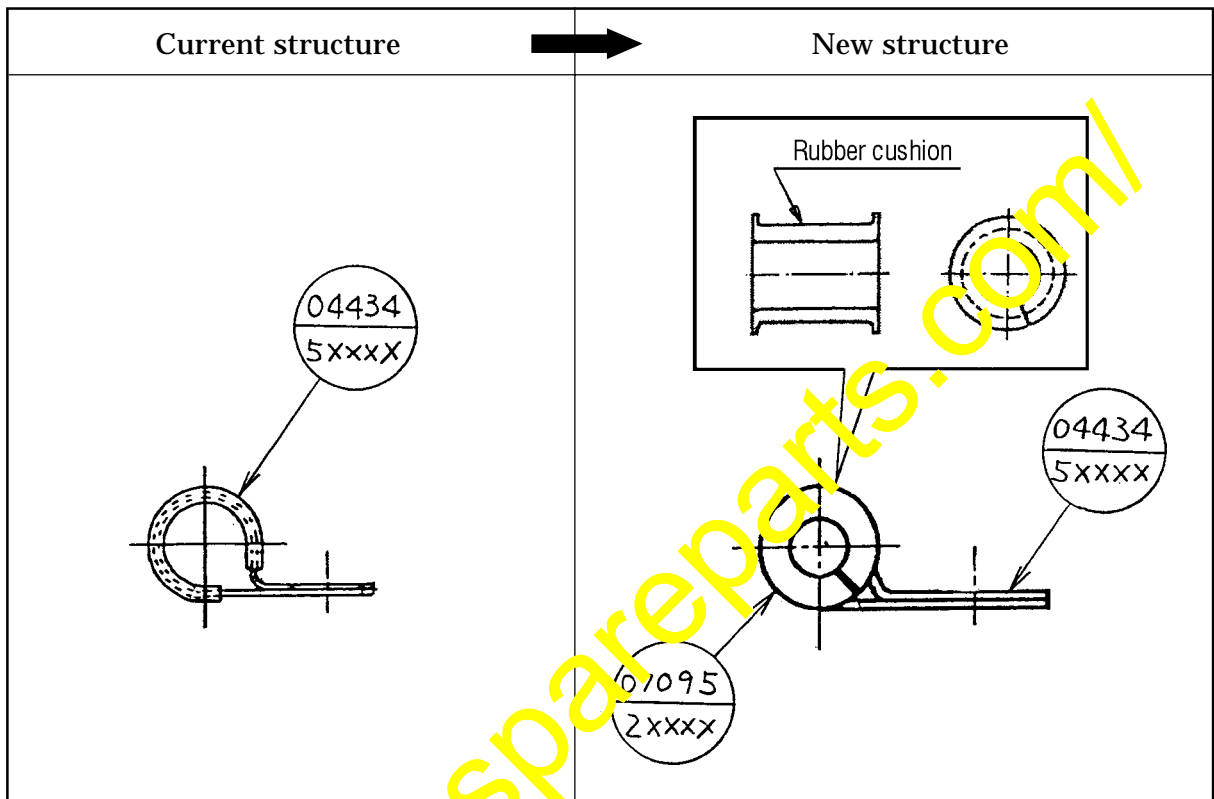
Since the clamped sections of the engine wiring harness on the WA1200-3 wheel loaders may wear by vibrations of the machine and the engine wiring harness may be damaged, implement the modification being introduced in this Service News to prevent occurrence of the aforementioned damage of the engine wiring harness.

The size of the clamp has been reviewed and, at the same time, the clamp has been changed to rubber cushioned clamp to eliminate the backlash between the harness and the clamp thus preventing occurrence of wears of the clamped section by vibrations of the machine.
