**PARTS & SERVICE
NEWS**

REF NO.	AT02114
DATE	Oct. 21, 2002

SUBJECT: REPAIR PROCEDURE OF WATER LEAKS FROM CYLINDER HEAD U-PLUG ON SA(A)6D170

PURPOSE: To introduce modification procedure to repair or to prevent occurrence of water leakage by corrosion of the U-plug of the cylinder head of the S (A or AA) 6D170 engines

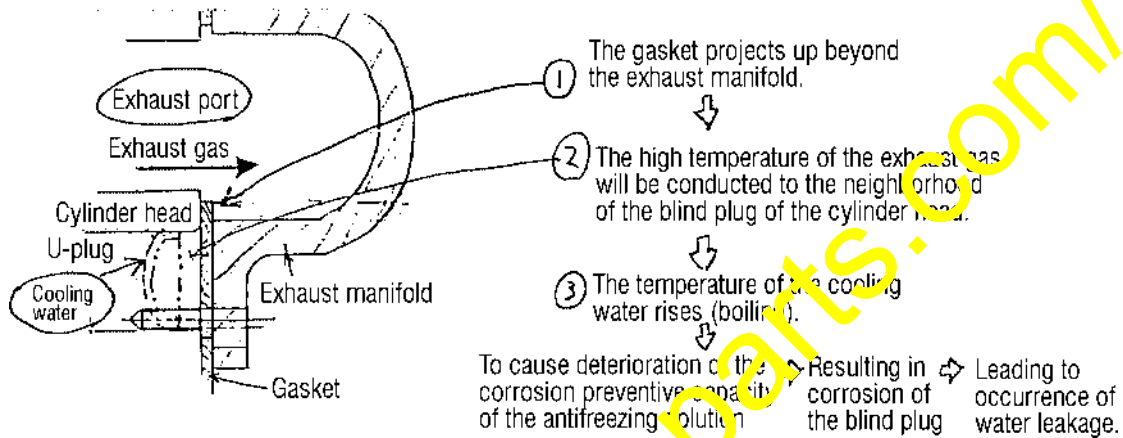
Fig. 1

- ① With the S(A or AA)6D170-1 type engines, since the exhaust manifold will be installed below the cylinder head and below the top edge of the exhaust manifold gasket when it is being assembled, the gasket may project up beyond the exhaust manifold.
- ② By this structure, the high temperature of the exhaust gas will be conducted through the gasket to the blind plug of the cylinder head.
- ③ Therefore, the temperature of the cooling water in the neighborhood of the blind plug rises to cause deterioration (by boiling) of the corrosion preventive capacity of the antifreezing solution thus resulting in corrosion of the blind plug → and in occurrence of water leakage.
