PARTS & SERVICE NEWS

REF NO.	AT02152A
DATE	Nov. 1, 2002

SUBJECT: REPAIR PROCEDURE OF OIL LEAK FROM TRANSMISSION REAR COUPLING (SLIDING TYPE)

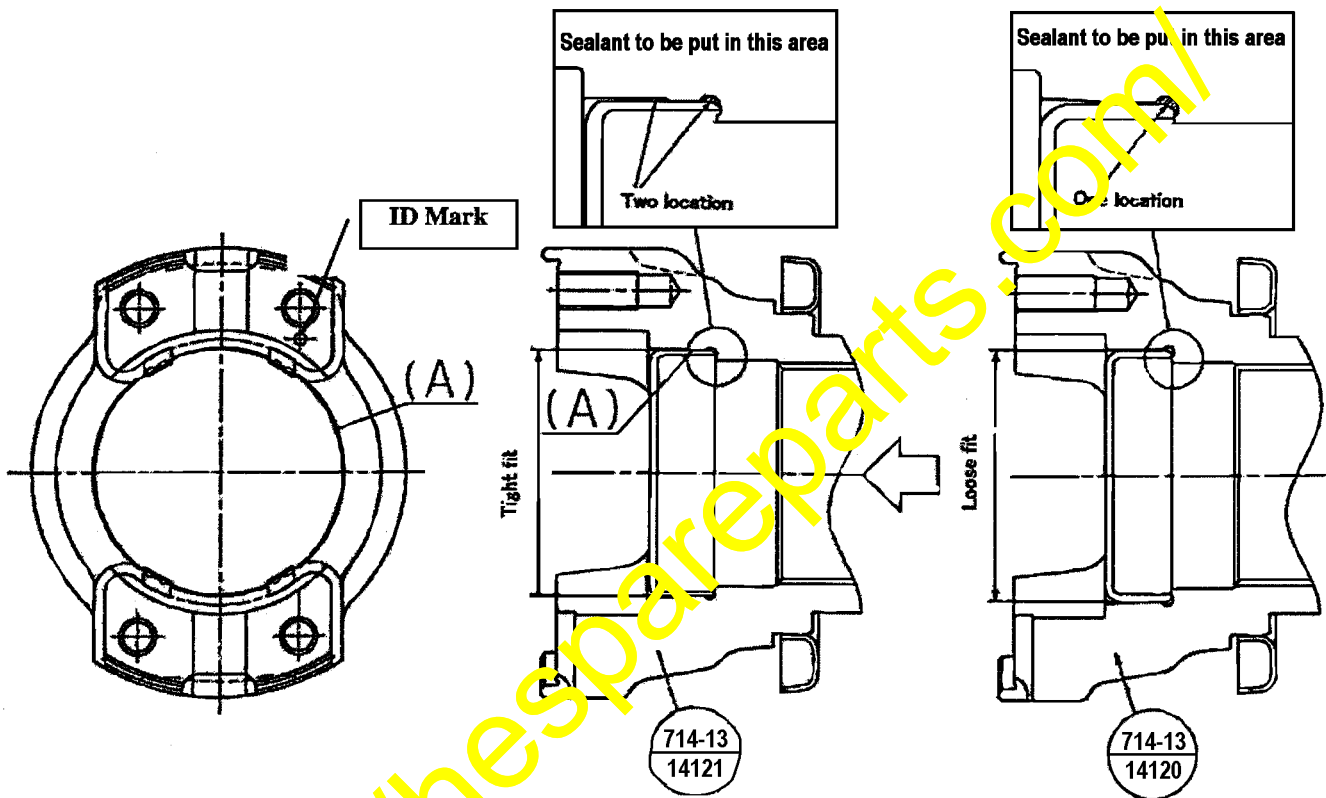
There is a possibility of oil leak from between coupling and cover indicated (A) in the drawing below. It has been improved changing the clearance tolerance from loose to tight fit.

The location on which sealant putting is increased one to two as indicated in the drawing below.

In order to clarify the improved coupling the ID mark is punched as shown in the drawing below.

Replace the coupling according to the instructions in the Shop Manual.
