PARTS & SERVICE NEWS

REF NO.	AT02155
DATE	Dec. 10, 2002

SUBJECT: REPAIR PROCEDURE OF AIR CONDITIONER COMPRESSOR TUBE DAMAGE ON WA120-3

APPLICATION: WA120-3A Wheel Loaders, Serial Nos. 54001 thru 54130
WA120L-3 Wheel Loaders, Serial Nos. 54001 thru 54129

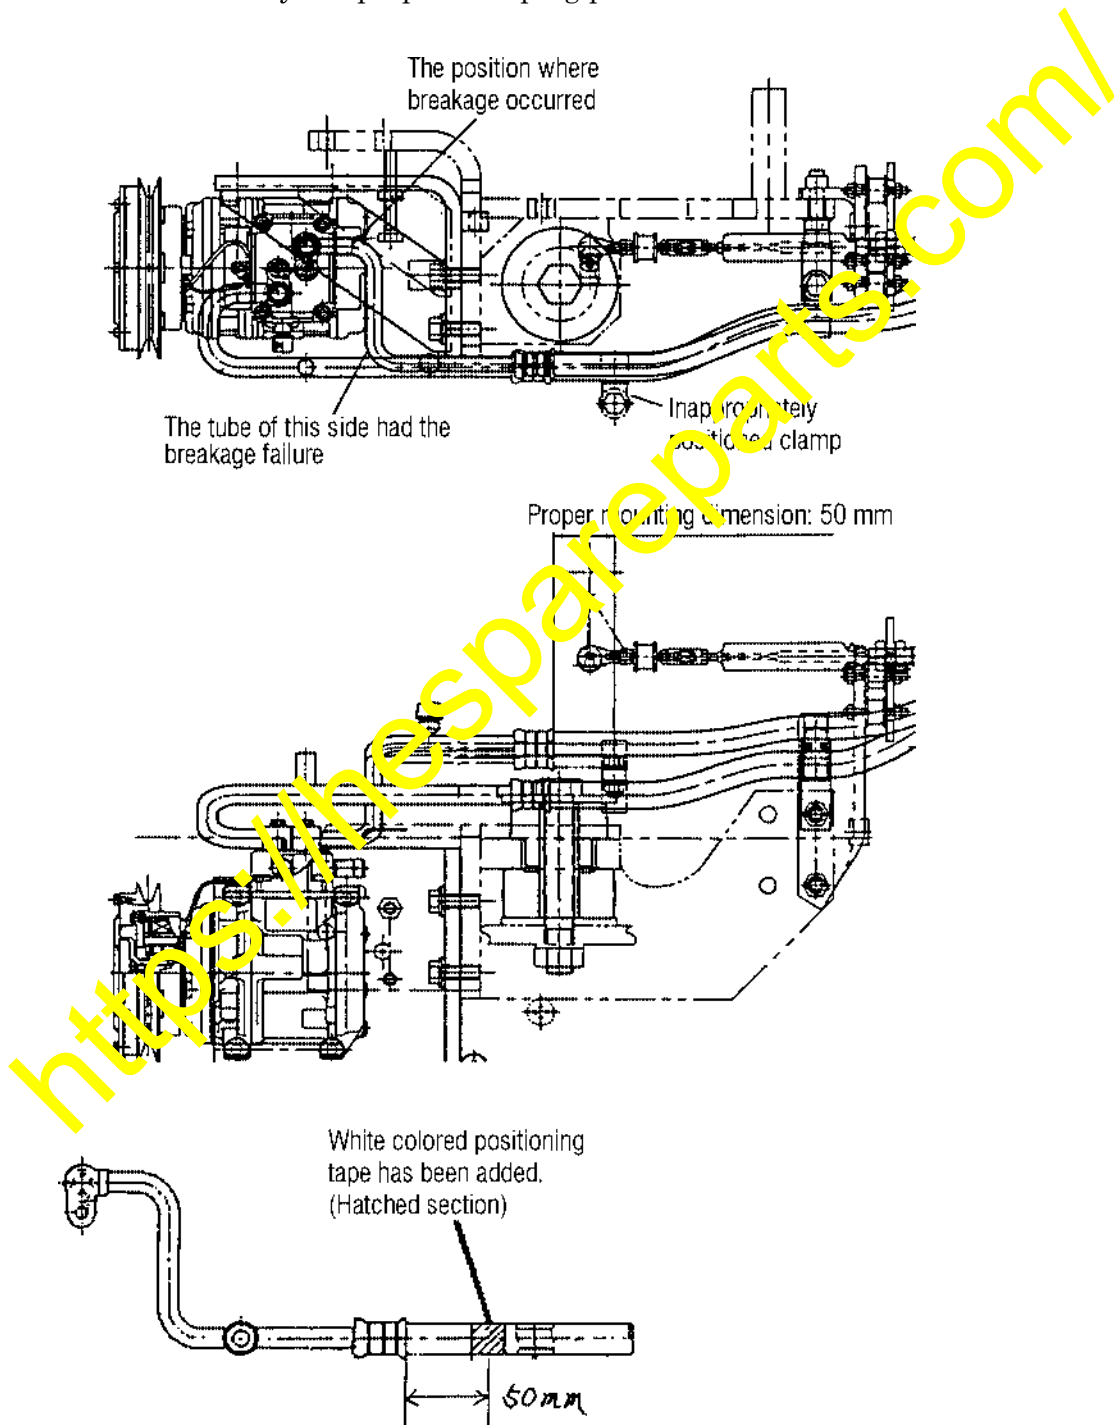
- 1) Breakage failure of the tube connecting to the air compressor occurred.
- 2) Owing to inappropriate position of the clamp, the resonance point has changed to cause excessive resonance strain resulting in fatigue breakage.

- 1) White colored positioning tape has been added at the proper clamping position of the hose to clarify the proper clamping point.

(The hose 416-S62-2321 is the one white colored positioning tape was added to 416-S62-2320.)
