REF NO.	AT02195			
DATE	Jan. 15, 2003			
	Page 1 of 7

SUBJECT: INTRODUCTION OF THE IMPROVED EXHAUST VALVE ON WA800/WA900

PURPOSE: To introduce the improved exhaust valve on WA800/WA900

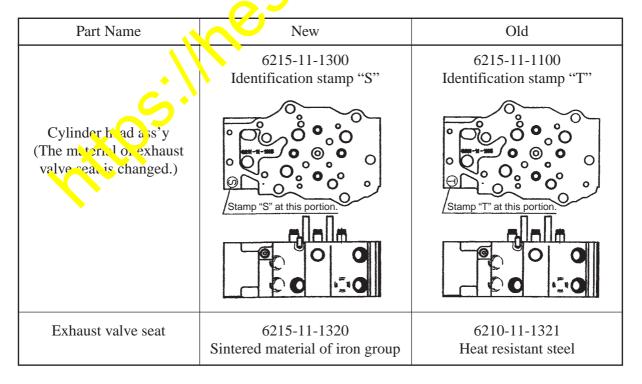
(1) Change of exhaust valve seat

The material of exhaust valve seat is changed and the wearing of contact surface between the exhaust valve and the exhaust seat is mproved. Therefore, the margin of durability for the exhaust valve is improved.

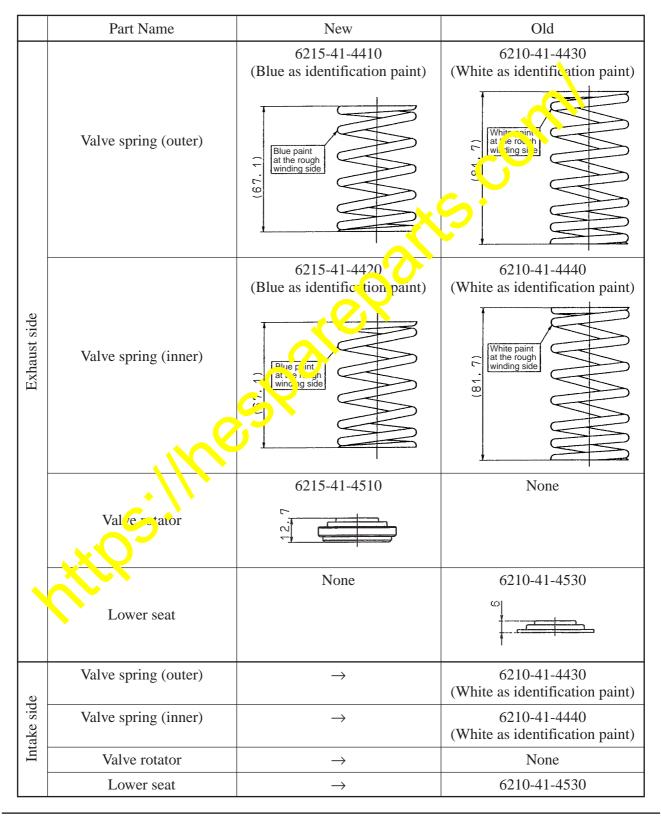
(2) Rotator addition to exhaust valve

By adding the valve rotator to the exhaust valve side, the stress occurred to the seat surface of exhaust valve is prevented from concentrating to the special places. Therefore, the durability margin of exhaust valve is improved.

In addition, in combination with this, the valve spring of exhaust side is changed.

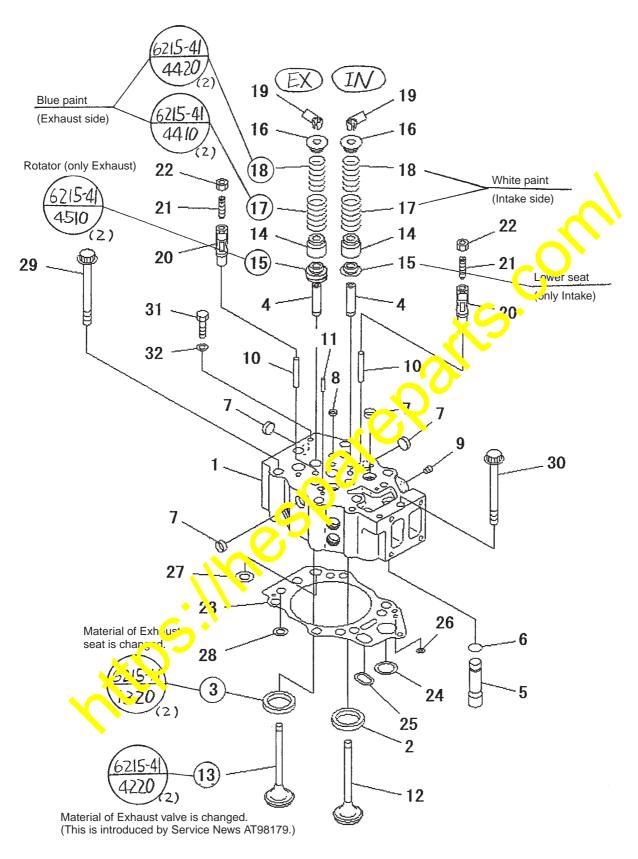
Parts enclosed by a circle are changed.
