**PARTS & SERVICE
NEWS**

REF NO.	AT03013
DATE	Feb. 19, 2003

SUBJECT: REPAIR PROCEDURE OF JOYSTICK SWITCH ON WA700-3, WA800-3, WA900-3, WA1200-3

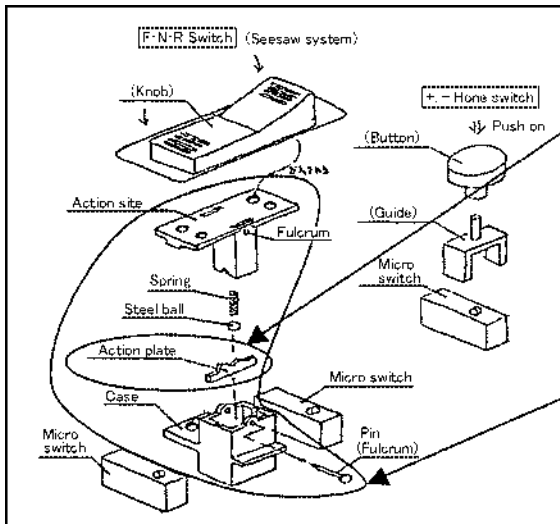
3. Details of the modification

- 1) The detent section of the F/R seesaw switch on the AJSS type joystick lever knob on the WA1200-3, WA900-3, WA800-3 and WA700-3 wheel loaders may wear out to cause malfunctioning of returning to the "N" (neutral) position not staying at the "R" (or "F") position even after the switch is turned to the "R" (or "F") position.

The surface hardness of the detent supporting action plate has been increased to improve the wear resistance.

↓
Replacing new part:
CASE, DETENT (42C-S33-1160)
