# PARTS & SERVICE NEWS

REF NO.	AT03046
DATE	Apr. 4, 2003

**SUBJECT:** IMPROVEMENT OF TRANSMISSION PUMP SPLINED SHAFT ON GD825A-1, -2

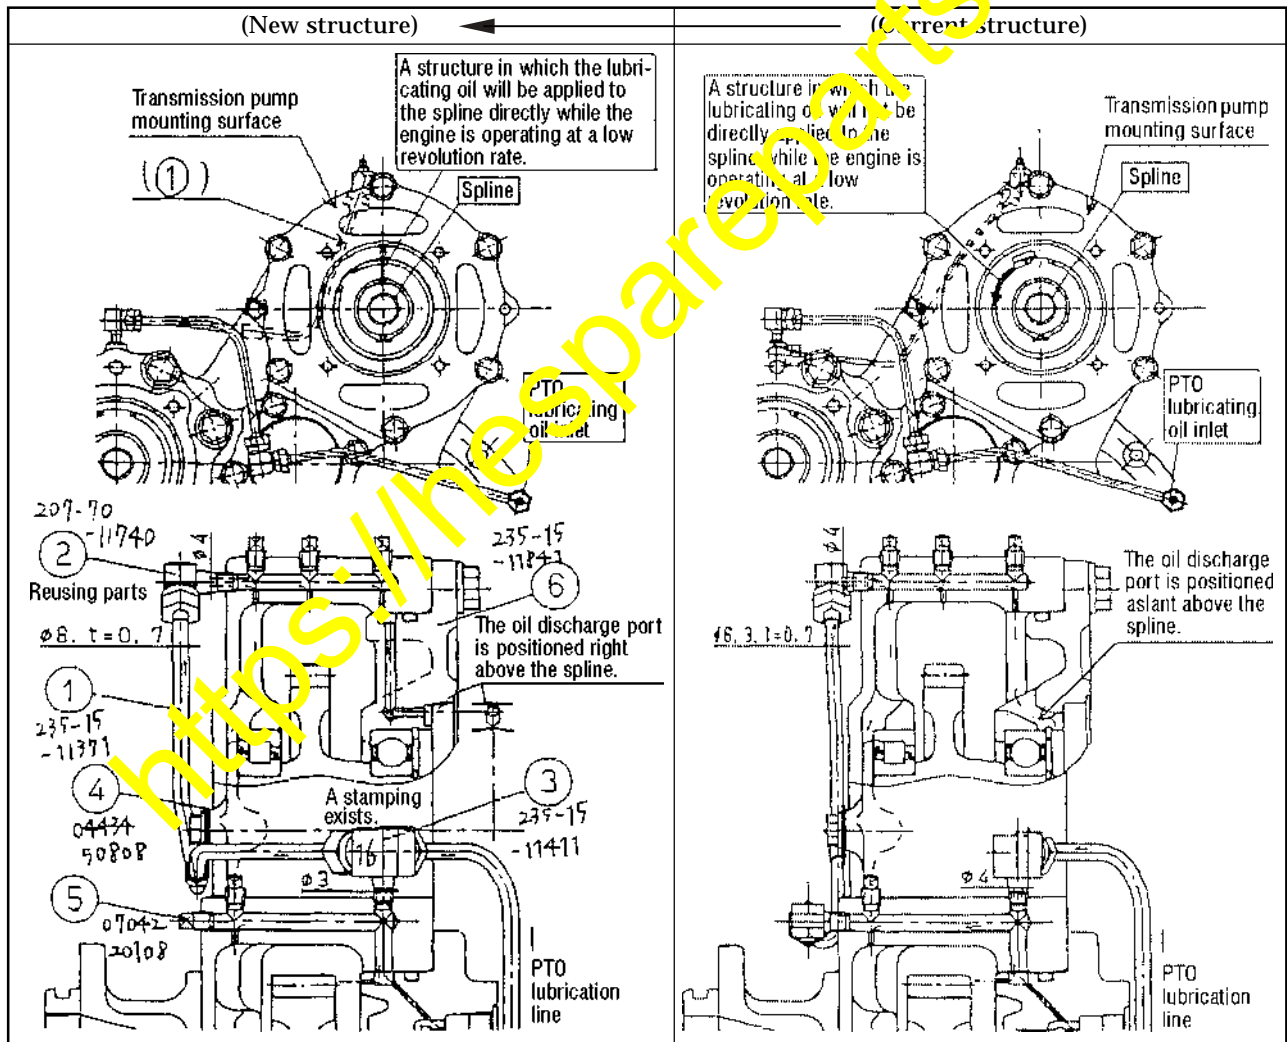
The quantity of the lubricating oil for the transmission pump shaft has been increased.

- 1) By changing the route of the PTO lubrication tube, the quantity of the lubricating oil for the transmission pump shaft has been increased. (With the parts No. ① thru No. ⑤ in the table shown below)
- 2) By changing the position of the hole on the cage, through which the lubricating oil goes to the pump shaft to the point right above the spline, the structure has been changed so that the lubricating oil may be applied to the splined section of the pump shaft directly. (With the parts No. ⑥ in the table shown below)

No.	New structure ←			Current structure		
	Part Name	Par No.	Identification method	Part Name	Par No.	Identification method
①	Tube	235-15-11371	φ8	Tube	235-15-11370	φ6.3
②	Elbow	207-70-11740		Elbow	568-13-16560	
③	Tee	235-15-11411	Stamping "16" exists.	Elbow	207-70-11740	
④	Clip	04434-50808		Clip	04434-00608	
⑤	Plug	07042-20108		Elbow	568-13-16560	
⑥	Cage	235-15-11841	The position of the lubricating oil hole is right above the spline.	Cage	235-15-11840	The position of the lubricating oil hole is aslant above the spline.

- Refer to the Section "Disassembly and Assembly of PTO" in the Shop Manual.
- Although the part number of the bearing [06040-06211] does not change, since there is a possibility of damaging the bearing while removing from the current cage [235-15-11840], prepare the bearing as spare parts when carrying out this modification.
- Reuse the snap rings [04065-01030] and [04064-05520].
