PARTS & SERVICE NEWS

REF NO.	AT03108A
DATE	Oct. 22, 2003
(C) Page 1 of 3

SUBJECT: REPAIR PROCEDURE OF COOLANT LEAKAGE OF RADIATOR

APPLICATION: WA200-3 Wheel Loaders, Serial Nos. ~~60001~~ thru 64393

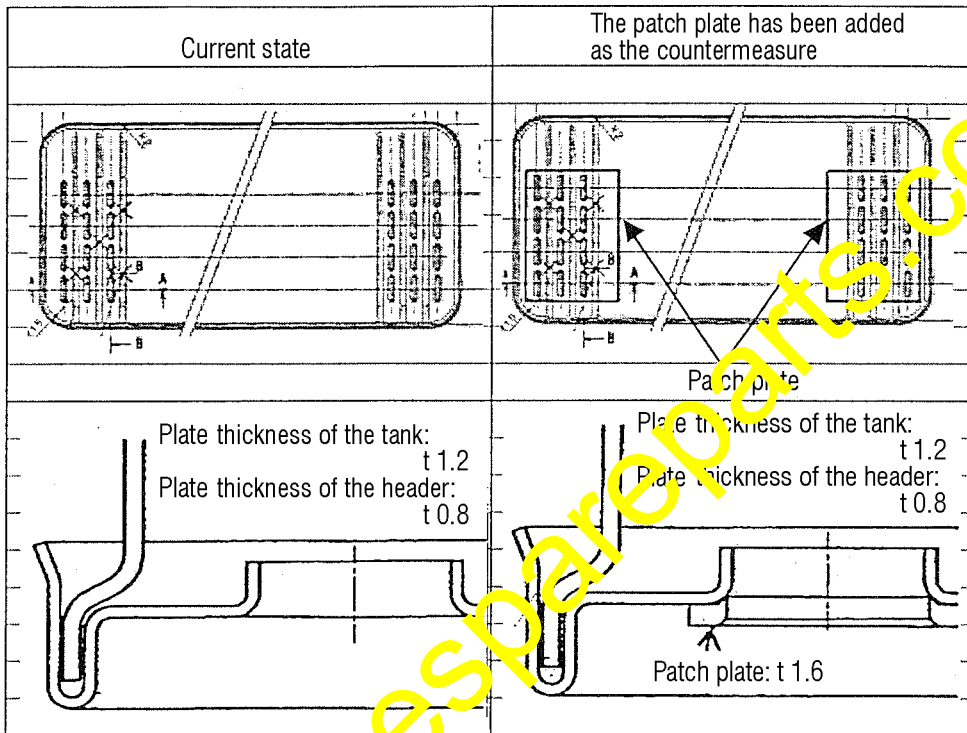
- 1) The soldering which is fastening the tubes at the four corners of the radiator core and the header may be cracked and separation of these parts may occur to result in water leakage.

- 1) The patch plate has been added to the header at the four corners of the radiator core for the reinforcement purpose.
