**PARTS & SERVICE
NEWS**

REF NO.	AT03114B
DATE	Jun. 21, 2004

SUBJECT: REPAIR PROCEDURES FOR WHITE SMOKE & BACK FIRE AT COLD OPERATION AND FOR TROUBLE MESSAGE 318 ON SAA6D170E-3

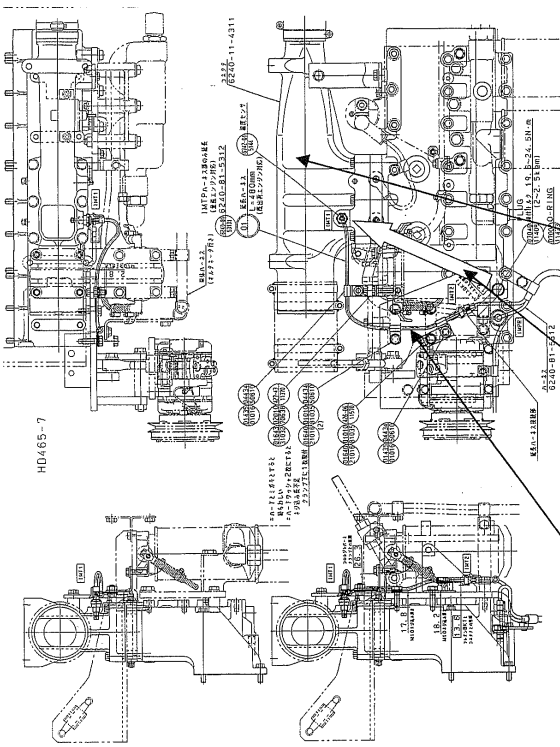
Fig. 1

Addition and clamping of the extension harness

Replacement of the air intake connector
Replace the air intake connector with the new air intake connector equipped with the sensor mounting seat.

Shifting the position of the boost temperature sensor to the air intake connector where thermal influence of the head is smaller. In the meantime, install the plug to the opening after the intake air temperature sensor has been removed.
