# PARTS & SERVICE NEWS

REF NO.	AT03125
DATE	Jul. 10, 2003

**SUBJECT:** REPAIR PROCEDURE OF REAR COVER BRACKET IN CAB ON HD465-7, HD605-7

**APPLICATION:** HD465-7 Dump Trucks, Serial Nos. 7001 thru 7143  
HD605-7 Dump Trucks, Serial Nos. 7001 thru 7053

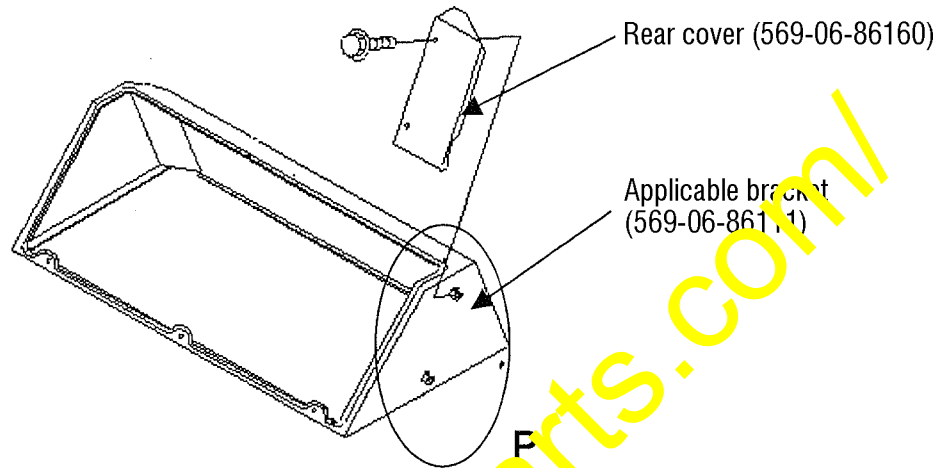
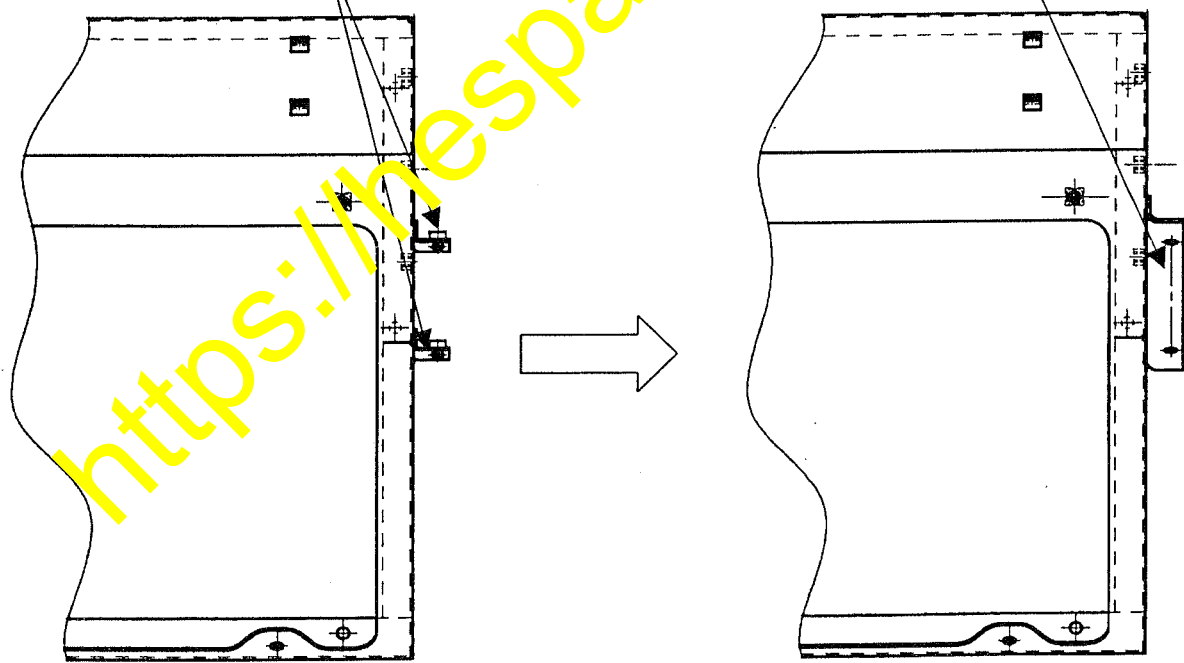
Details drawing of the section "P"

With the HD465-7 and HD605-7 dump trucks, depending on the operating conditions, the rear cover mounting bracket positioned inside the operator's cab may break.

- ① L-shaped plates in 2 pieces → L-shaped plate of a solid structure
- ② Sheet thickness: t 2.3 → t 3.2

The rear cover mounting bracket positioned inside the operator's cab is to be modified as indicated below to reinforce its structure.
