# PARTS & SERVICE NEWS

REF NO.	AT03188
DATE	Sep. 24, 2003
(C) Page 1 of 4

**SUBJECT:** REPLACEMENT OF STEERING VALVE MOUNTING BRACKET ON WA320-5

**APPLICATION:** WA320-5 Wheel Loaders, Serial Nos. 60004 thru 60038

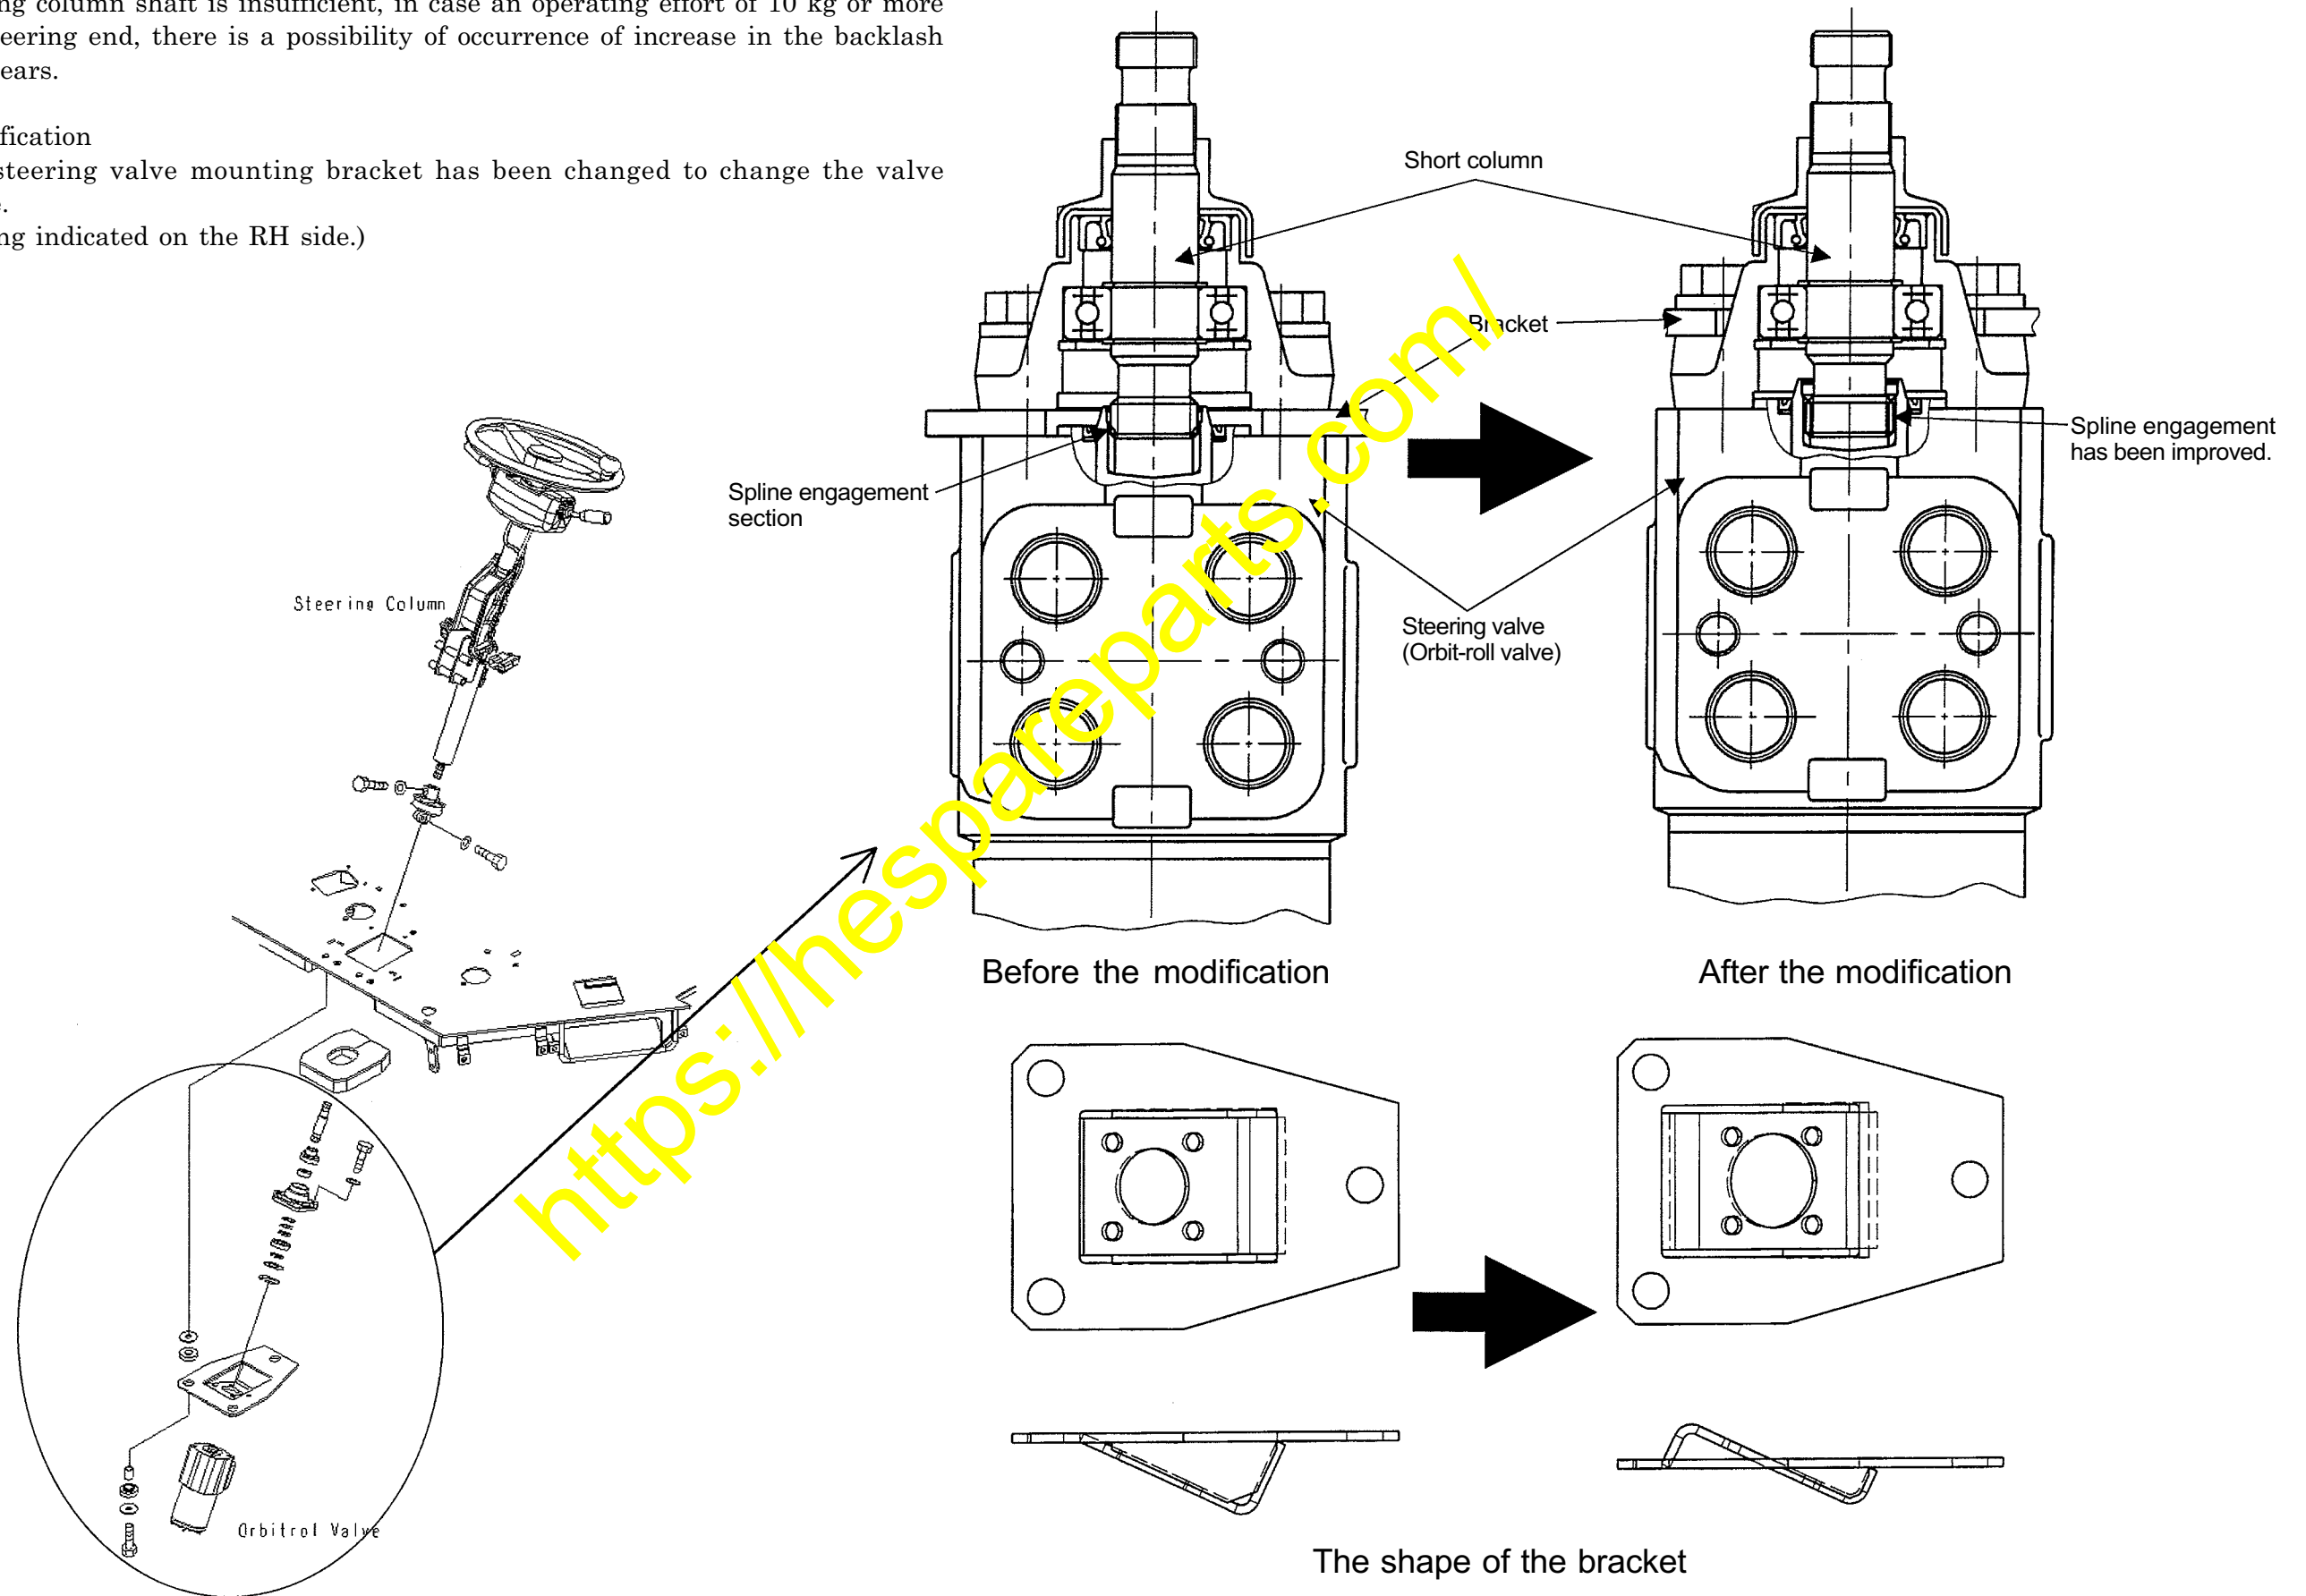
Since the spline engagement depth between the steering valve being positioned under the floor and the steering column shaft is insufficient, in case an operating effort of 10 kg or more is applied at the steering end, there is a possibility of occurrence of increase in the backlash because of spline wears.

The shape of the steering valve mounting bracket has been changed to change the valve mounting structure.  
(Refer to the drawing indicated on the RH side.)
