PARTS & SERVICE NEWS

REF NO.	AT03244
DATE	Dec. 26, 2003
(C) Page 1 of 10

SUBJECT: WA700-3/WA800-3/WA900-3/WA1200-3
REPAIR OF BACKLASH AT ARM REST AREA

PURPOSE: To introduce modification procedure to repair the backlash of the AJSS arm rest section on WA700-3, WA800-3, WA900-3 and WA1200-3 wheel loaders

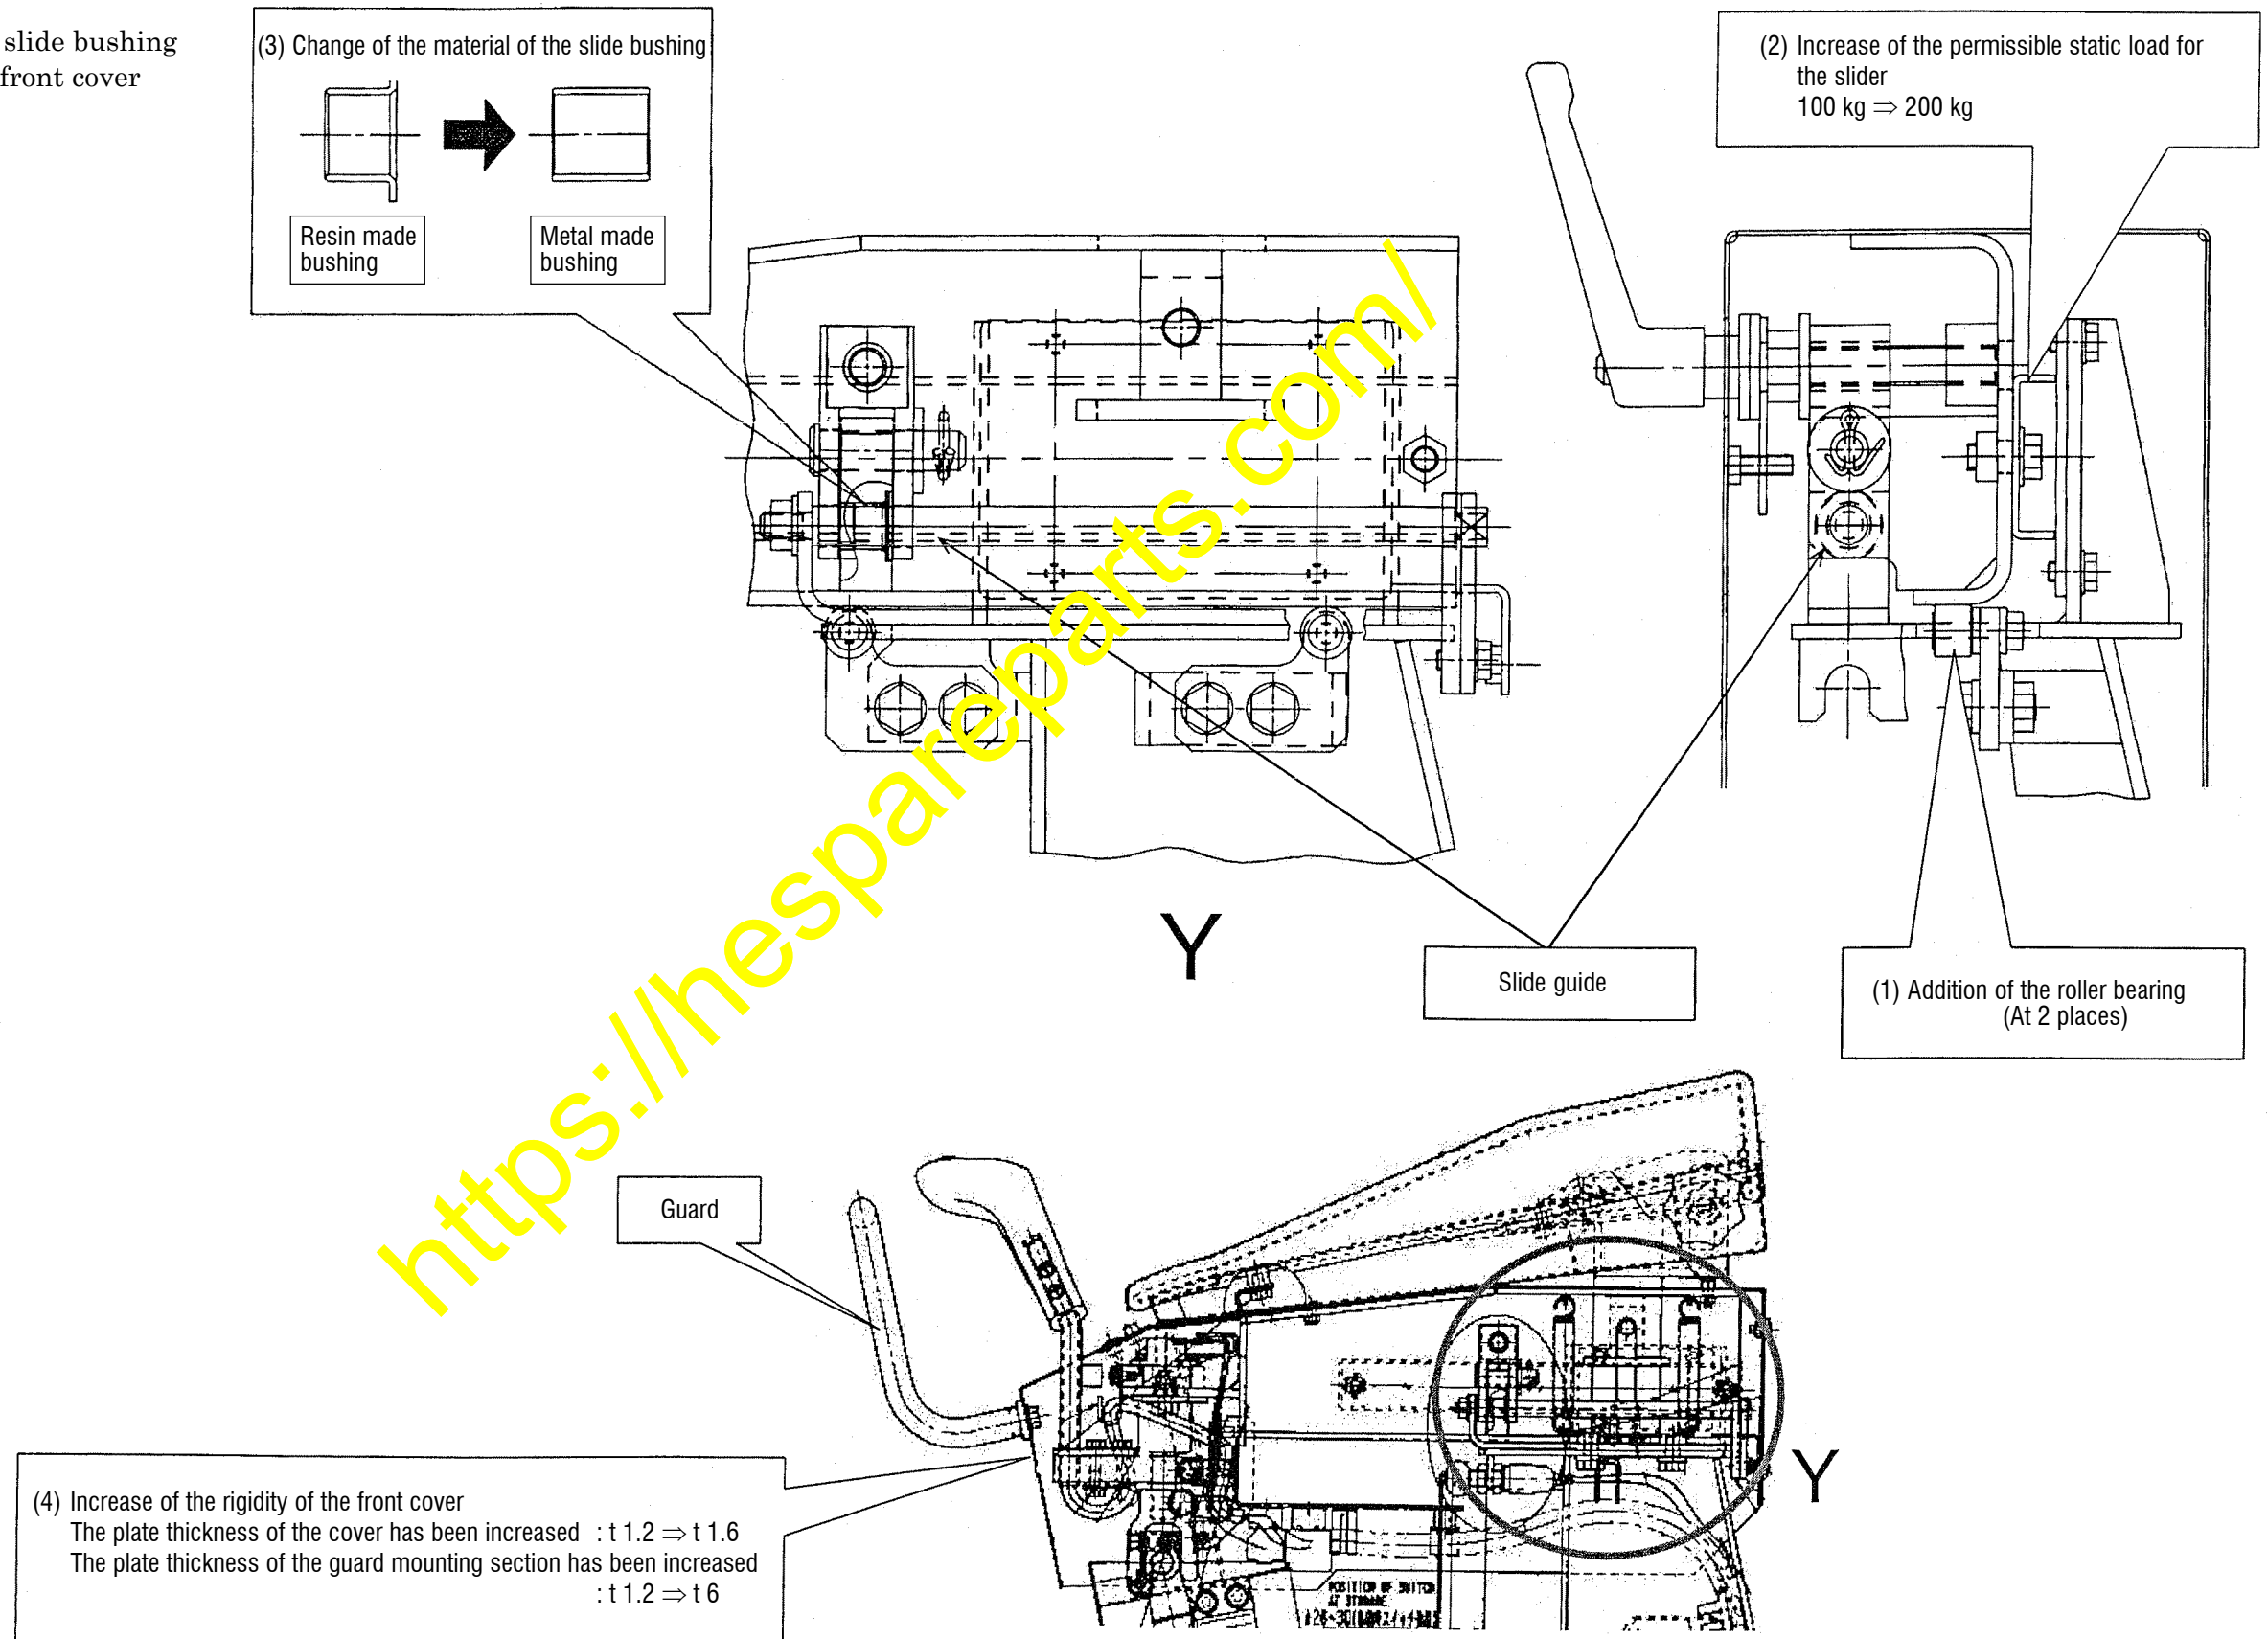
Fig. 1

- (1) Addition of the roller bearing
- (2) Increase of the permissible static load for the slider
- (3) Change of the material of the slide bushing
- (4) Increase of the rigidity of the front cover

For details, refer to Fig. 1.
