REF NO.	AT04013		
DATE	Feb. 3, 2004		
(C)	Page 1 of 3

- **SUBJECT:** MODIFICATION OF THE MUD GUARD FOR THE BODY ON HM300-1, HM350-1 AND HM400-1
- **PURPOSE:** To introduce the modification of the mud guard for the body on HM300-1, HM350-1, and HM400-1.
- **APPLICATION:**HM300-1Articulated Dump Trucks, Serial Nos.1001 thru 1088HM350-1Articulated Dump Trucks, Serial Nos.1001 thru 1059HM400-1Articulated Dump Trucks, Serial Nos.1001 thru 1.1.

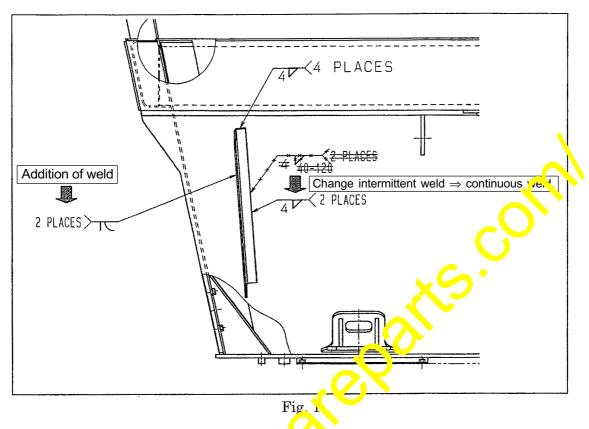
The bracket weld may be cracked by warp on the side plate of the body due to impact and earth pressure when loaded. In such a case, in ke a modification in the manner introduced by this Service News.

To prevent cracks in the bracket weld of the mud guard for the body, rigidity was improved by changing to full arc weld as shown below (See Fig.1).

- 3. Procedure of Modification
 - 3-1 Stop the vehicle on the flat ground, hock the wheels and stop the engine.
 - 3-2 Remove the guard and plate points damage during mending by weld (See Fig. 2). Care should be taken not to lose the parts removed, because they will be reused.
 - 3-3 Remove the welded brack t and clear welding beads.
 - 3-4 Mend by weld as shown in Fig. 1.
 - 3-5 Install the guard and plate removed.
