**PARTS & SERVICE
NEWS**

REF NO.	AT04077
DATE	Apr. 20, 2004

SUBJECT: MODIFICATION PROCEDURE FOR ENGINE MUFFLER ON WA100-5/
WA150-5 (WITH CABIN)

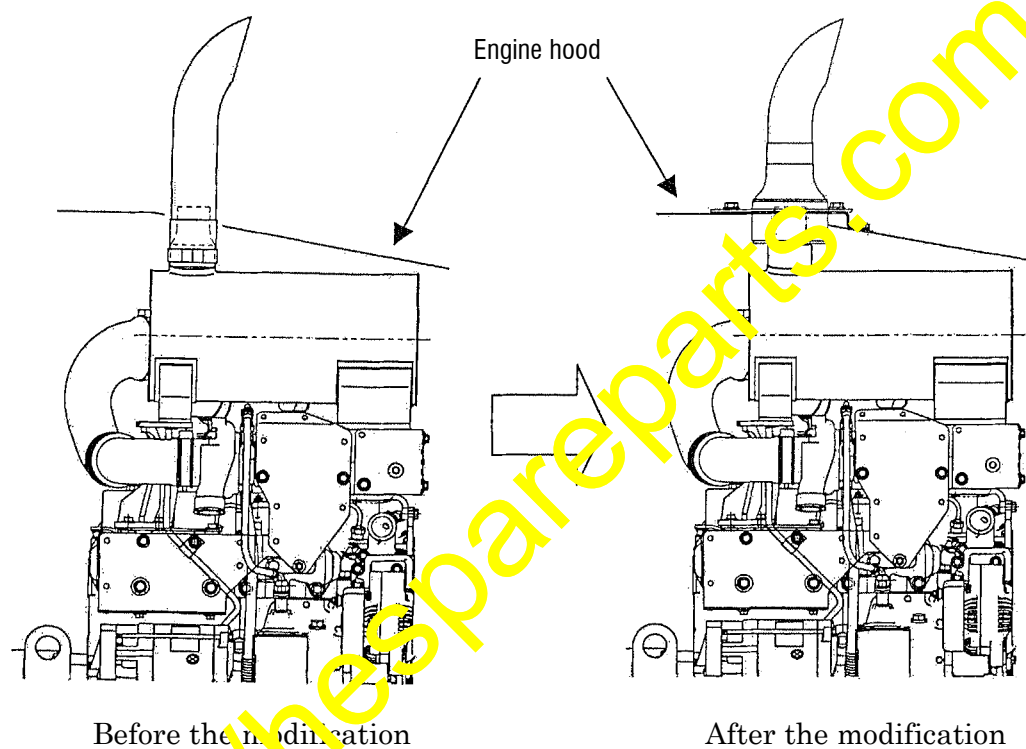
Fig. 1

Since there is a possibility that the outlet port section of the muffler for the SAA4D102E-2 engines on the WA100-5 and WA150-5 wheel loaders (operator's cab spec. machines) breaks, make the modification introduced in this Service News to prevent the breakage failure.

The exhaust pipe installation structure has been changed to the structure to install the exhaust pipe to the engine hood from the structure to install it to the muffler directly.
