AT04090

REPAIR PROCEDURE FOR EXHAUST MANIFOLD GASKET FOR SUBJECT:

SA12V140 ENGINES

**PURPOSE:** To introduce modification procedure to repair the breakage failure of

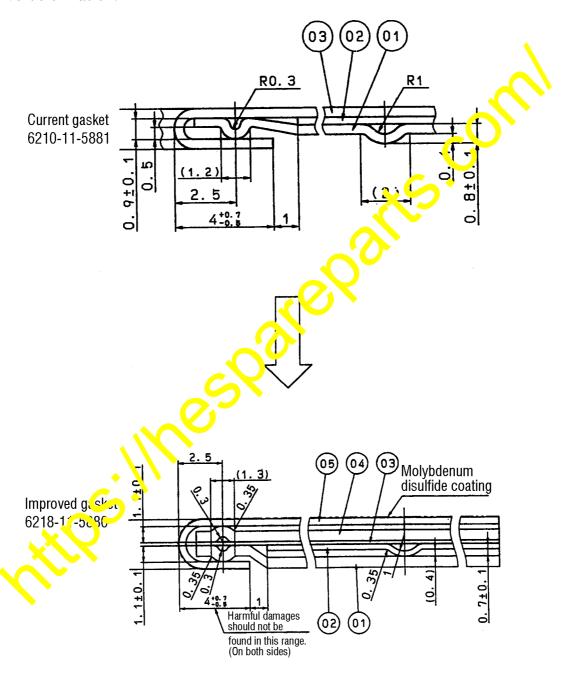
Fig. 1

- 3. Details of the modification
  - (1) Molybdenum disulfide coating is being applied to the exhaust manifold gasket on the contact surface side to the exhaust manifold.
     (Even if the exhaust manifold moves by thermal deformation, the gasket will slips to avoid deformation. (To suppress the occurring stress)
  - (2) The structure of the gasket has been changed from 3 layer structure to 5 layer structure to equalize the surface pressure of the gasket, and also, to suppress relative deformation.

4. Disassembly and reassembly Carry out this modification following the instructions given in the Shop Manual.
