PARTS & SERVICE NEWS

REF NO. AT04159

SUBJECT: REPAIR PROCEDURE OF OIL LEAKAGE FROM OIL COOLER FOR SAA6D114E-2 ENGINE

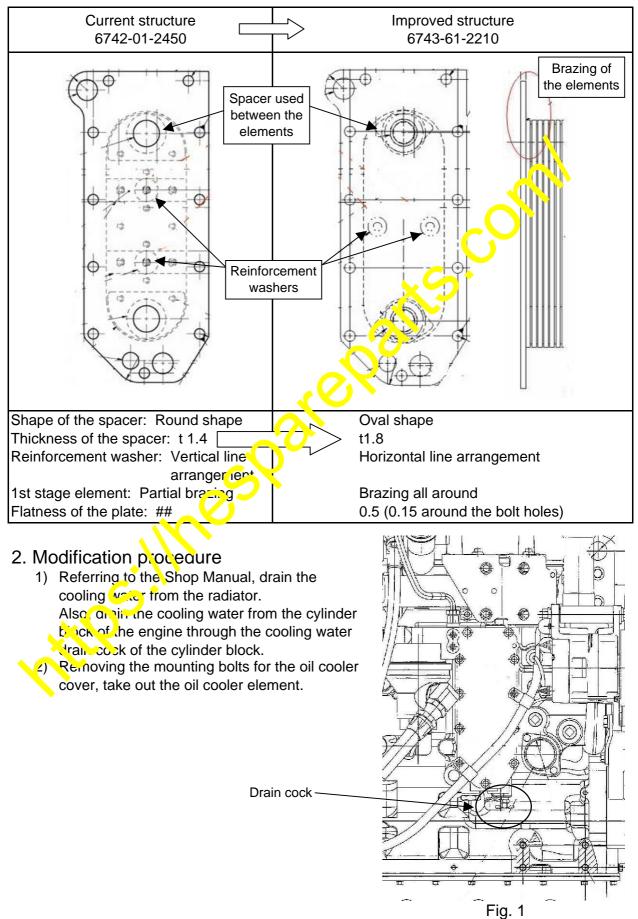
There is a rare possibility that the oil cooler cores for the SAA6D114E-2 engines have cracks and the engine oil may mix into the cooling water in the radiator. When the mixture occurs, repair the failure following the mdoification procedure described in this service news.

The structure of the oil cooler element has been modified as shown in the figure below to improve the rigidity against vibrations.
