PARTS & SERVICE NEWS

REF NO.	AT04219		
DATE	Aug. 25, 2004

SUBJECT: REPAIR PROCEDURE FOR CRACKS IN FINAL DRIVE CASE REAR CO-

VER SUPPORTING SECTION

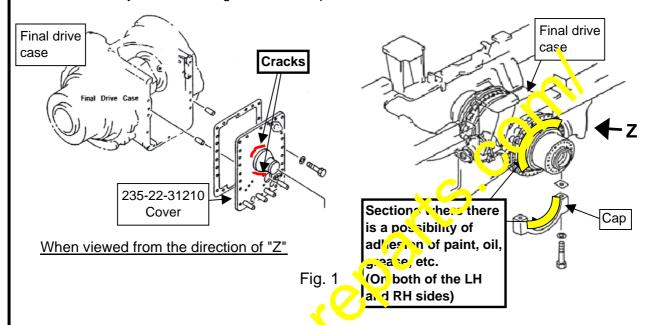
When cracks are found in the final drive case rear cover supporting section, since there is a possibility of adhesion of paint, oil, grease, etc. to the mounting surface (cap section) to the rear frame of the final drive side case section. Cleaning the section at the same time when making the replacement work for the rear cover.

* If the replacement work for the rear cover only is carried out omitting the cleaning work, cracks may occur once again in a short period of time.

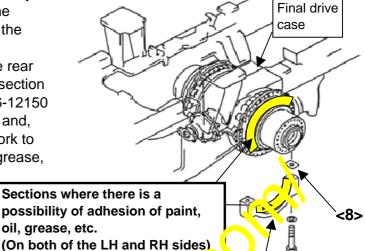
235-46-12150 CAP

- Remove the final drive & tandem ass'y, in the ass'y state, from the rear frame following the instructions given in the Shop Manual.
- Clean the mounting surface to the rear frame of the final drive side case section and the surface of the cap 235-46-12150 shown in Fig. 3 using sand paper and, after that, carry out degreasing work to remove adhered paint chips, oil, grease, etc.

(Clean the mounting surface and the cap on both of the LH and RH sides.)
