# PARTS & SERVICE NEWS

REF NO.	AT04239
DATE	December 6, 2004

**SUBJECT:** REPAIR PROCEDURE FOR CRACKS ON UNDER-VIEW MIRROR STAY OR SIDE-VIEW MIRROR GUARD

**APPLICATION:** HM300-1: 1001-1223  
HM300TN-1: 1001-1002

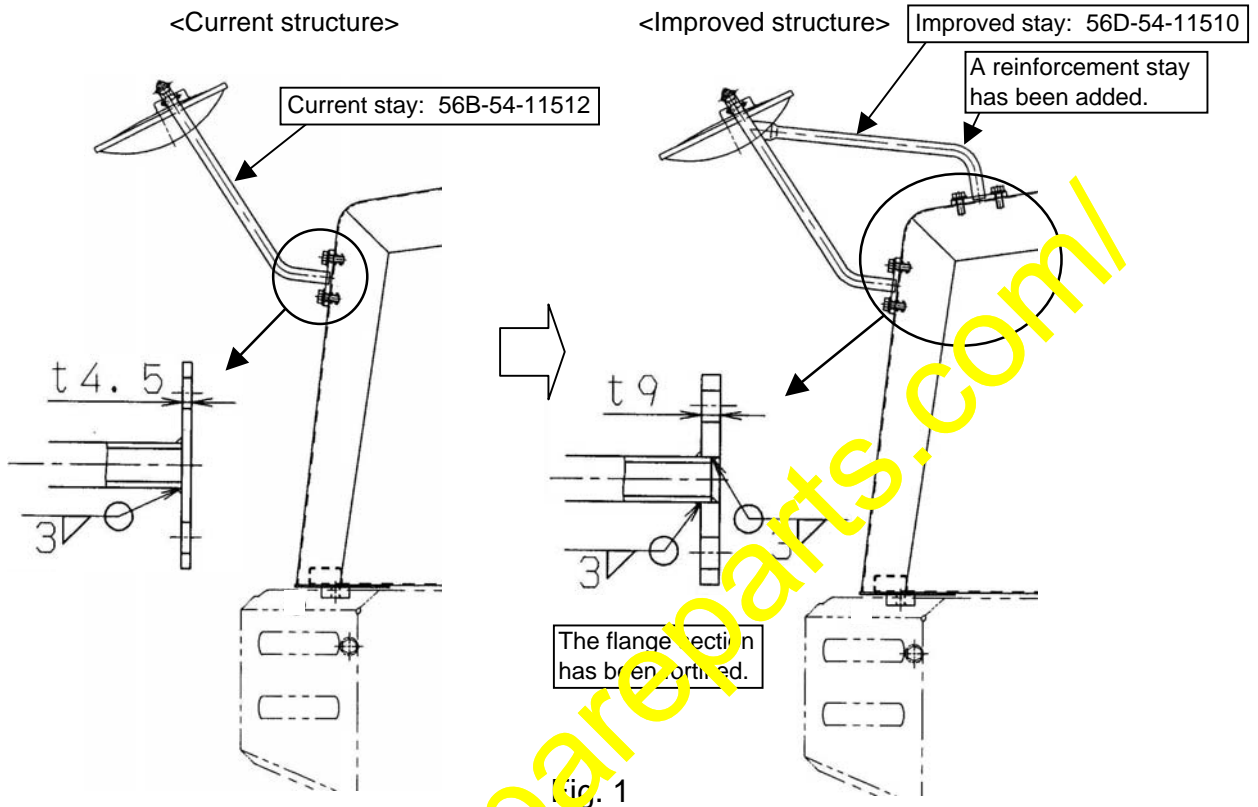
With the HM300-1 articulated dump trucks, when cracks occur on the under-view mirror stay or on the side-view mirror guard, carry out the modification introduced in this Service News to repair the cracks.

A reinforcement stay has been added to improve the structure to restrict vibrations. At the same time, the flange section has been fortified to prevent occurrence of cracks. (Refer to Fig. 1.)
