PARTS & SERVICE NEWS

REF NO.	AT04254
DATE	Sept. 28, 2004

SUBJECT: IMPROVED BEARING AT DIFFERENTIAL SIDE ON AXLE ON WA800-3, WA900-3, WA1200-3 AND WD900-3 TO PREVENT WEAR OF THE MOUNTING SECTION

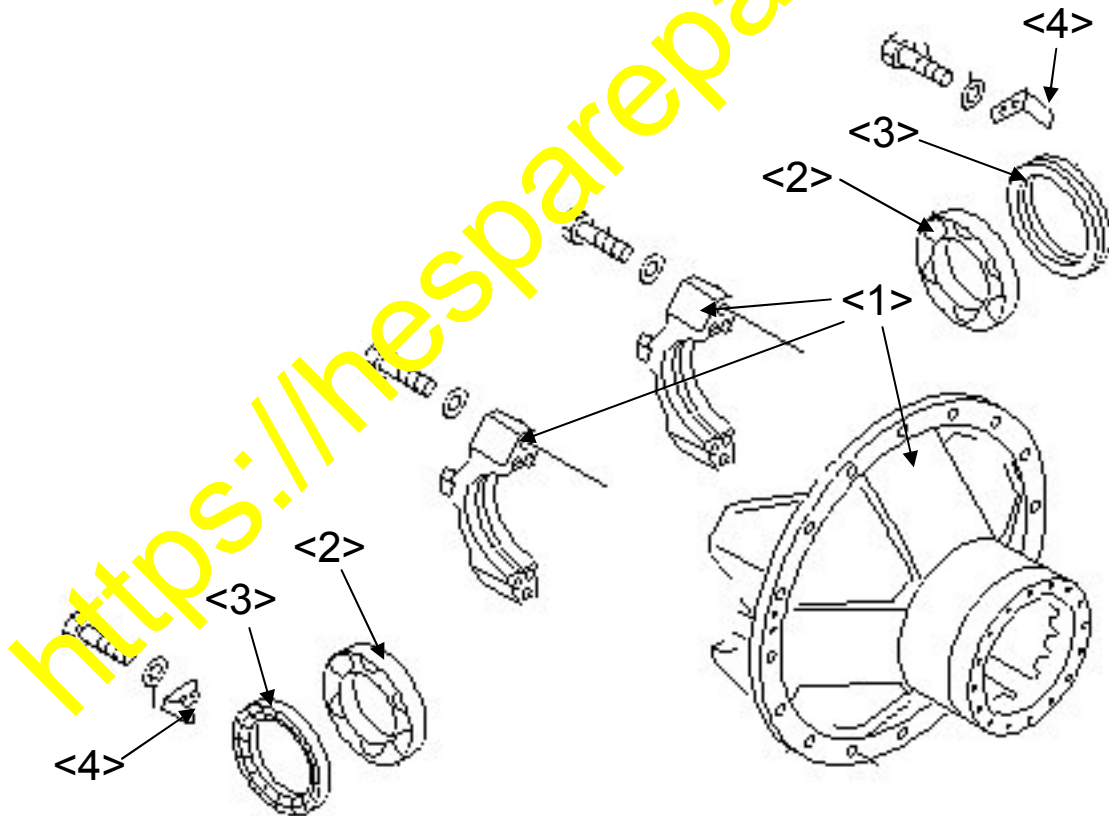
This Service News introduces the improved parts to prevent wear of the adjusting nut end surface and carrier bore that is caused by bearing turning by dragging at differential side on the axle on WA800-3, WA900-3 and WD900-3

No.	Part name	Q'ty/machine	Current parts	Improve parts	Description of change
<1>	CARRIER & CAP A. For the WA800/900-3 and WD900-3 For the WA1200-3	2 2	427-22-00610 42C-22-11103	427-22-00611 42C-22-11104	The tolerance of the bore diameter of the bearing has been changed.
<2>	BEARING	4	568-22-11960	561-22-61960	The tolerance of the outer diameter has been changed.
<3>	ADJUST NUT	4	568-22-11611	585-22-21140	The induction hardening has been added to the contact surface of the bearing. The square area of the contact surface of the bearing has been increased.
<4>	LOCK	4	427-22-11150	561-22-61150	The shape has been changed by modification of the adjusting pitch of the adjust nut.

- (1) Increasing the area of the contact surface to the bearing of the adjust nut, and addition of induction hardening
- (2) Decreasing the tolerance of the outer diameter of the bearing.

The adjust nut <3> and the lock <4> must be replaced in a set. Other parts can be used separately.
