PARTS & SERVICE NEWS

REF NO.	AT04276
DATE	December 16, 2004

SUBJECT: THE THRUST WASHER WITH IMPROVED WEAR-RESISTANCE

APPLICATION: WA600-3: 50001-50435, 52001-52054, 54001-54012
 WA600-3A: 52055-52154
 WA600-3D: 53001-53053

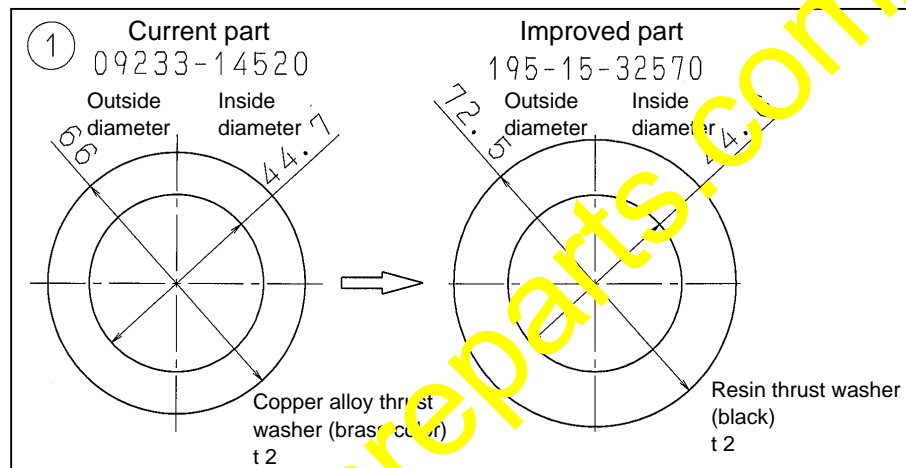
Fig. 1

Row R

① <Current> 09233-14520
↓
<New> 195-15-32570

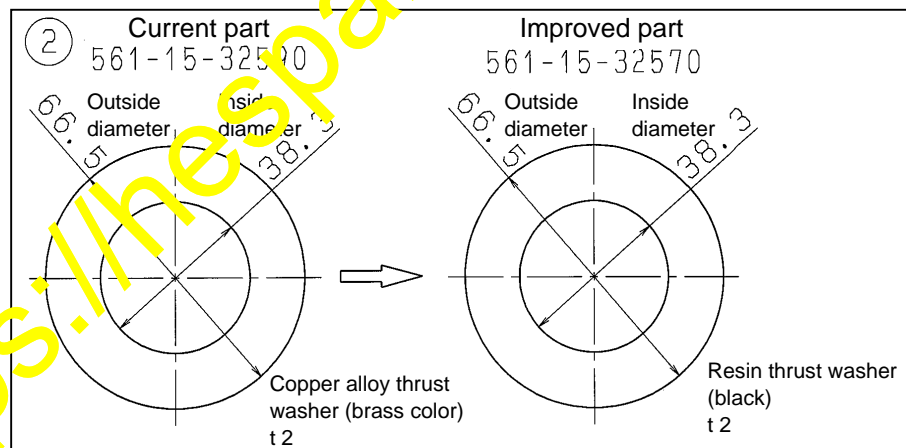
Fig. 2

F, 4th row

② <Current> 561-15-32590
↓
<New> 561-15-32570

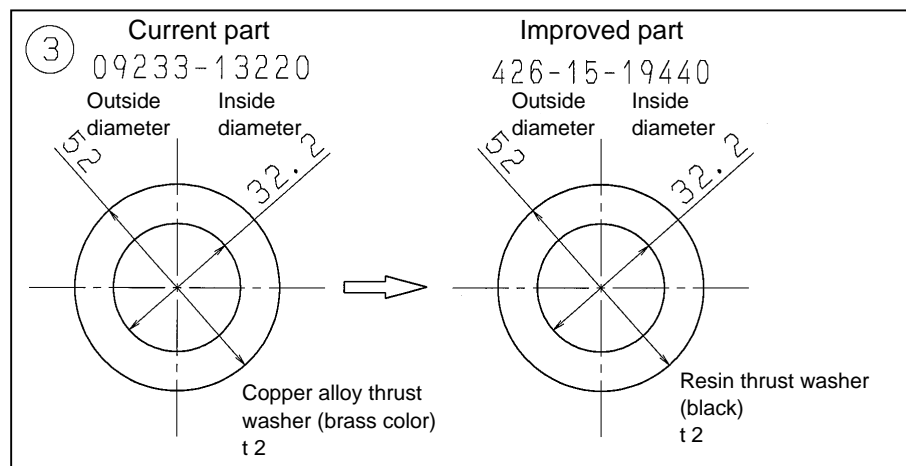
Fig. 3

3rd row

③ <Current> 09233-13220
↓
<New> 426-15-19440

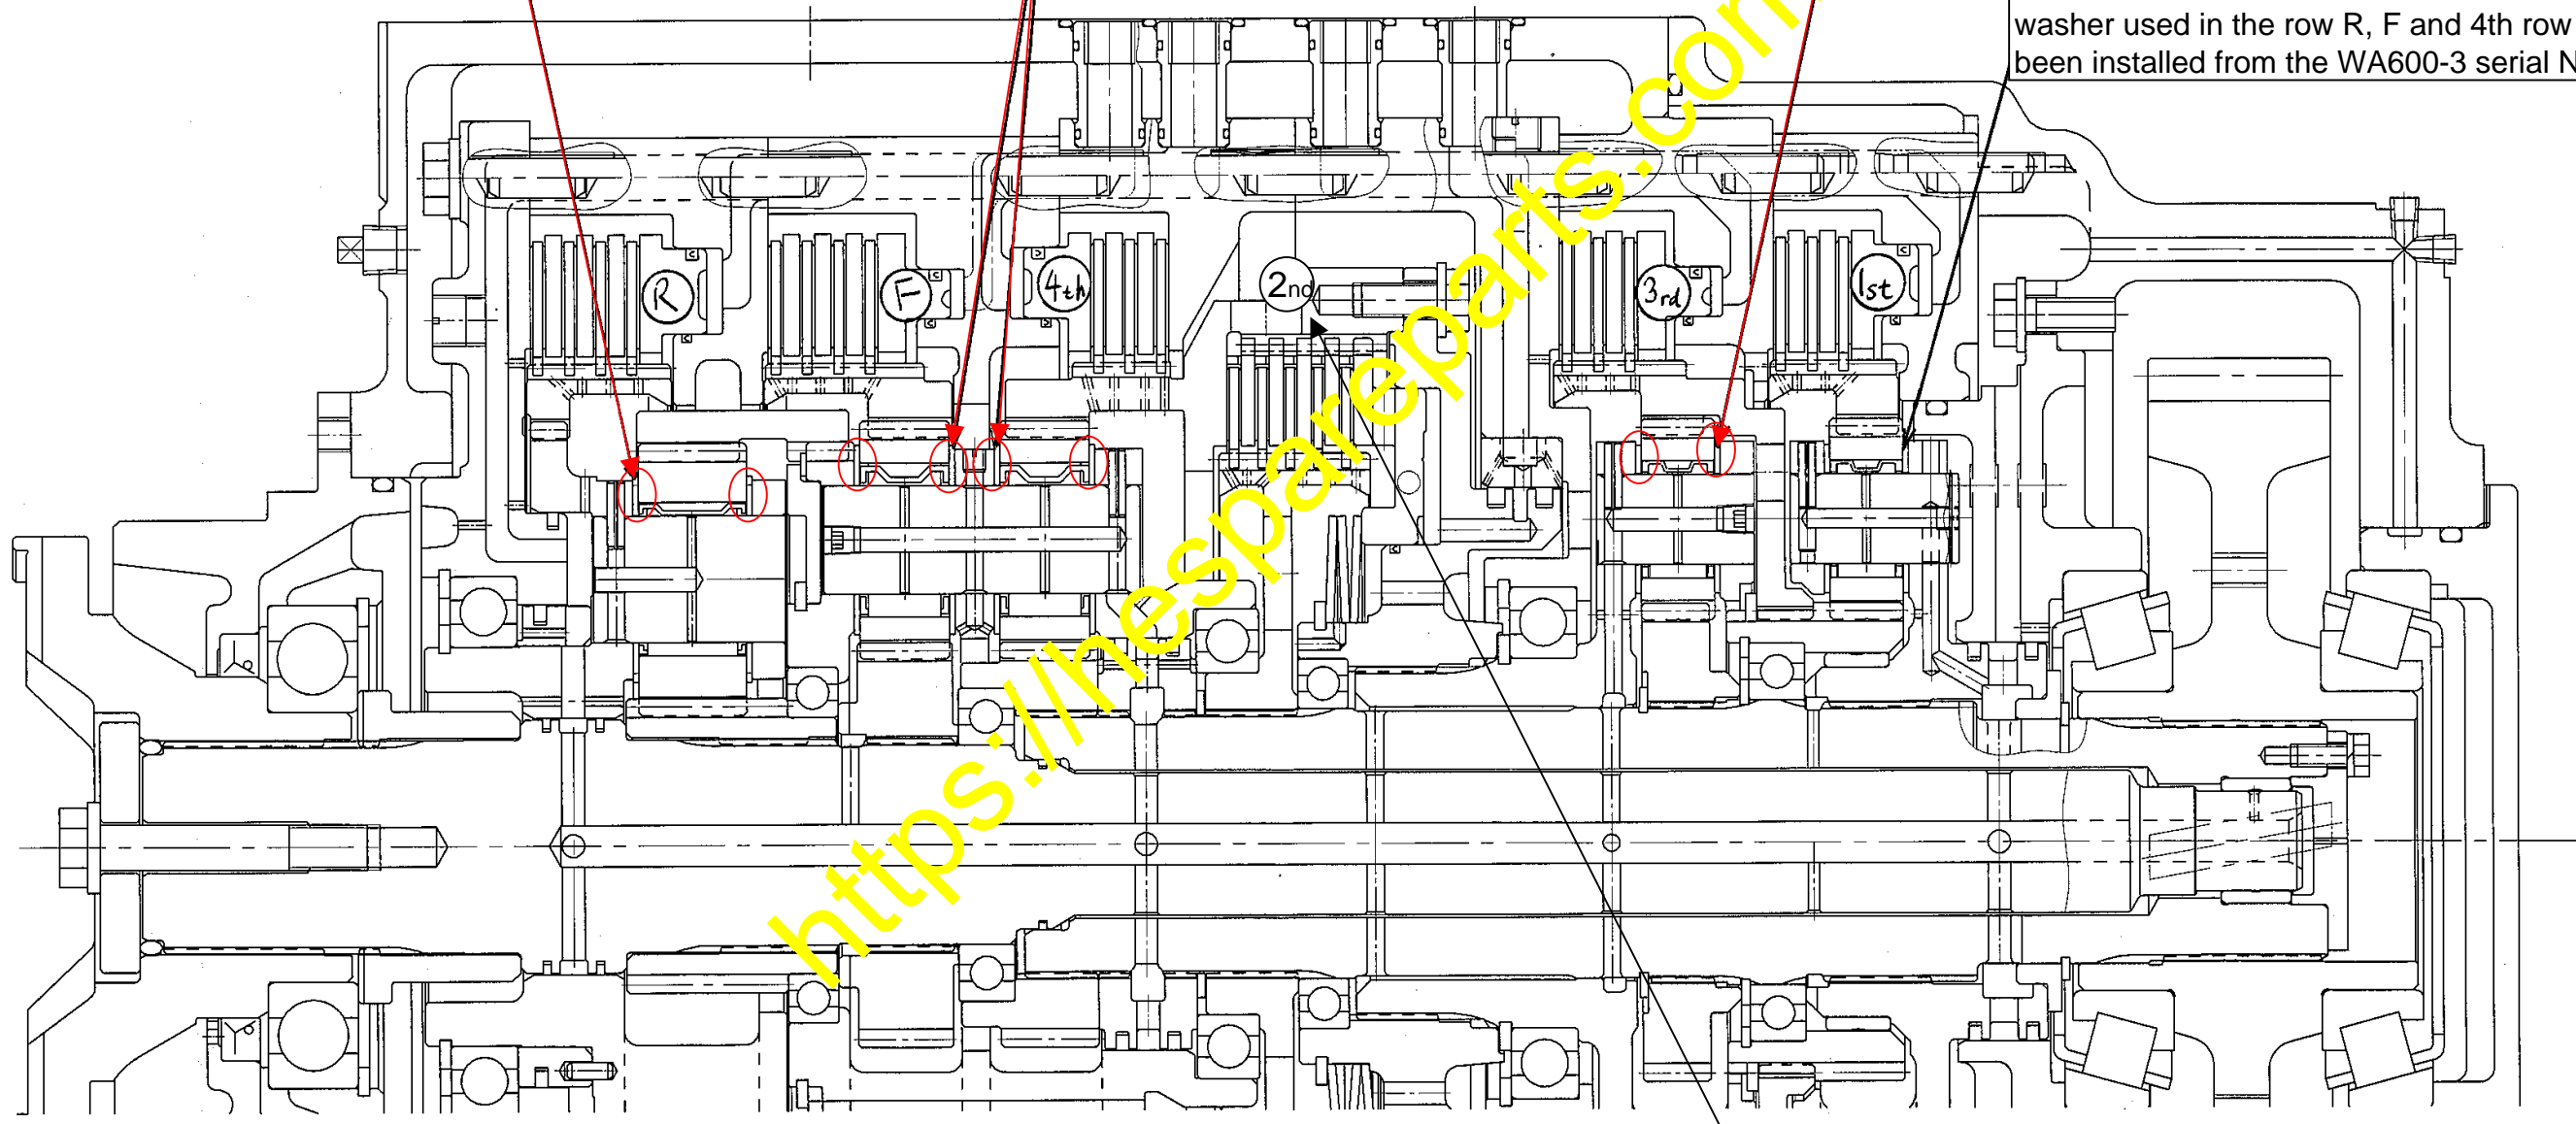
Fig. 4

WA600-3 transmission sectional view

In the 1st row, the parts with improved wear-resistance made of the same material as the thrust washer used in the row R, F and 4th row have been installed from the WA600-3 serial No. 1.

The 2nd row has no thrust washer since it is a revolution clutch.

The copper alloy thrust washer used in the transmission planetary section has been changed to a resin washer to improve the wear-resistance.

For the procedures for disassembling and assembling the transmission, see the Shop Manual.

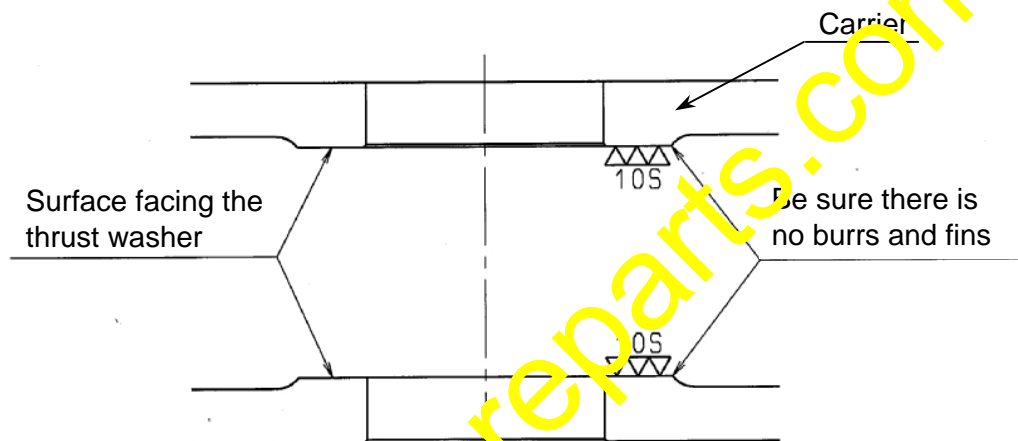
Fig. 5

Sectional view of the pinion shaft hole section of the carrier

- <1> Check that there is no abnormality (wear, scratch, burrs and fins, etc) on the carrier surface facing the thrust washer.
- <2> Remove burrs and fins as much as possible.
