# PARTS & SERVICE NEWS

REF NO.	AT04392
DATE	December 24, 2004

**SUBJECT:** MODIFICATION PROCEDURE TO REPAIR BROKEN MOUNTING BOLTS FOR THE AIR COMPRESSOR OF THE AIR CONDITIONING SYSTEM

**APPLICATION:** WA100-5: 70001-71083  
WA150-5: 70001-71083

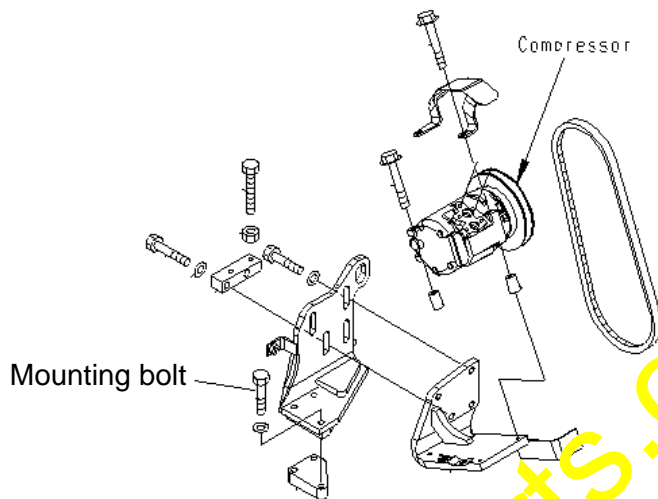
Fig. 1

The mounting bolts for the air compressor of the air conditioning system become broken owing to resonance of the air compressor bracket to the engine vibration.

- 1) The air compressor bracket for the air conditioning system has been strengthened to prevent occurrence of resonance to the engine vibration.
