# PARTS & SERVICE NEWS

REF NO.	AT04802
DATE	May 14, 2004

**SUBJECT:** REPAIR PROCEDURE FOR GRAMMER'S SEAT WITH AJSS ON WA700-3, 800-3, 900-3 AND 1200-3

**PURPOSE:** To introduce modification procedure to repair GRAMMER's operator's seat on the AJSS spec. WA700-3, 800-3, 900-3 and 1200-3 wheel loaders

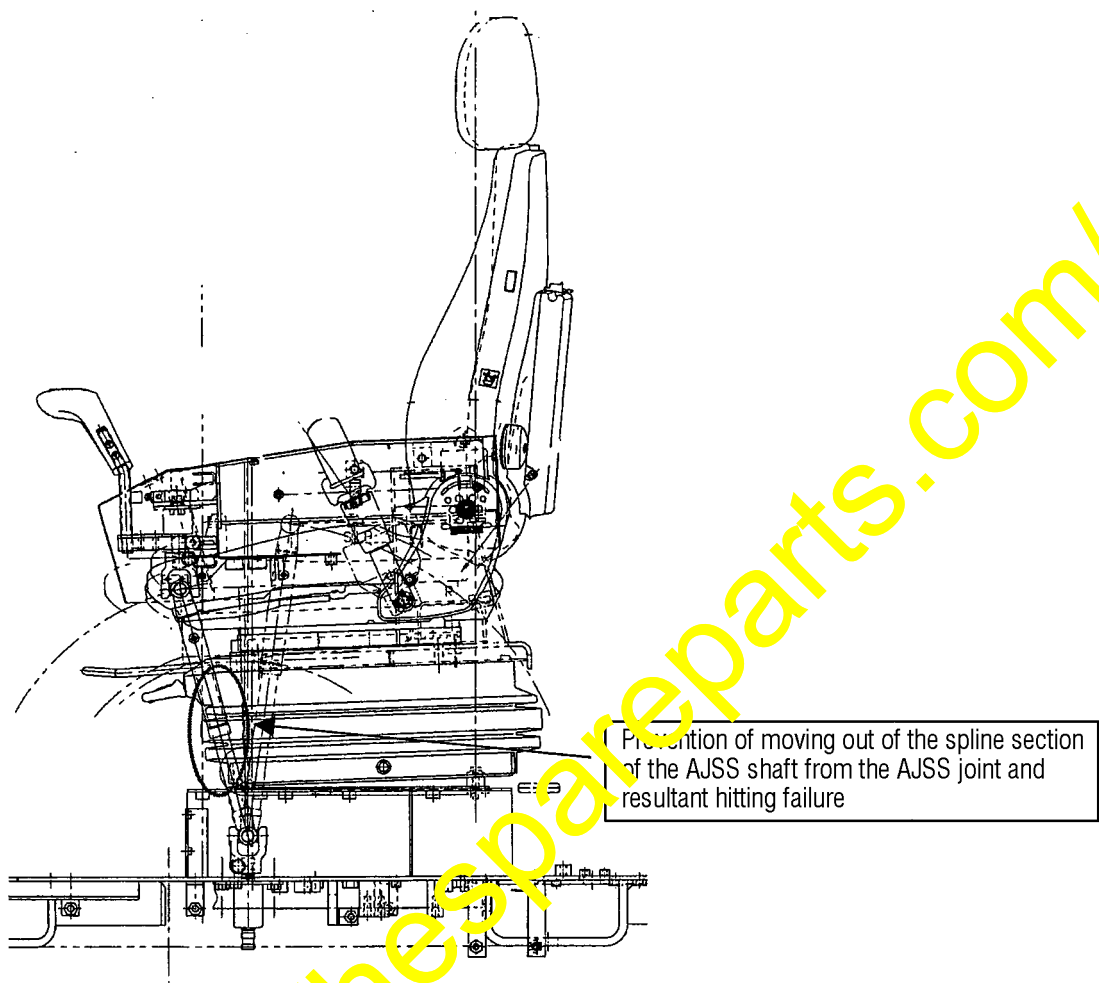
Fig. 1

- (1) The positions of the suspension stoppers (the highest position and the lowest position) for the operator's seat have been changed to prevent the spline section of the AJSS shaft from moving out and hitting.

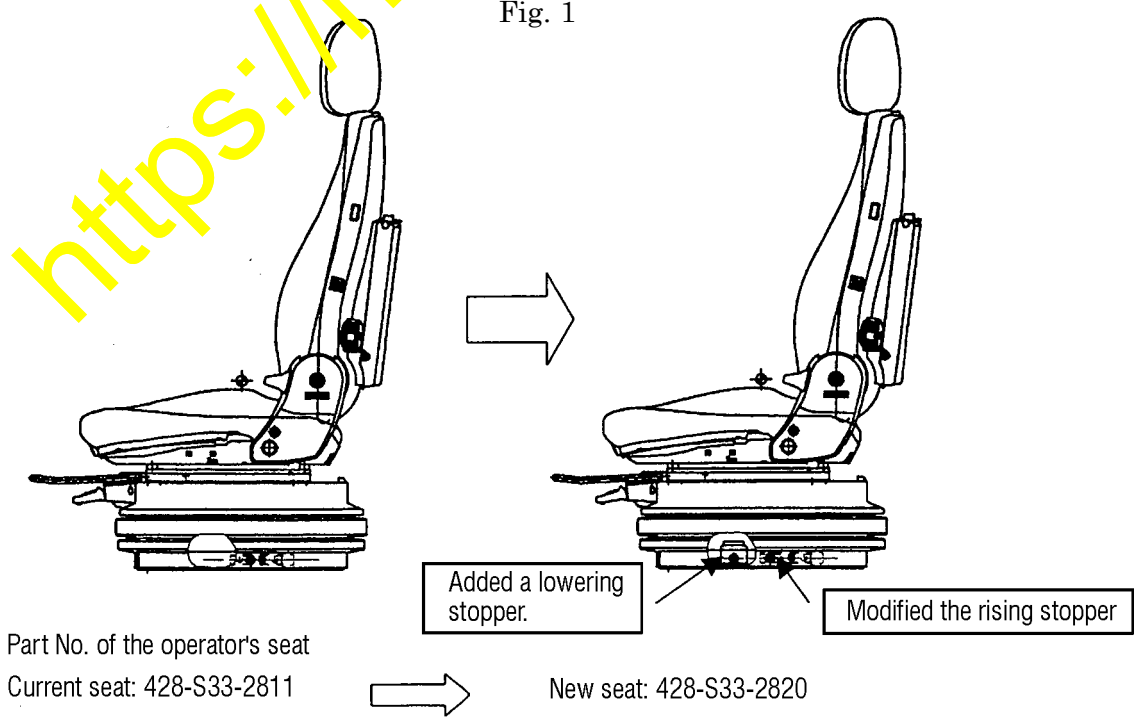
Fig. 2

Part No. of the operator's seat  
Current seat: 428-S33-2811

New seat: 428-S33-2820

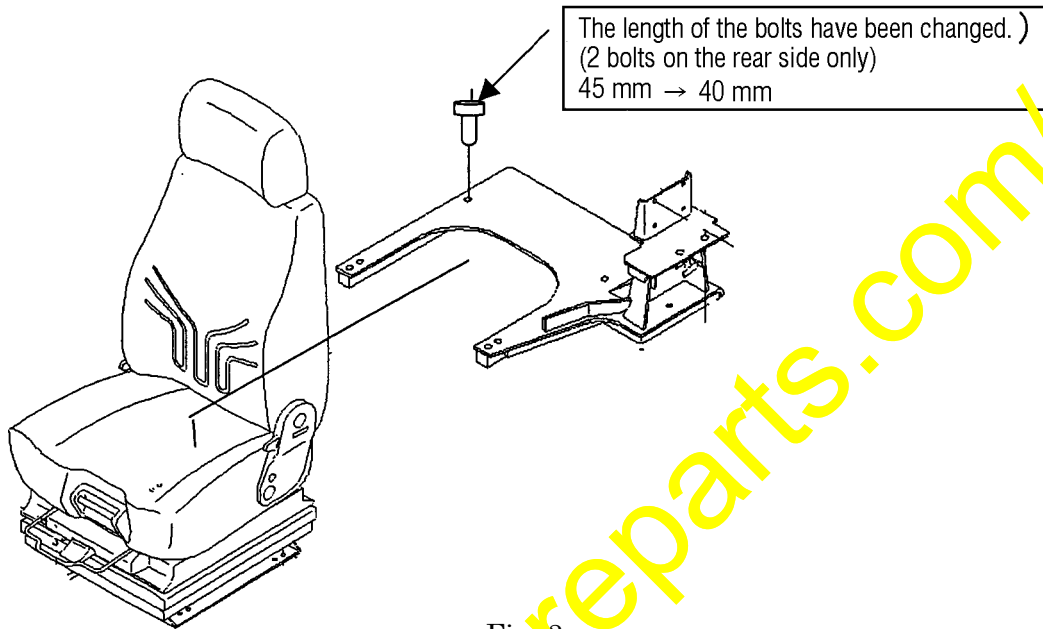
Fig. 3

- (2) The length of the AJSS bracket mounting bolts have been changed to prevent occurrence of interference between the bolt and the suspension.

(Failure phenomenon)

Interference occurs between the bolt and the suspension link to shorten the suspension stroke.

Current bolt: Part No. 01252-70845

New bolt: Part No. 01252-70840
