COMPONENT CODE 54 PARTS & SERVICE REF NO. AT04812 DATE May 26, 2004 Page 1 of 7

SUBJECT: STRENGTHENED DRIVE SHAFT GUARD FOR HM300-1

- **PURPOSE:** To introduce strengthened drive shaft guard for use on HM300-1 articulated dump trucks
- **APPLICATION:**HM300-1Articulated Dump Trucks, Serial Nos. 1001 thru 1147HM300TN-1Articulated Dump Trucks, Serial Nos. 1001 thru 1002

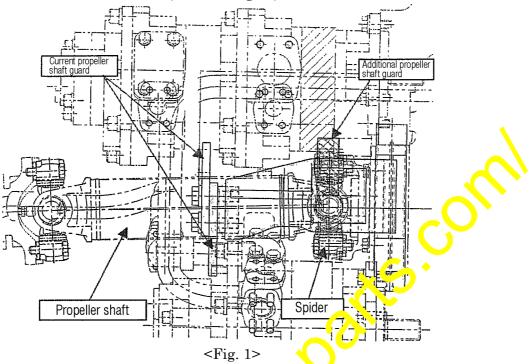
3. Details of the modification

In order to avoid the damages of the parts around the drive shaft between the engine and the torque converter on the HM300-1 articulated dump tracks even if the shaft is broken, KOMATSU has improved the drive shaft guard to increase the strength and introduces the improved guard in this Service News.
