COMPONE	ENT CODE 79
PARTS & SERVICE	REF NO.	AT04823
NEWS	DATE	Jun. 4, 2004
		Page 1 of 5

SUBJECT: REPAIR PROCEDURE FOR TAIL GATE (OPTION) ON HM400-1

PURPOSE: To introduce modification procedure to replace the tail gate on HM400-1 articulated dump trucks with the improved parts (optional)

APPLICATION: HM400-1 Articulated Dump Trucks, Serial Nos. 1071 thru 1076 Serial Nos. 1087 thru 1088 Serial Nos. 1118 thru 1119

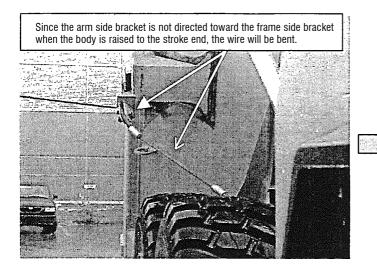
- 3. Details of the modification
 - (1) The mounting angle of the wire mounting bracket is changed to make a structure where the wire may be pulled straight forward when the body is raised to the stroke end.

The motion of the wire mounting brack t is changed so that the arm side bracket may be directed toward the frame side bracket when the body is raised to the stroke end.

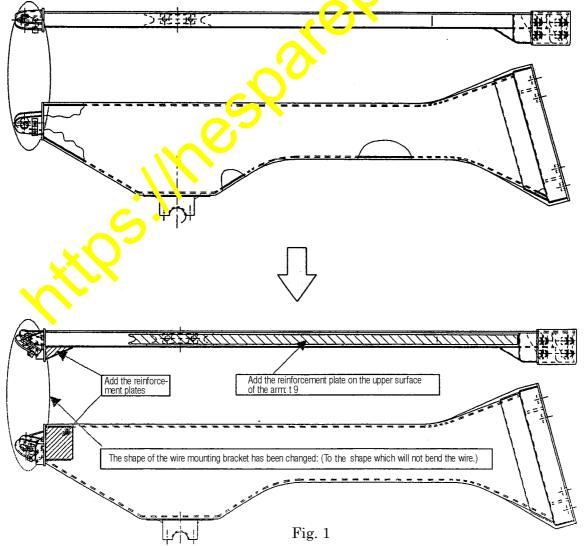
On the HM400-1 articulated dump trucks, the arm of the tail gate may be deformed to cause interference with the body. If the interference of turs with the tail gate arm, make the modification introduced in this Service News to repair the interference.

(2) To prevent the deformation of the arm, add the reinforcement plates to the upper surface and to the rear section of the wire mounting section to increase the rigidity.
