PARTS & SERVICE NEWS

REF NO.	AT97109
DATE	Jun. 6, 1997

SUBJECT: IMPROVEMENT HYD. OIL COOLER PIPING ON WA800/WA900-1

PURPOSE: To introduce crack occurrence preventive modification procedures for the hydraulic oil cooler piping on WA800-1/2 and WA900-1 wheel loaders.

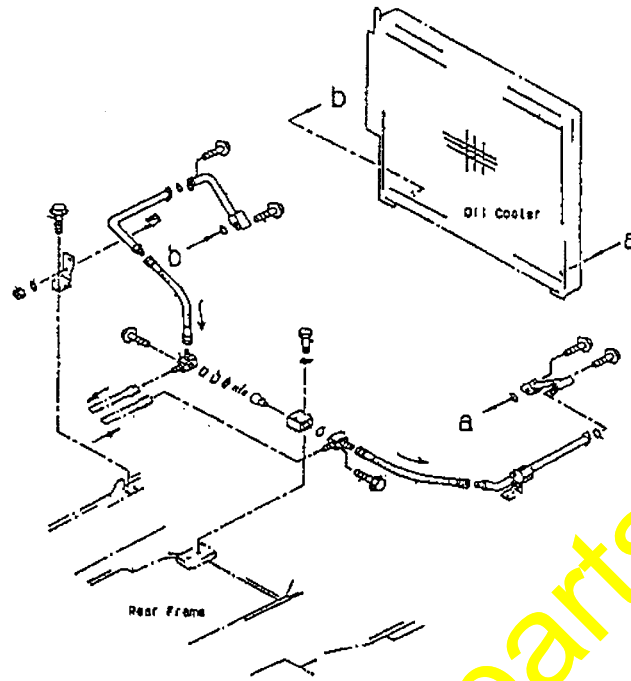
Current

With the WA800 and WA900 wheel loaders, the peak internal pressure occurring in the hydraulic circuit connecting to the inlet of the hydraulic oil cooler may cause cracks in the header root section of the piping for the air-cooling type hydraulic oil cooler, leading finally to an oil leakage failure. To prevent occurrence of such a failure, execute the modification introduced in this Service News.
