PARTS & SERVICE NEWS

REF NO.	AT99038
DATE	Apr. 12, 1999

SUBJECT: REPAIR PROCEDURE OF TUBE FROM E/G TO T/C COOLER ON WA800/900, WD900

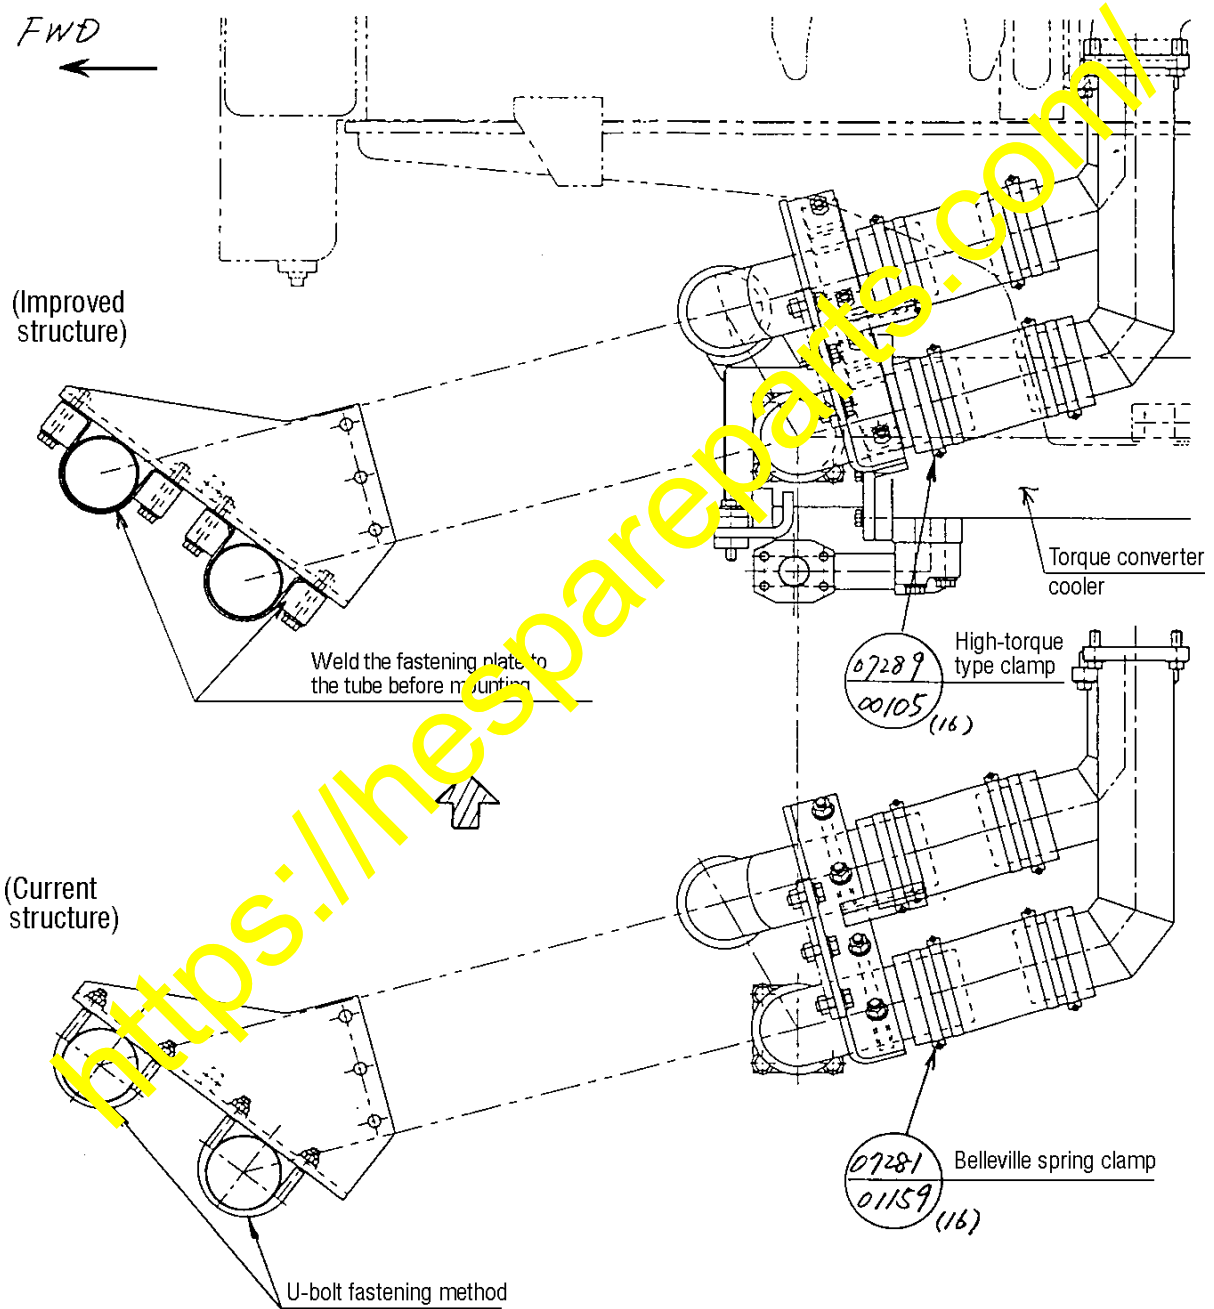
By deformation of the tubes connecting between the engine and the torque converter cooler on the WA800, WA900 and WD900 wheel loaders, the U bolts fastening these tubes may become loose to cause slipping out of the tubes from mating hoses by pressure of the water and by vibrations occurring while the machine is in operation. To prevent the above failure, make the modification introduced in this Service News by changing the designated parts to the improved versions.

- ① Modify the fastening method for the tube connecting between the engine and the torque converter cooler.
 - Change the current U-bolt fastening method to a new method where the tube fastening plate is welded to the tubes before mounting them to their positions.
- ② Modify the type of clamp for the hose connecting between the engine and the torque converter cooler.
 - Change the belleville spring clamp to the high-torque type clamp.
