**PARTS & SERVICE
NEWS**

REF NO.	AT99140
DATE	Sep. 16, 1999

SUBJECT: REPAIR OF CAP AT HARNESS CONNECTOR FOR ECSS (OPT.) ON WA320—WA470-3

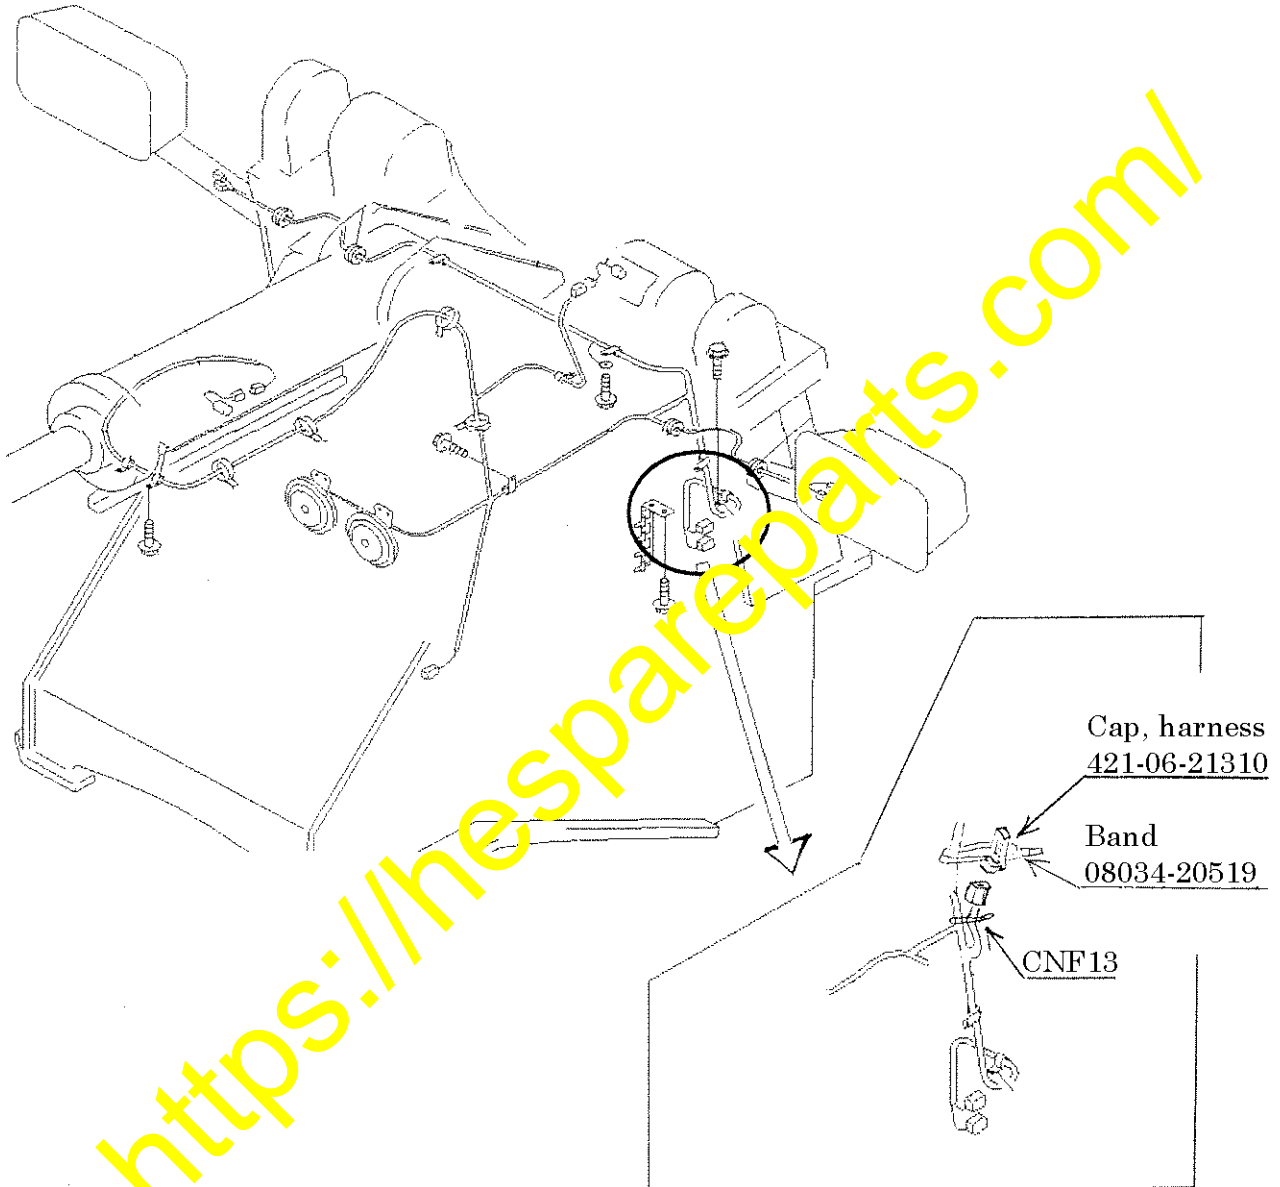
When the optional ECSS is not installed leaving the harness connector for the ECSS unconnected, a cap needs to be installed to the harness connector to prevent entry of water. However, there is a possibility that some of the above listed machines were shipped without installing such a cap and consequently, you are kindly requested to check the connector section at opportunities such as of rendering periodical services, and if the cap is found not installed, install it following the procedures outlined in this Service News.

※ If the connector CNF13 is left unused without installing the harness cap and if water enters in the harness, malfunction of bucket leveler, boom kick-out, etc. may result.

Inspect the front harness connector (CNF13) located at L.H. inside of the front frame, to check whether the cap, harness (421-06-21310) is installed or not. (It is not necessary to check the machine with the ECSS.) If not installed, install the cap and fix it to the harness with the band.
