PARTS & SERVICE	REF NO.	AT99155
NEWS	DATE	Nov. 1, 1999
		Page 1 of 6

SUBJECT: INTRODUCTION OF IMPROVED M-CLUTCH DISC OF TRANSMISSON ON 530M

PURPOSE: To introduce new M-clutch discs with improved wear resistance for use with the transmission assembly on 530M

APPLICATION: 530M Dump truck S/.N 32638, A30003 THRU A30035

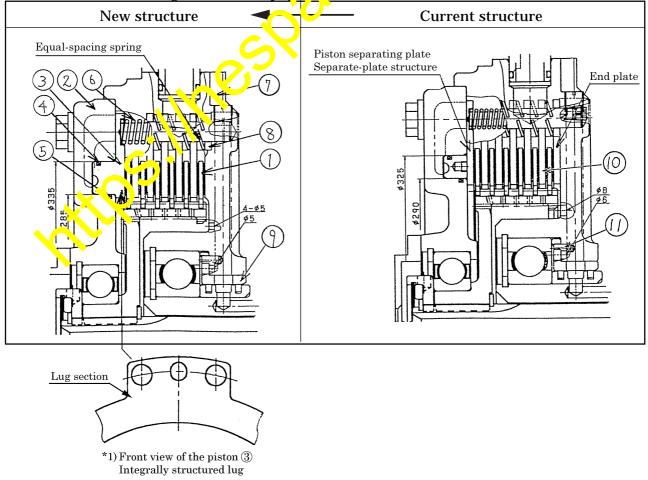
When the machine is used in work sites where "shifthunting" (automatic gear shifting) occurs and speed changes must be made frequently, the M-clutch discs may wear quicker. To solve this problem, we have made the following improvements to enhance the wear resistance of the M-clutch discs.

- 1) We have changed the friction material of the disc ① from molded resin to sintered alloy to improve the wear resistance and heat radiation performance.

- 2) Since the friction coefficient of the sintered alloy disc is smaller than that of the molded resin disc, the sectional area of the piston ③ has been enlarged to maintain the same clutch torque capacity as with the current state.
 Pursuant to this change in the sectional area of the piston ③, the housing ② and seal rings ④ and ⑤ have also been changed.

- 3) Pursuant to the aforementioned change of the material of the disc, the structure of the piston has been changed from the separate-plate structure to integral-rug structure [*1] and use of the end plate has been discontinued.

- 4) Pursuant to the discontinuation of use of the end plate according to the above Paragraph 3), the shape of the housing has been changed and the plate (1) needs to be supplemented to preserve the positioning of the equal-spacing spring (in a shape of a spring washer).

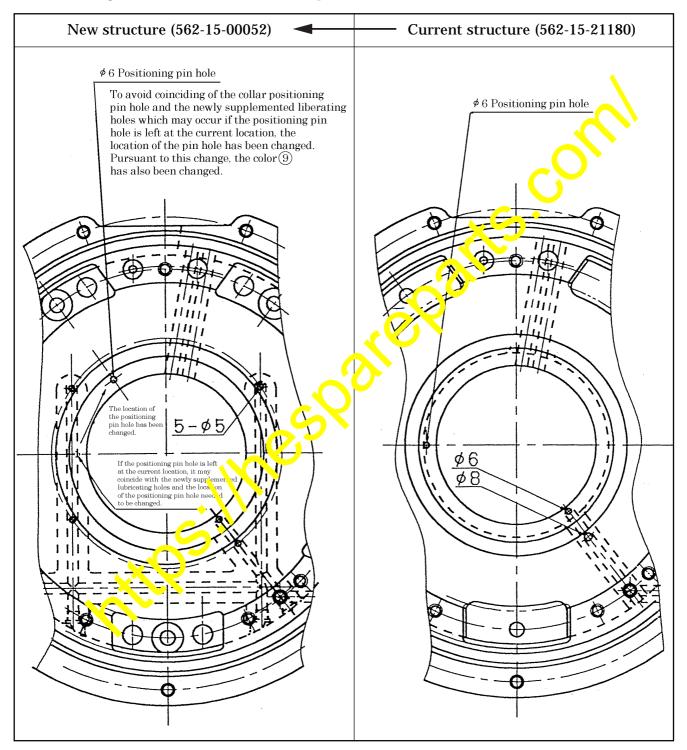
• Detail drawing for the changes according to Paragraphs 5) and 6) on page 3

- 5) To improve the lubrication efficiency for the discs, the number of the lubricating holes in the housing ⑦ has been increased.
 - New structure: 5 ϕ 5 \leftarrow Current structure: $\phi + \phi \delta$

- 6) To avoid coinciding of the collar positioning pit hole and any of the newly supplemented lubricating holes which may occur atten the change of the lubricant circuit according to the above Paragraph 4), the location of the positioning pin hole in the collar

(9) has been changed. (Refer to page 2)
