# PARTS & SERVICE NEWS

REF NO.	AT99219
DATE	Feb. 7, 2000

**SUBJECT:** REPAIR OF ENGINE MOUNTING BOLT ON WA100-3 – WA250-3

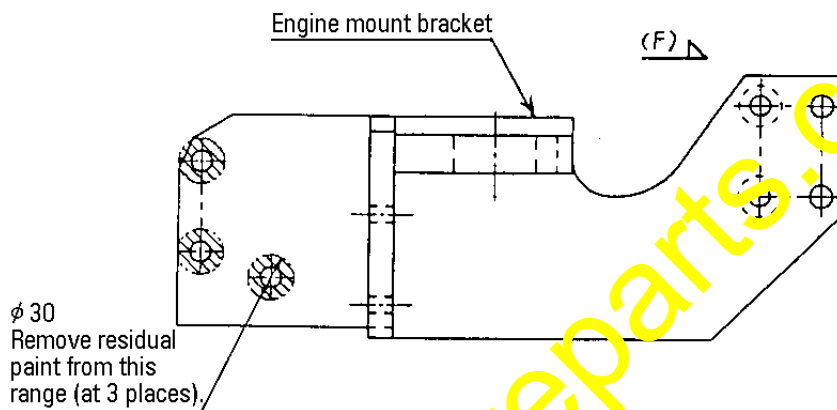
With the wheel loaders of Models WA100-3 thru WA250-3, there is the danger of loosening of the mounting bolts for the engine-mount bracket (on the RH side of the chassis) because of the fatigue occurring on the bearing surface of the mounting bolts.

As for the rear side mounting bolts (3 units) for the engine mount bracket on the RH side of the chassis, we have replaced the current washer-faced-head bolts with bolts plus washers to reduce the bearing pressure applied to the bearing surfaces of the mounting bolts to eliminate fatigue thereby to prevent loosening of the mounting bolts.

- 1) Remove the mounting bolts (washer faced head bolts) for the engine mount bracket on the RH side of the chassis.
- 2) Remove the remaining paint from the contact surfaces, to the bearing surfaces of the mounting bolts, on the engine mount bracket. (For the range of  $\phi 30$  at 3 places)
