INSTALLATION MANUAL

REF NO.	BA99001
DATE	Oct. 27, 2003 (Rev.)

SUBJECT: INTRODUCTION OF REINFORCED BELLCRANK

APPLICATION: WA500-1 Wheel Loader, All Domestic and Imported Serial Numbers

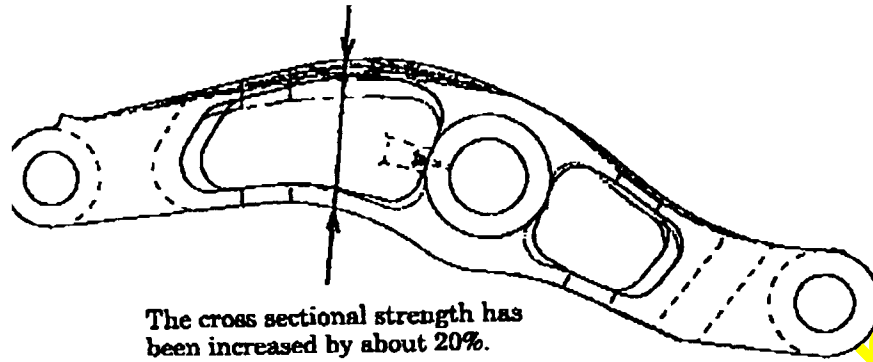
Contents of the Improvement:

When the wheel loader is equipped with a heavy weight front attachment locally fabricated and installed and when the operator frequently shakes the attachment of frequently employs the shock-dumping movement to accelerate the dumping effects, the bellcrank of the vehicle may break.

This **Installation Manual** will introduce a further improvement to withstand use of a heavy weight attachment by increasing the strength of the bellcrank. Meanwhile even after implementation of this modification of the bellcrank, we suggest you to commonly implement the modification according to the **Parts & Service News** A890227, to alleviate the influence of the impact loads being applied to the vehicle body.
