INSTALLATION MANUAL

REF NO.	BT02066
DATE	Oct. 31, 2002

SUBJECT: INTRODUCTION OF REINFORCED TYPE MOUNTING BRACKET OF A/C COMPRESSOR ON WA1200-3

PURPOSE: To introduce modification procedure to reinforce the air compressor mounting bracket of the air conditioning system on WA1200-3 wheel loaders to prevent occurrence of cracks

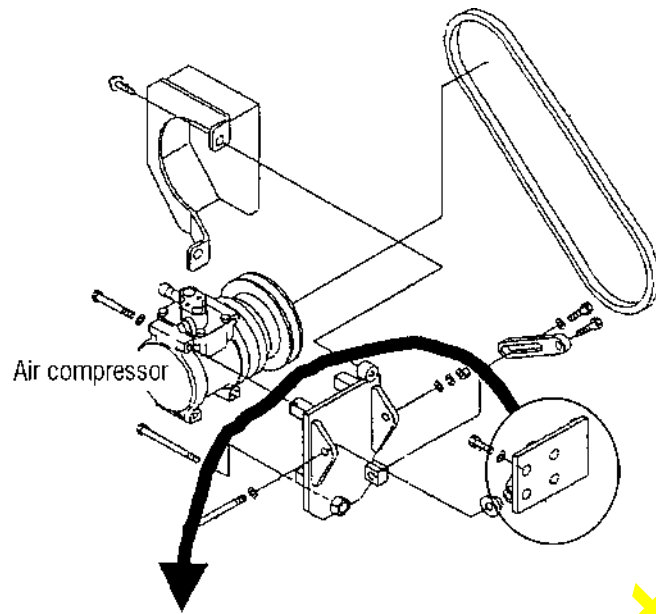
On the WA1200-3 wheel loaders, there is a possibility of occurrence of cracks in the welded section between the pipe and the plate (refer to page 2 for the exact position) owing to insufficient strength of the air compressor mounting bracket of the air conditioning system.

Air compressor mounting bracket (Part No. 42C-07-11161) of the air conditioning system:

There is a possibility of occurrence in the welded section between the pipe and plate.

welded section between the pipe and the plate

- ① When modifying the bracket locally, make the modification as per the modification procedure being indicated on pages 3 and 4.
- ② When ordering the improved bracket (42C-07-11162) to replace the current bracket, it is not necessary to make the modification as per pages 3 and 4.

Weld the reinforcement plate to the hatched section additionally.

New part number: Same as the current Part No. 42C-07-11162
