INSTALLATION MANUAL

REF NO.	BT98045A
DATE	Feb. 13, 2002
-	Page 1 of 3

- SUBJECT: INTRODUCTION OF IMPROVED AIR RESERVOIR ON HD325-5, HD325-6, HD405-6, HD255-5
- PURPOSE: To introduce strengthened air reservoir for use on HD325-5, HD325-6, HD405-6 and HD255-5 dump trucks
- APPLICATION: HD325-5 Dump Trucks, Serial Nos. 2001 thru 4293 HD325-6 Dump Trucks, Serial Nos. 5001 and up HD405-6 Dump Trucks, Serial Nos. 1001 and up
 A HD255-5 Dump Trucks, Serial Nos. 1001 and up

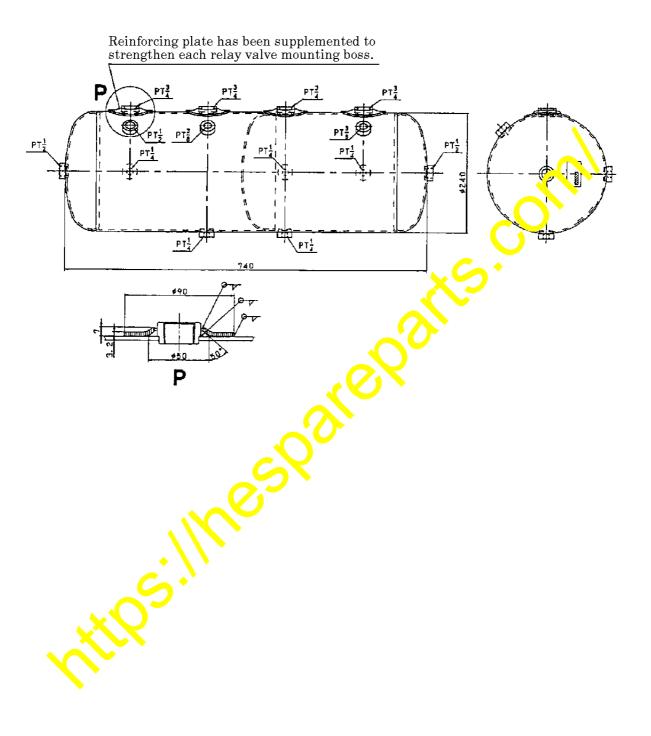
3. Contents of the strengthening modification with the air reservoir Reinforcing plates have been supplemented to strengthen the relay valve mounting bosses.
