PARTS & SERVICE NEWS

REF NO. AT04171

SUBJECT: MODIFICATION PROCEDURE TO PREVENT ABNORMAL WEAR OF SPLINE SECTION OF ADDITIONAL COOLER FAN DRIVE MOTOR SHAFT

- **PURPOSE:** To inform Field Personnel
- APPLICATION: WA900-3 Wheel Loaders, S/N 50001 thru 50041 WD900-3 Wheel Dozer, S/N 50001 thru 50014
- FAILURE CODE: L932CC

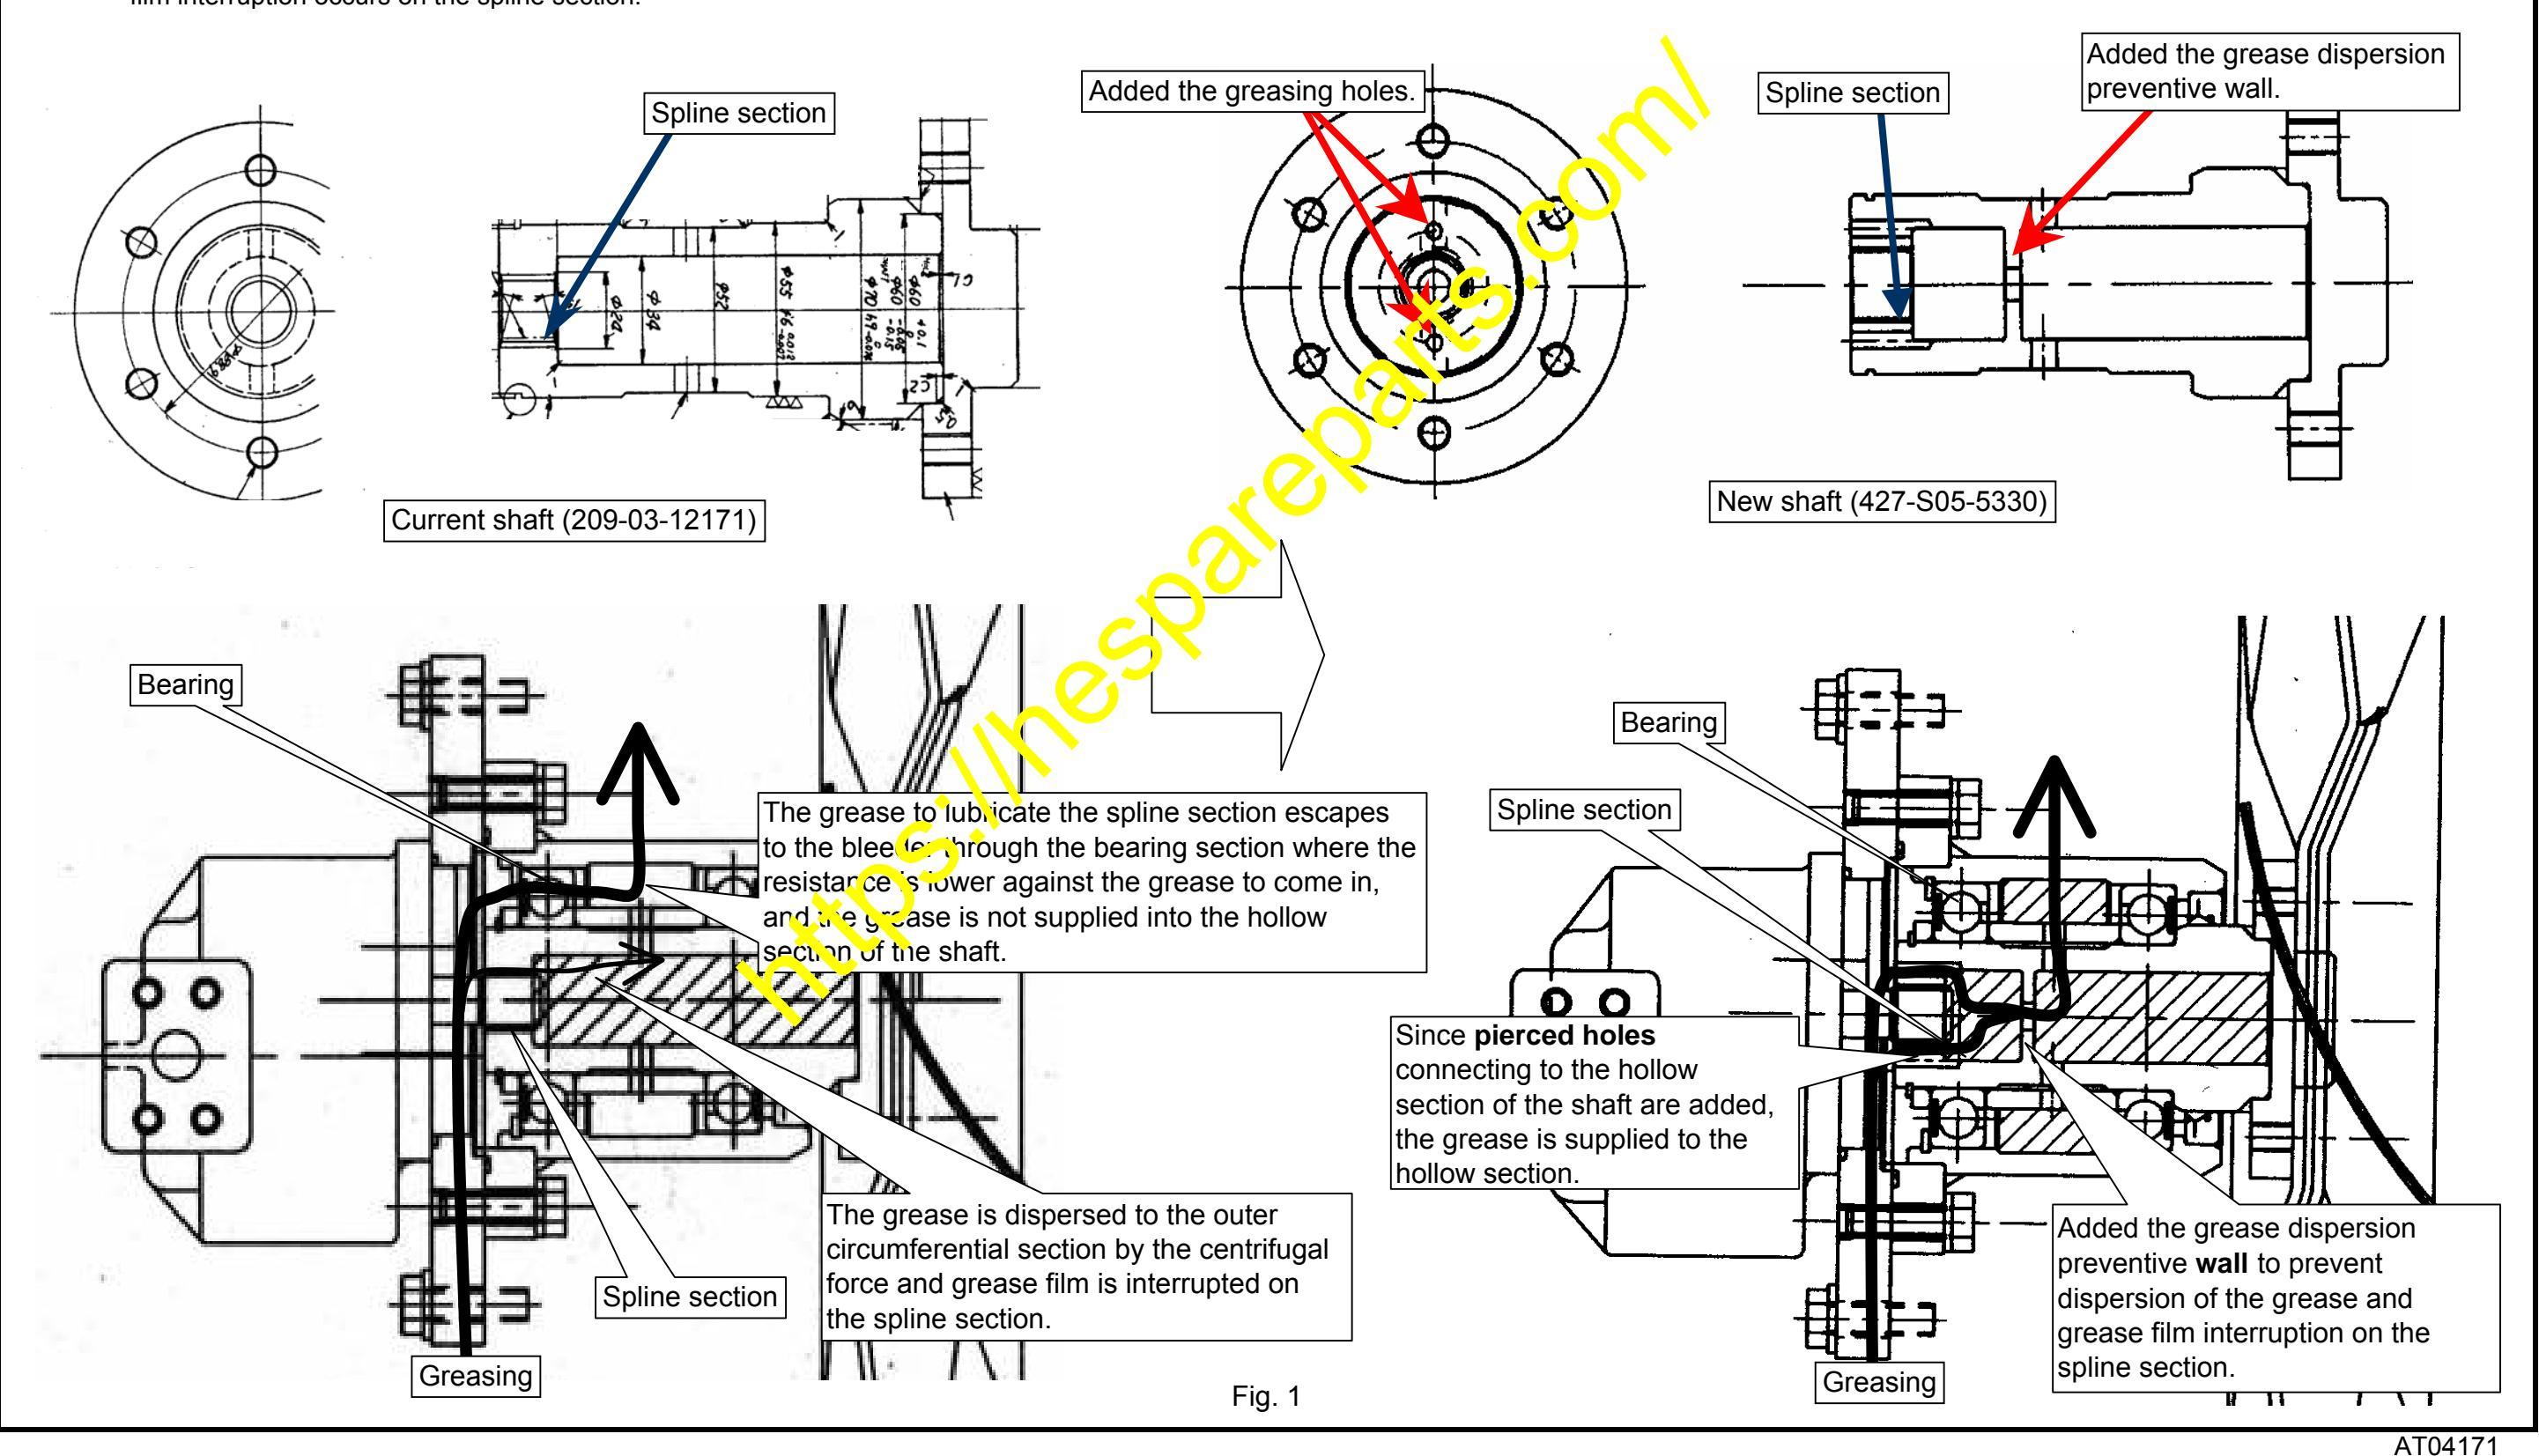
Current state

- <1> The grease to lubricate the spline section escapes to the outer circumferential section through the bearing where the immersion resistance is low and the grease is not supplied into the hollow section of the shaft.
- <2> The grease is dispersed to the outer circumferential section by the centrifugal force and grease film interruption occurs on the spline section.
