PARTS & SERVICE NEWS

REF NO.	AA00200A
DATE	January 26, 2001

SUBJECT: IMPROVE BLADE LOWERING PERFORMANCE

PURPOSE: To eliminate vibration when lowering the blade, particularly the 14 foot blade.

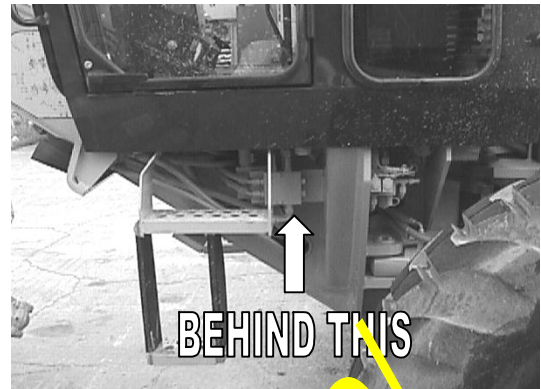
1. Lower the blade so it rests on the ground.
2. Locate the dual counterbalance valve assembly on the left side of the machine, under the cab.

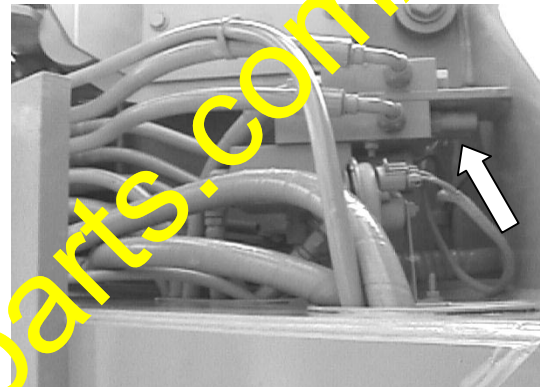
3. The valve cartridges that need to be replaced are on the inside of the mounting bar, as shown, looking at the assembly from under the machine.

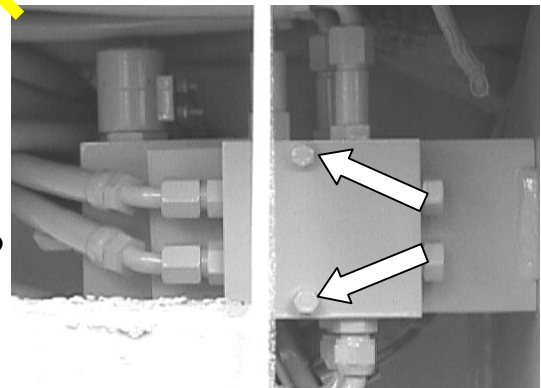
4. Remove both of the 5/16 inch nuts and mounting bolts. Pivot the valve block clockwise to allow enough room to remove the old cartridges. It may be necessary to loosen the horn mounting bracket and rotate the horn out of the way, or to remove the horn.
5. Place a container on the ground under the valve block to catch excess hydraulic fluid. A cup or so of hydraulic fluid may leak out when the cartridges are loosened.
6. Loosen and slowly back out the cartridges. Replace the old cartridges (2) with new ones (1440 166 H91). Tighten each to 10~35 lbf ft (40.7~47.4 N•m) with a 7/8 inch wrench.
7. Reinstall the 5/16 inch mounting bolts and nuts. Tighten to 15~17 lbf ft (20.3~23.0 N•m). Reinstall the horn in its original position.

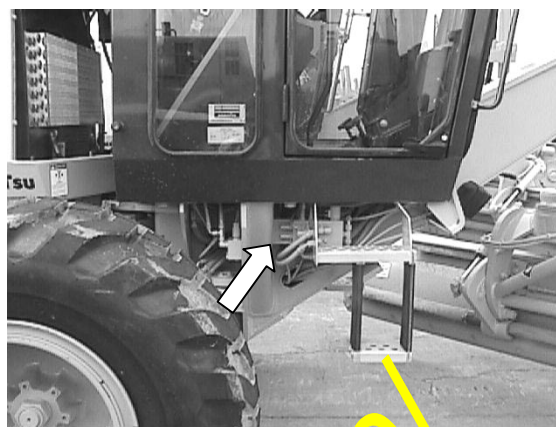
8. Locate the dual counterbalance valves on the right side of the machine, under the cab. On this side of the machine, the cartridges are toward the outside and can be seen in these pictures.

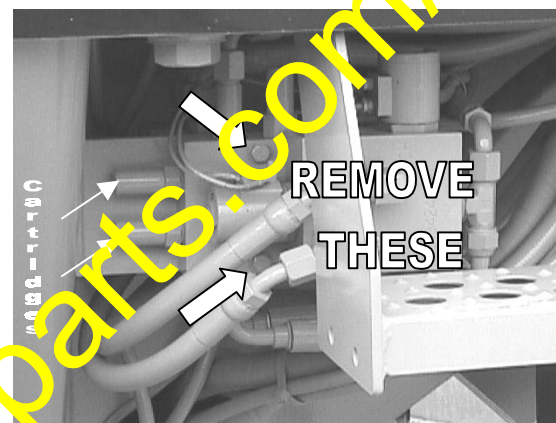
9. Remove the two 5/16 inch mounting nuts and bolts illustrated in the picture. Do not confuse them with those in the following picture. It may be necessary to loosen and pivot one or both of the hose fittings seen in these pictures in order to get the lower bolt out.

10. When the bolts are pulled out, two spacers should fall out. Be sure to put these back as indicated later.

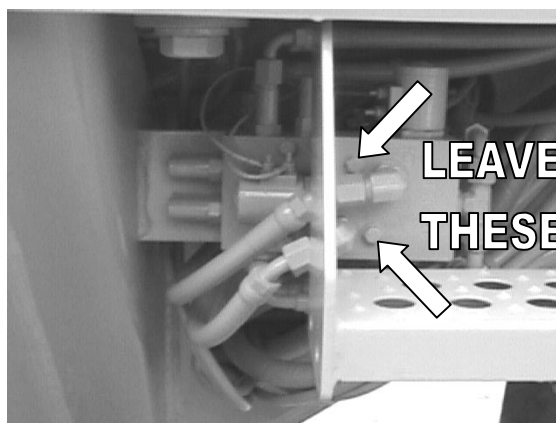
11. Rotate the valve block counter-clockwise to a low enough room to get the old cartridges out. Place a container under the valve block to catch excess hydraulic fluid.
12. Slowly back each cartridge (2) out and replace it with a new one (1440 106 H31). Tighten to 30~35 lbf ft (40.7~47.4 N•m) with a 7/8 inch wrench.

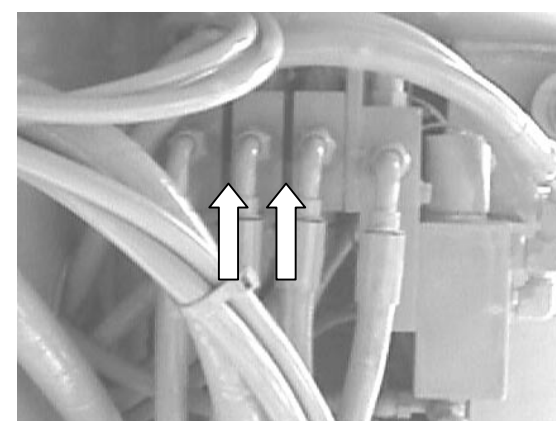
13. Reinstall the valve block mounting hardware. After pushing the bolts through, put the spacers back in place as shown. Tighten to 15~17 lbf ft (20.3~23.0 N•m). Finally, tighten any hose fittings that were loosened in the process.
