# PARTS & SERVICE NEWS

REF NO.	AA01115
DATE	June 29, 2001

**SUBJECT:** FAN GUARD MOUNTING REWORK

**PURPOSE:** Introduce the procedure to modify the fan guard mounting

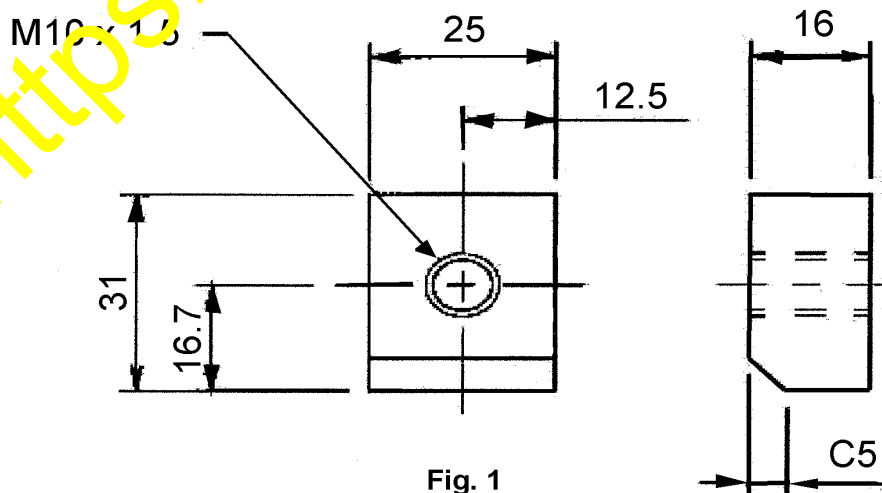
Part No.: 01

Part name: Seat

Material : SS400P

Qty : 2 / Vehicle

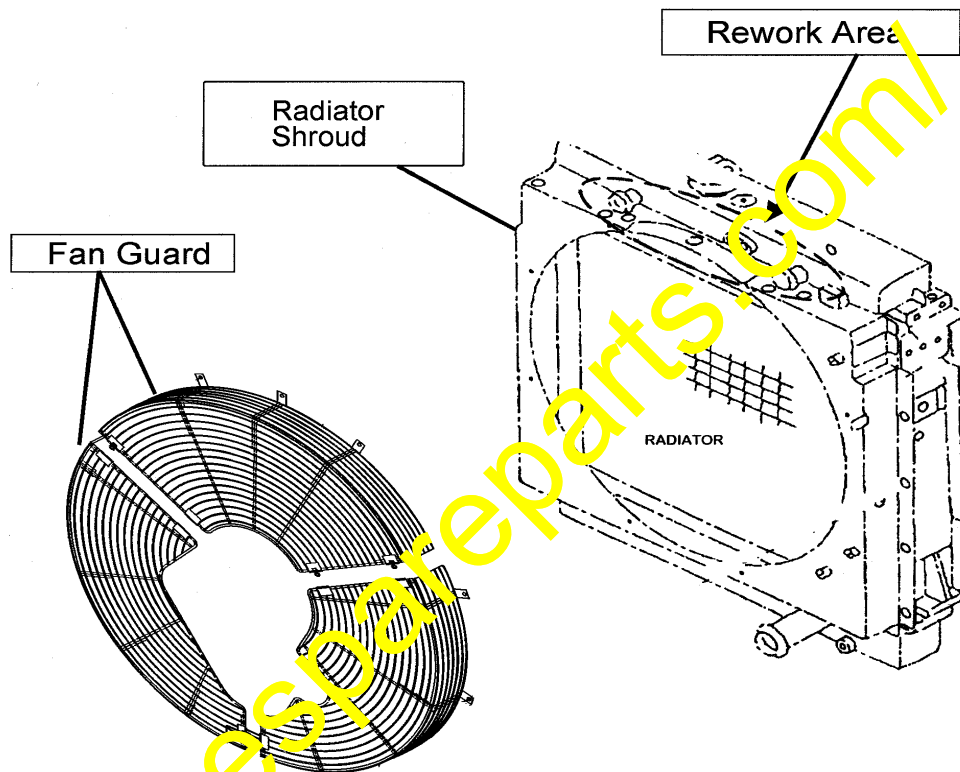
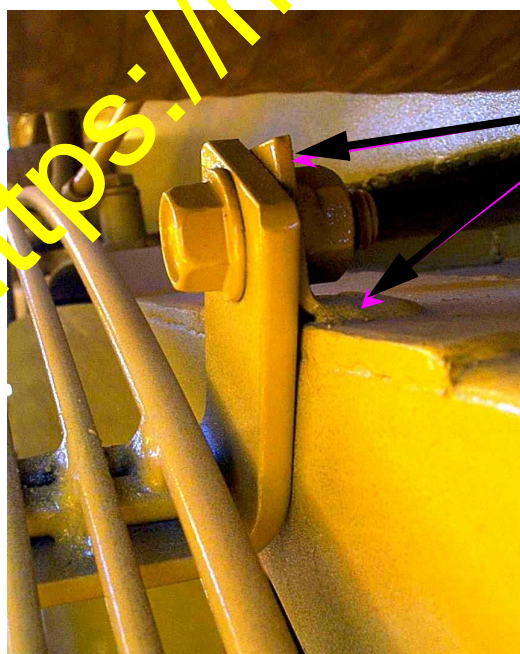
1. Uninstall fan guards from shroud.
2. Remove broken plates from radiator shroud  
(LH and RH, 2 places)

Remove the L-shape brackets,  
LH & RH from Radiator shroud  
and grind removed area to  
smooth.  
Photo shows LH side.

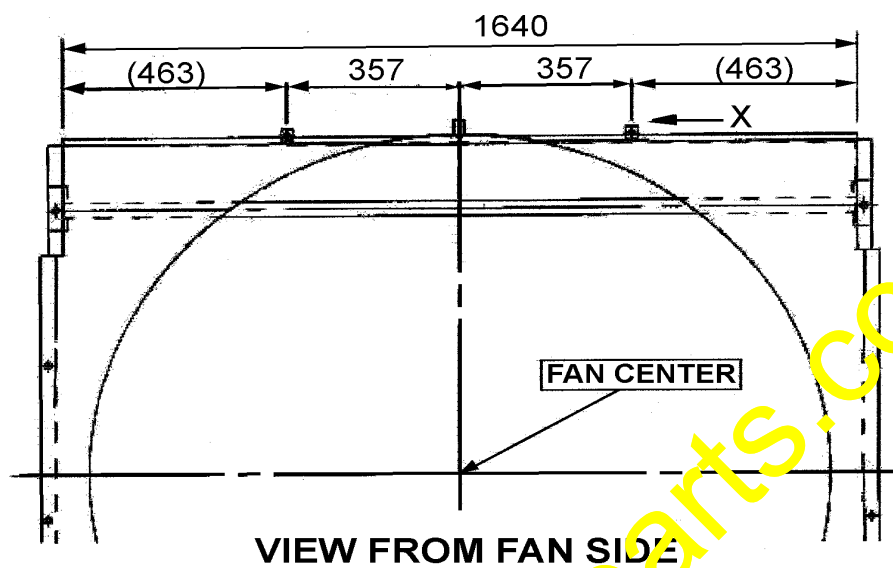
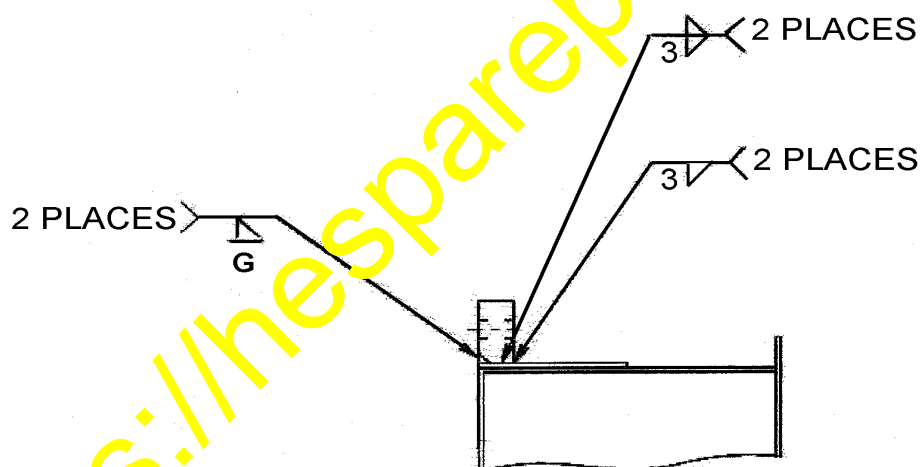
3. Weld new mounting block

Weld new seats as shown below.

Fan guards may be used for seat positioning.
