# PARTS & SERVICE NEWS

REF NO. AA02165

- SUBJECT:** ENGINE WARNING INDICATORS IN THE OVERHEAD DISPLAY
- PURPOSE:** Inform the field of an available kit for changing the location of one of two red "stop engine" warning indicators currently located in the overhead display.
- APPLICATION:** Komatsu Electric Drive Dump Trucks:  
930E: AFE48-A & Up, A33019, A30026 & Up  
830E: AFE50-A & Up, A30544 & Up;  
**equipped with Cummins QSK-60 engines or Komatsu S37A16V160 engines**
- FAILURE CODE:** DP00Z9
- DESCRIPTION:** Engine Warning Light Modification Kit (XKC152)

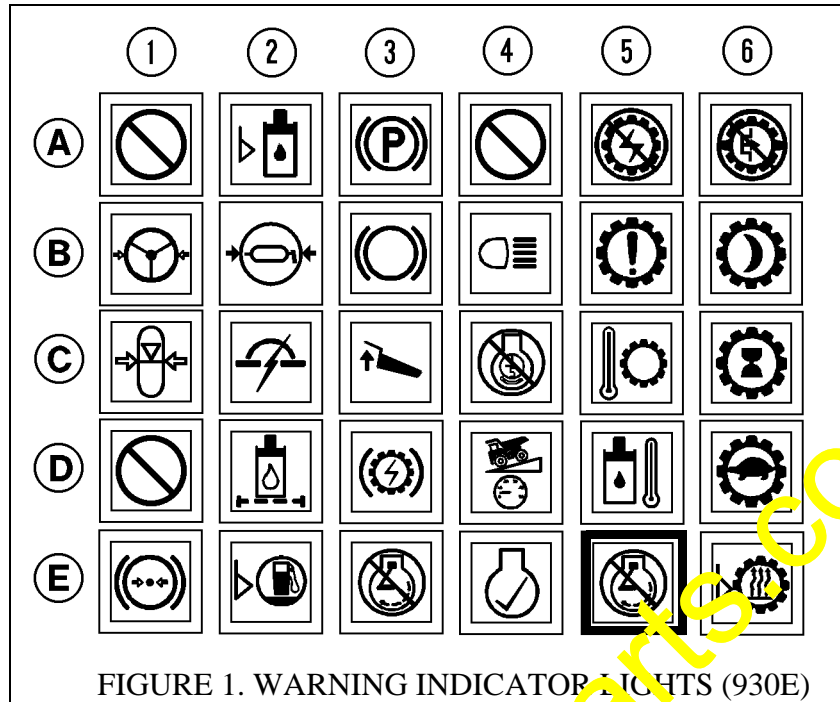
- 930E trucks:** The two red lamps are located in E3 & E5, and the yellow lamp, E4. Refer to Figure 1.
- 830E trucks:** The two red lamps are located in E3 & A5, and the yellow lamp, E4. Refer to Figure 2.

The seemingly redundant, red "stop engine" lamp in E5 (A5 on 830E trucks) has caused some confusion as to the proper response actions when illuminated. Because of the confusion caused by this light, a kit has been developed that initiates moving the E5 light (A5 on 830E trucks) near the engine diagnostic connector, away from the view of the operator. A "not used" decal will replace the current decal in the overhead display.
