PARTS & SERVICE NEWS

REF NO.	AA02202A		
DATE	June 26, , 2003

SUBJECT: RADIATOR MOUNT CRACK REPAIR PROCEDURE

APPLICATION: WA700-1L Wheel Loaders Serial Numbers A20001 to A20015

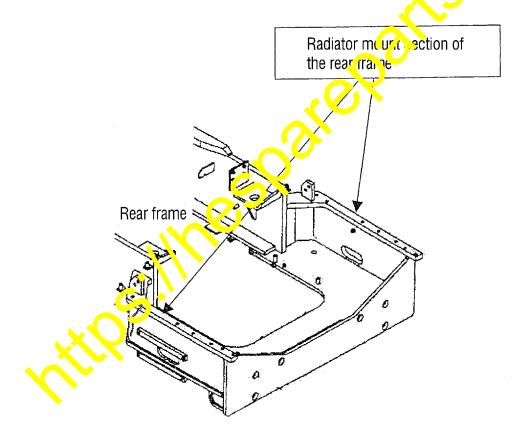
The radiator mount section may crack at the rear frame. When the cracks occur, repair the cracks per this Parts and Service News.

- 1. Repair procedure for the cracked section
 Refer to the shop manual regarding the removal and installation that is relevant to the procedure.
 - 1. Completely rermove the cracked sections with a grinder (or by gouging).
 - 2. Perform a dye penetrant test (PT) to esnure that all cracks are completely removed. If any cracks remain, perform the gouging again.
 - 3. Fill the gouged section with build-up welding. Welding conditions:

Welding rod: Low hydrogen type 50 kg/mm² grade welding rods JIS D5816 type (AWE8016-G equivalent).

- 4. Grind the welded section smooth.
- 5. Perform a dye penetrant test again.
- 6. Paint the welded section with the same color paint.
