PARTS & SERVICE NEWS

REF NO.	AT03102
DATE	Jun. 11, 2003

SUBJECT: REINFORCED PIN FOR WORK EQUIPMENT ON WA1200-3

PURPOSE: To introduce strengthened work equipment pin for use on WA1200-3 wheel loaders and the modification procedure to replace the pin

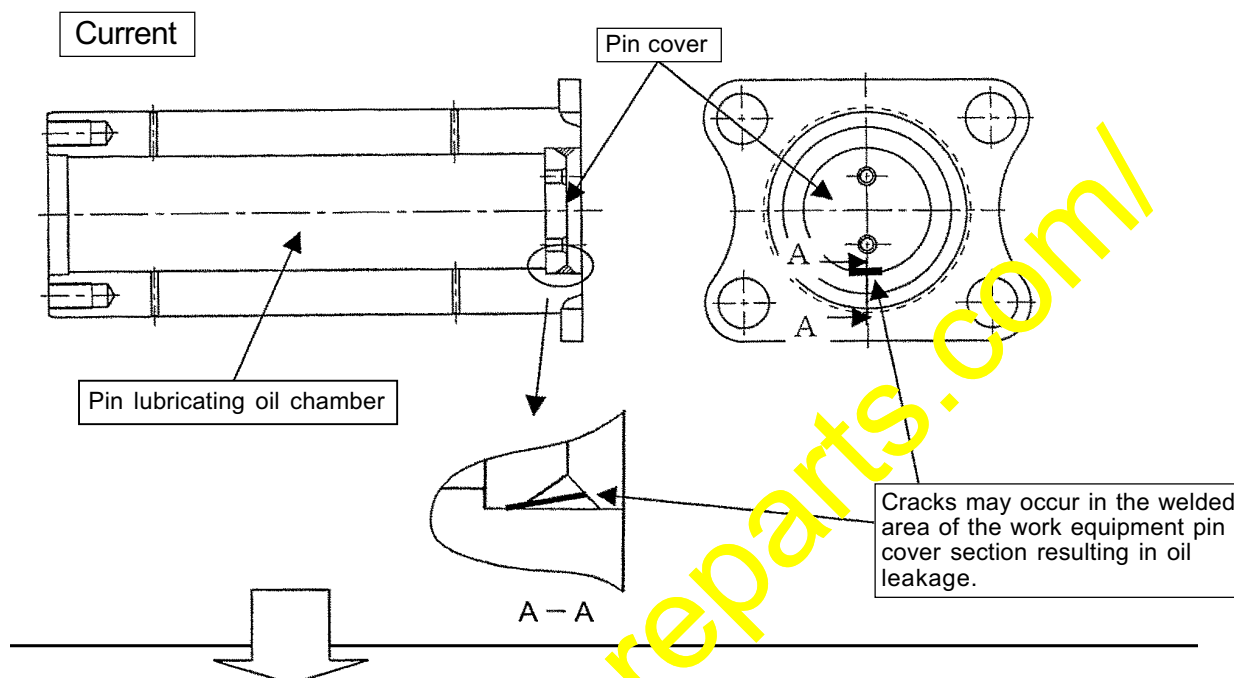
- ① When the machine is used under severe conditions (in operations where the digging load is heavy and the frequency of such operation is also large), cracks may occur in the welded area of the work equipment pin cover section as shown in the drawing below resulting in oil leakage.

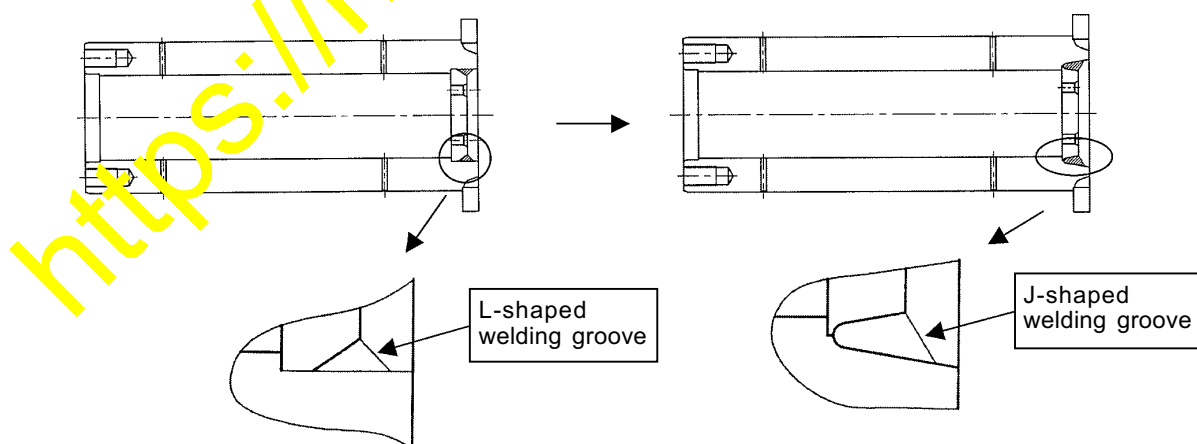
**New**

- ② The welding groove for the work equipment pin cover section has been changed from the L-shaped to the J-shaped, thus increasing the weld penetration volume to strengthen the welded section

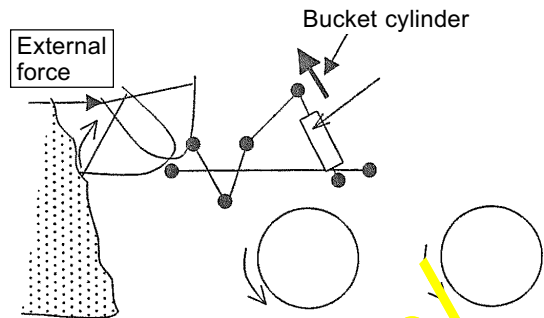
- (2) While the machine is being used for wall face digging, etc., when the bucket cylinder reaches its stroke end and when the overload relief does not work, if those operations where the bucket is pushed against the wall face, the bucket cylinder mounting pin ("D" and "E" in the drawing shown on the RH side) are overloaded and cracks may occur in the pin.

By the excessive external force, the cylinder rod will be pulled out to its stroke end and excessive force will be applied to the pin.

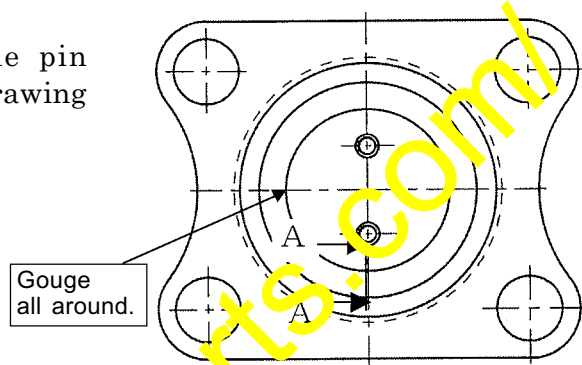
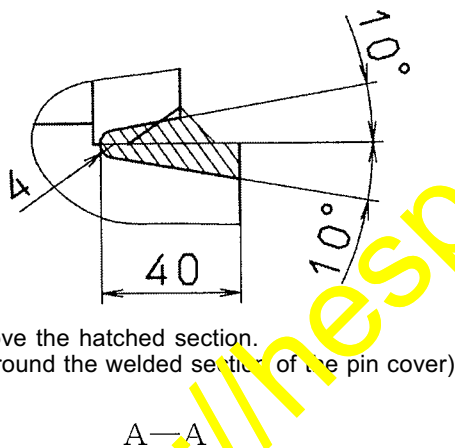
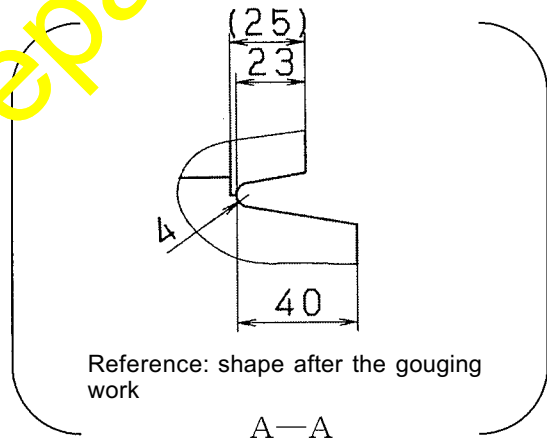
(2) Gouging of the cracked section

① Gouge the welded section of the pin cover to the shape shown in the drawing below.

② Gouge all around.

(If the repair is made on the cracked section only, there will be a possibility of occurrence of cracks once again. Therefore, make this repair all around.)

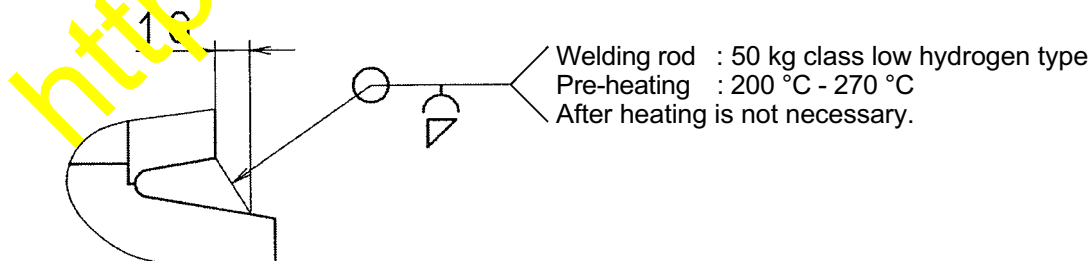
(3) Welding of gouged section

Weld all around the gouged section of the pin cover as shown in the drawing below.

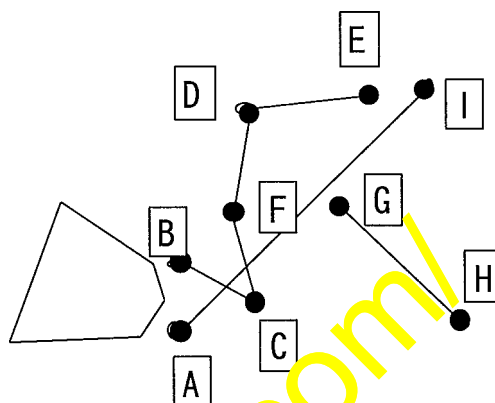
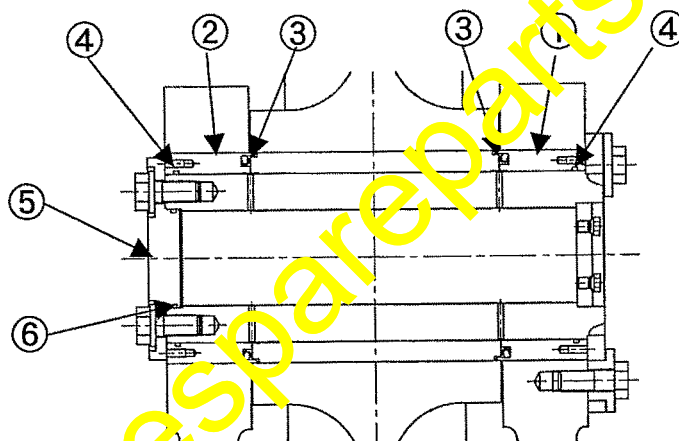
Introduced below are the part numbers of the reinforced pins and the positions where these pins are used

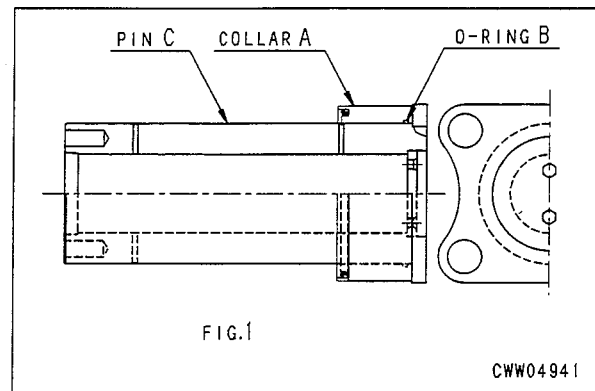
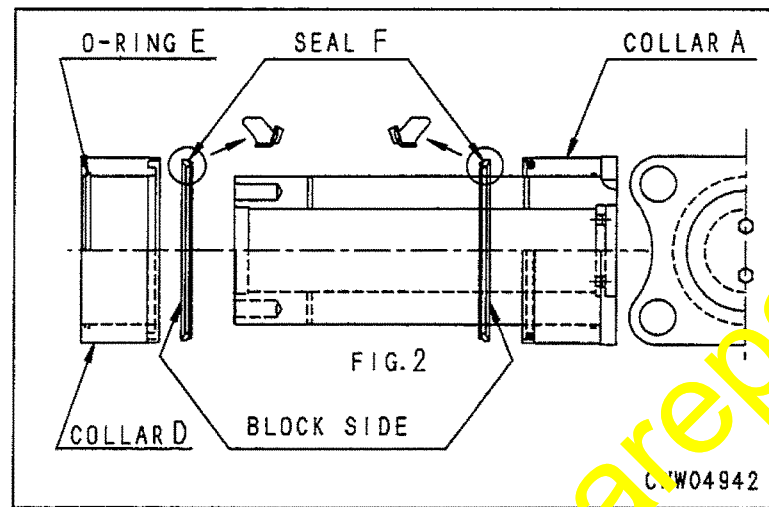
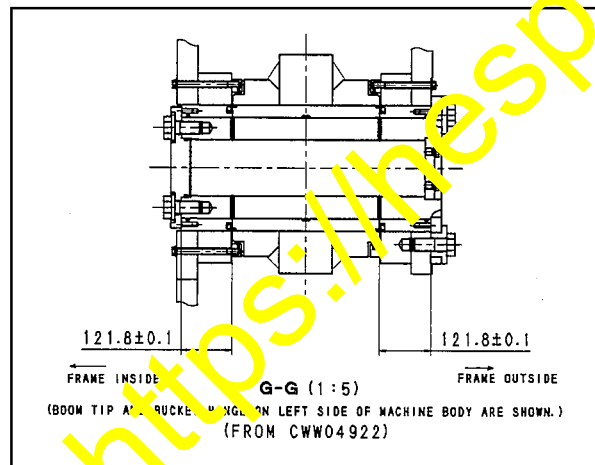
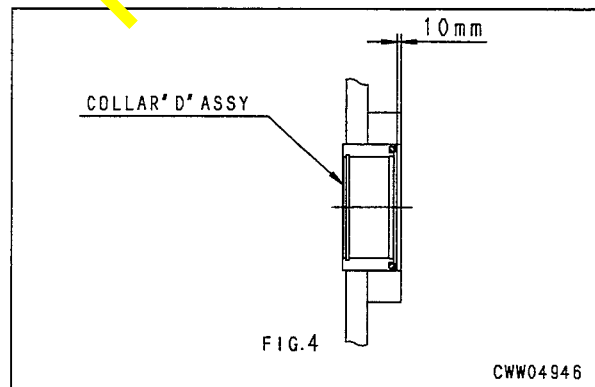
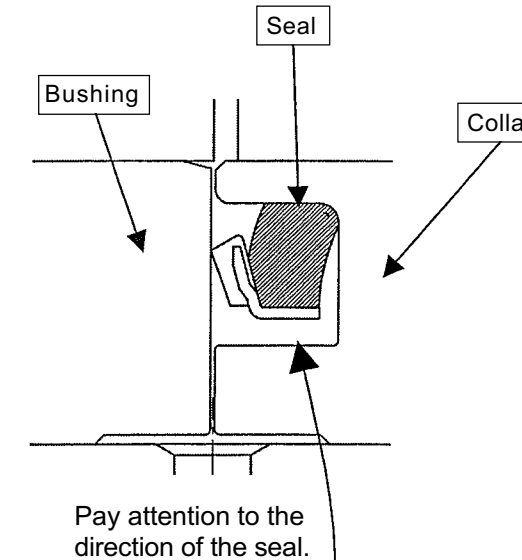
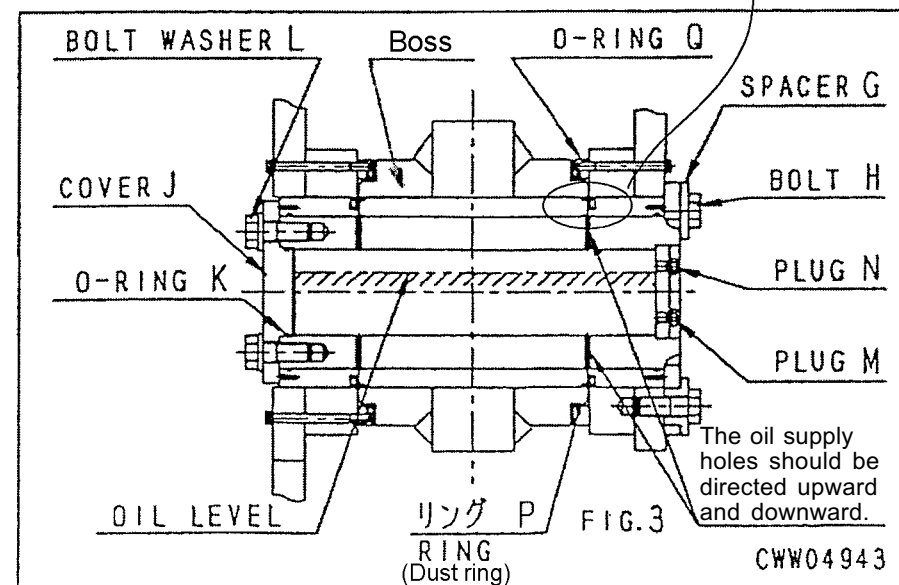
1. Install O-ring (A) to collar (B) and insert them into pin (C).
2. Clean the bore and outer surface of bushing of assembling parts (boom, bellcrank, cylinder, bucket, bucket link) after inspection of damage or dent. Apply the gear oil (API, GL-5, 80W/90) to outside of pin lightly.
3. Install O-ring (E) to collar (D).

4. Install seal (F) to collar (A) and (D).
Direction of seal is as follows. (The black surface of seal to be toward the collar)
(Pay attention to the direction of the seal.)

6. Put the ring (Q) which has installed in ring (P) at section G-G. See following dwg.

7. Overlap both center of pin (C) ass'y and collar (D) ass'y to the center of bore of pin. And insert them into the bore.
If the collar ass'y (D) put into the bore, see Fig. 4.

8. Install pin by bolt (H) and spacer (G).
Rotate the pin to vertical position of oil filler holes at section D-D.
