PARTS & SERVICE NEWS

REF NO.	AT03138
DATE	Jul. 25, 2003

SUBJECT: INTRODUCTION OF TRANSMISSION HI CLUTCH HUB BEARING IMPROVEMENT ON HD785-3/-5, HD985-5

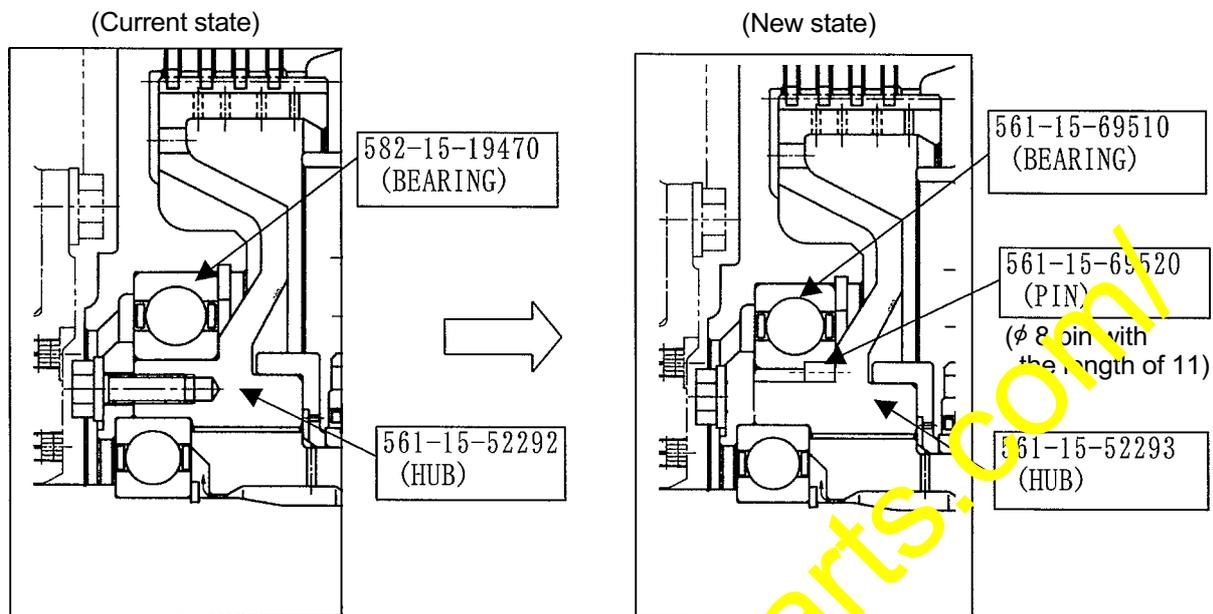
3. Details of the improvement

KOMATSU have added a lock pin to prevent occurrence of creeping wear of the inner race of the bearing for the Hi clutch.

As KOMATSU have added a lock pin to prevent occurrence of the aforementioned creeping of the bearing, Komatsu are introducing the new parts to prevent occurrence of creeping of the bearing in the Hi clutch hub section in this Service News.
