INSTALLATION MANUAL

REF NO. | BA03007

SUBJECT: INTRODUCTION OF HYDRAULIC PIPING CLAMP

- **PURPOSE:** To introduce modification procedure to improve the hydraulic piping clamping clips
- APPLICATION:
 330M Dump Trucks, S/N A10231 and A10232

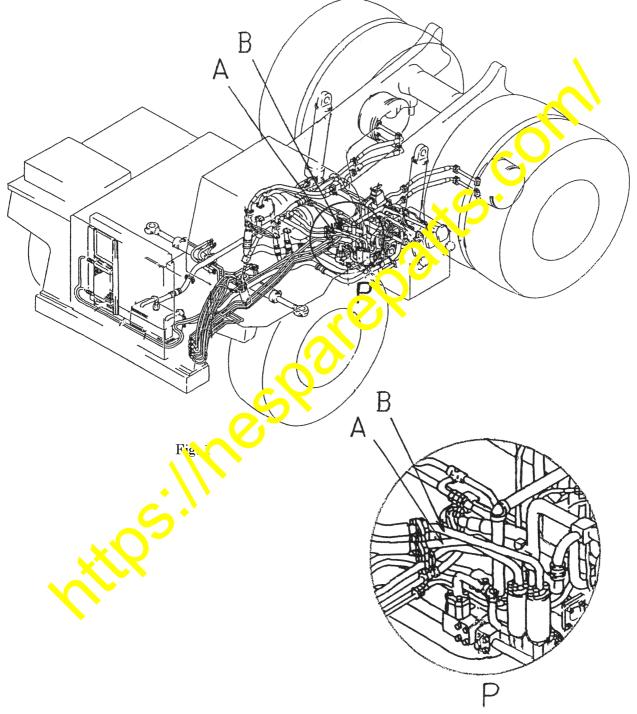
Change the clips which are clamping the tubes connecting between the pump and the line filter of the steering line and of the hoisting line onto the bracket to the clips of the type to use the seat which are less apt to become loose even when substantial hydraulic vibrations are applied to the tubes, in order to prevent occurrence of cracks in these tubes.

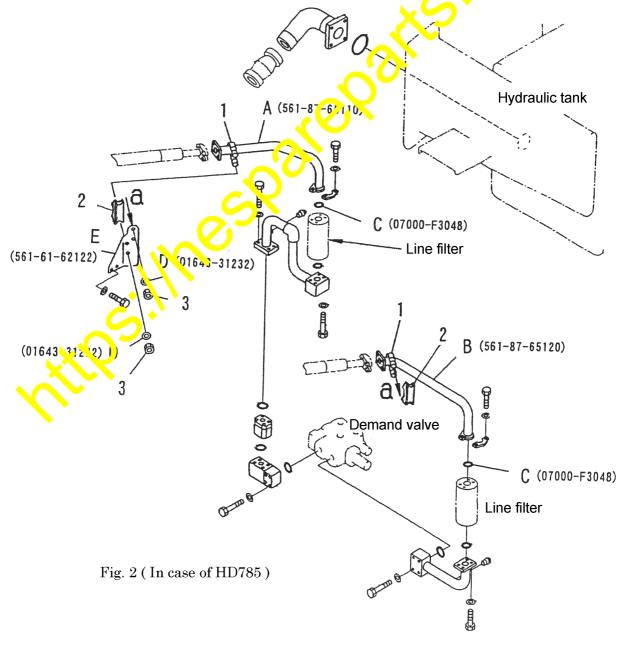
In case of HD785, refer to Fig. 2 and in case of HD985, refer to Fig. 3.

- (1) Remove the clip (1), washer (D) and nut (3) which are clamping the tube connecting between the pump and the line filter to the bracket. Abolish the removed clip (1) and the nut (3).
- (2) Inserting the seat (2) between the bracket (E) and the tube (A or B), clamp the tube using the newly prepared clip (1) and nut (3) and the removed washer (D).
- (3) If the tube (A or B) is cracked, replace the tube (A or B) together with the O-ring (C) to new parts.
- (4) If the tube is pressed forcefully while being clamped by the thickness of the additional seat (2), remove the bracket (E) and make the additional working (to change the round hole to a slotted hole) as per Fig. 4.After that, reinstall the bracket back to its original position.

In the meantime, when reinstalling the bracket (E), adjust the positioning of the bracket (E) so as not to make gaps between the contact surfaces of the seat (2) for the tube (A or B) and the bracket (E).
