PARTS & SERVICE NEWS

REF NO.	AA01250		
DATE	Dec. 13, 2001

SUBJECT: REPAIR PROCEDURE OF CAB DOOR

APPLICATION: GD555-3C Motor Graders, S/N 50002 thru 50008, 50010 thru 50029

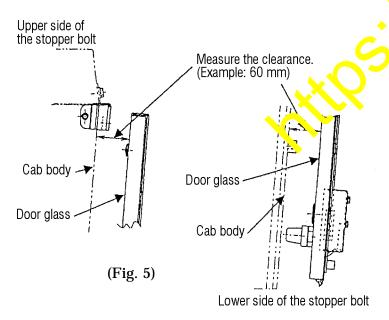
After the modification

(8) Confirm the clearance between the door handle and the cab body (glass surface). (Refer to Fig. 2.)

Use this in case it is not possible

to make the adjustment by the
