PARTS	&	SER	VICE
NEWS

REF NO. AA03143

SUBJECT: **REINFORCING A/C CONDENSER OUTLET PIPING PURPOSE:** To inform the field of a reliability improvement for air conditioner systems.

APPLICATION: Komatsu Electric Drive Dump Trucks: 445E: 32210-32972, 31202-31736, A511001-A511037; 510E: 31222-32259, 31682-32865; 630E: (170 ton): 31670-32866, A31435 & Up; 630E: (190 ton): 31678-32848, A31431 & Up; 685E: 31402 & Up; 730E: 32530-32845, A30079 & Up; 830E: 31320-32825, A30544 & Up; 930E: 32604-32816, A30019, A30026-A30120 930E-2: A30012, A30098, A30100, A30121 & Up; 930E-3: A30294, A30304 & Up; equipped with A/C condenser (PB9520) Komatsu Mechanical Drive Dump Tucks: 530M: A30001 thru A30038, 22523 HD1500-5: A30039 and up; equipped with A/C cordenser (PB9510)

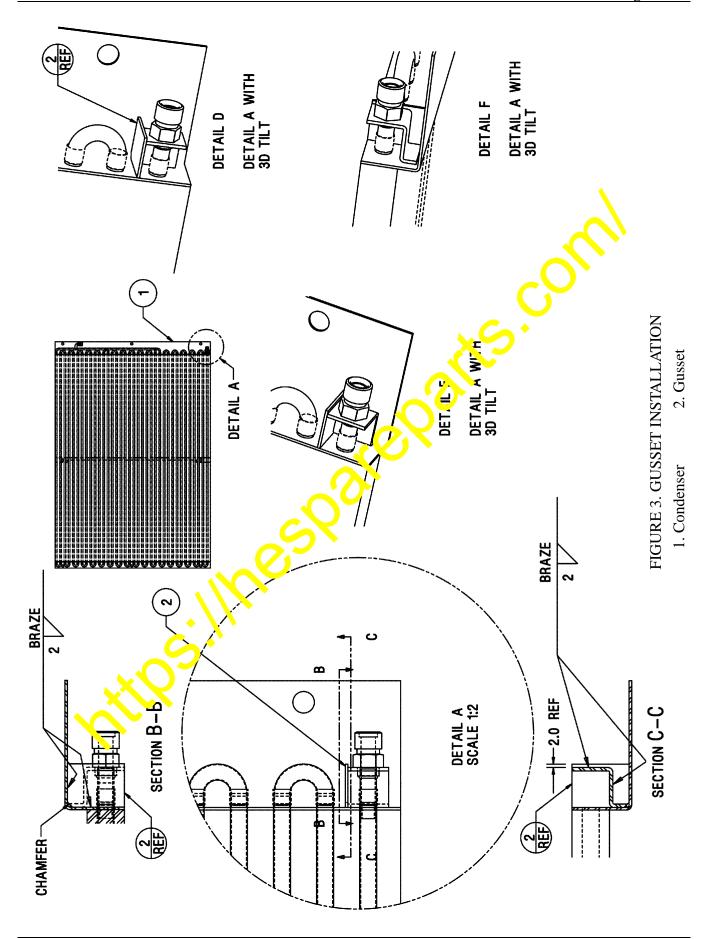
Some trucks in operation may experience damage to the outlet tube on air conditioning system condensers (PB9510). Normal truck operation and vibration can sometimes cause damage to this tube due to lack of support. Figure 1 illustrates the current outlet tube arrangement.

Inspect the condenser for cracking near the fitting. If any cracking is evident, repair or replace the condenser.

A field improvement has seen developed that entails welding a locally foricated support gusset to the existing support. The addition of the gusset reduces the possibility of this damage occurring and increases the life of the condense, resulting in less downtime.

Refer to Figure 2 for dimensions for fabricating the gusset. Refer to Figure 3 for welding specifications and installation details.

Evacuate the air conditioning system before brazing the gusset to the condenser. Refer to the appropriate shop manual for information on evacuating the air conditioning system.

Remove the O-ring from the fitting before welding. Use precautions such as applying wet cotton rags to the fitting for protection from excess heat. The receiver drier must be replaced after the system has been opened.
