PARTS & SERVICE NEWS

REF NO. AA99096

SUBJECT: HYDRAULIC TUBE BRACKET MODIFICATION OR REPLACEMENT

APPLICATION: WA800-2L WHEEL LOADER WITH S/N A20001 THRU A20019
WA800-2LC WHEEL LOADER WITH S/N A20020 THRU A20023
WA900-1L WHEEL LOADER WITH S/N A20001 THRU A20007
WA900-1LC WHEEL LOADER WITH S/N A20008 THRU A20014

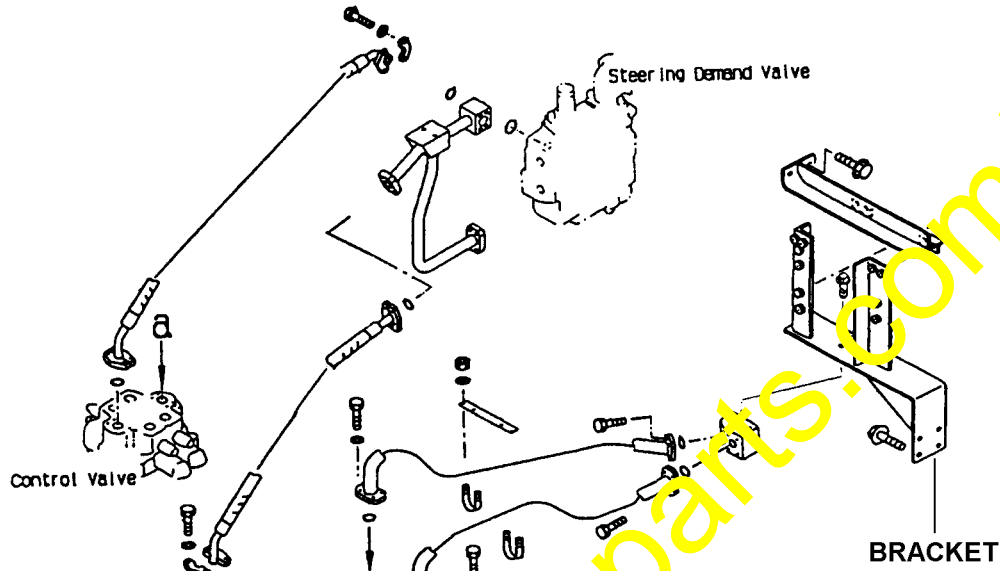
TOP VIEW

DESCRIPTION: Misaligned hydraulic oil piping may cause cracks in the oil piping tubes.

OLD BRACKET

NEW BRACKET

You will have a choice of using the new bracket or modifying the existing bracket.
