**PARTS & SERVICE
NEWS**

REF NO.	AT02114
DATE	Oct. 21, 2002

SUBJECT: REPAIR PROCEDURE OF WATER LEAKS FROM CYLINDER HEAD U-PLUG ON SA(A)6D170

PURPOSE: To introduce modification procedure to repair or to prevent occurrence of water leakage by corrosion of the U-plug of the cylinder head of the S (A or AA) 6D170 engines

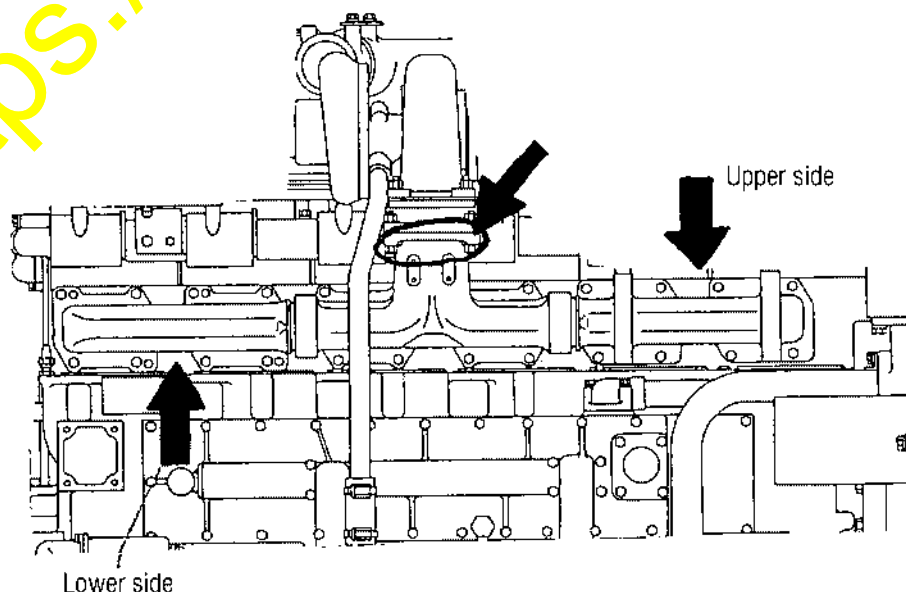
Fig. 4

Since the part number of the exhaust manifold is being stamped or embossed at the position shown in the drawing below, identify if the exhaust manifold is of before the modification or after the modification by the aforementioned part number.

When installing the exhaust manifold of the part numbers before the modification, regardless if water leakage is occurring or not through the blind plug section of the cylinder head, install the exhaust manifold using the mounting jig being introduced in this Service News.
