**PARTS & SERVICE
NEWS**

REF NO.	AT03013
DATE	Feb. 19, 2003

SUBJECT: REPAIR PROCEDURE OF JOYSTICK SWITCH ON WA700-3, WA800-3, WA900-3, WA1200-3

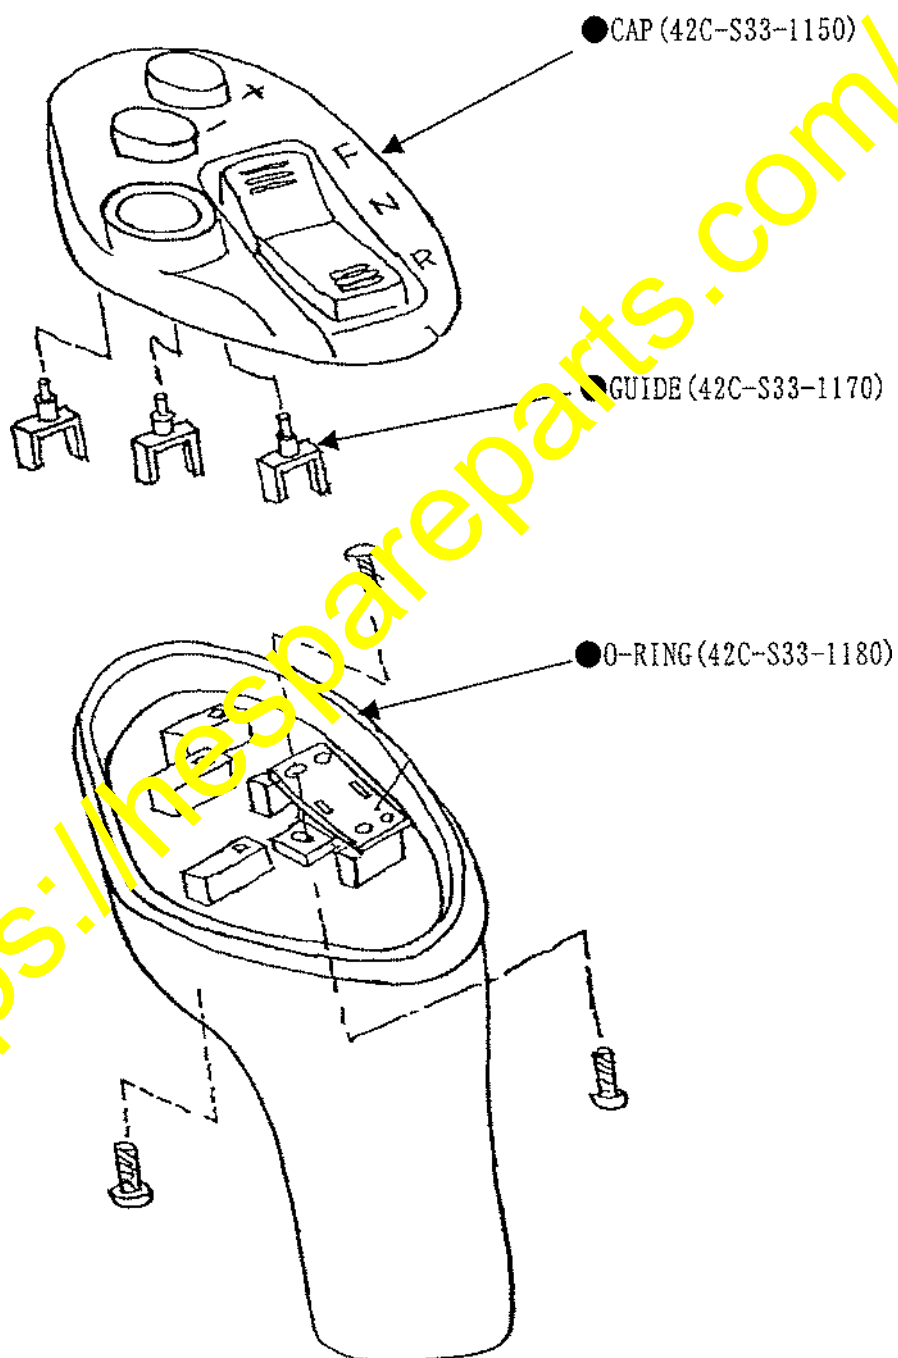
5. Other spare parts newly registered

- 2) The relevant parts such as the upper operating surface covering rubber cap, etc., which have been registered as well, are introduced in this Service News at the same time.
