PARTS & SERVICE NEWS

REF NO. AT04171

SUBJECT: MODIFICATION PROCEDURE TO PREVENT ABNORMAL WEAR OF SPLINE SECTION OF ADDITIONAL COOLER FAN DRIVE MOTOR SHAFT

- **PURPOSE:** To inform Field Personnel
- APPLICATION: WA900-3 Wheel Loaders, S/N 50001 thru 50041 WD900-3 Wheel Dozer, S/N 50001 thru 50014
- FAILURE CODE: L932CC

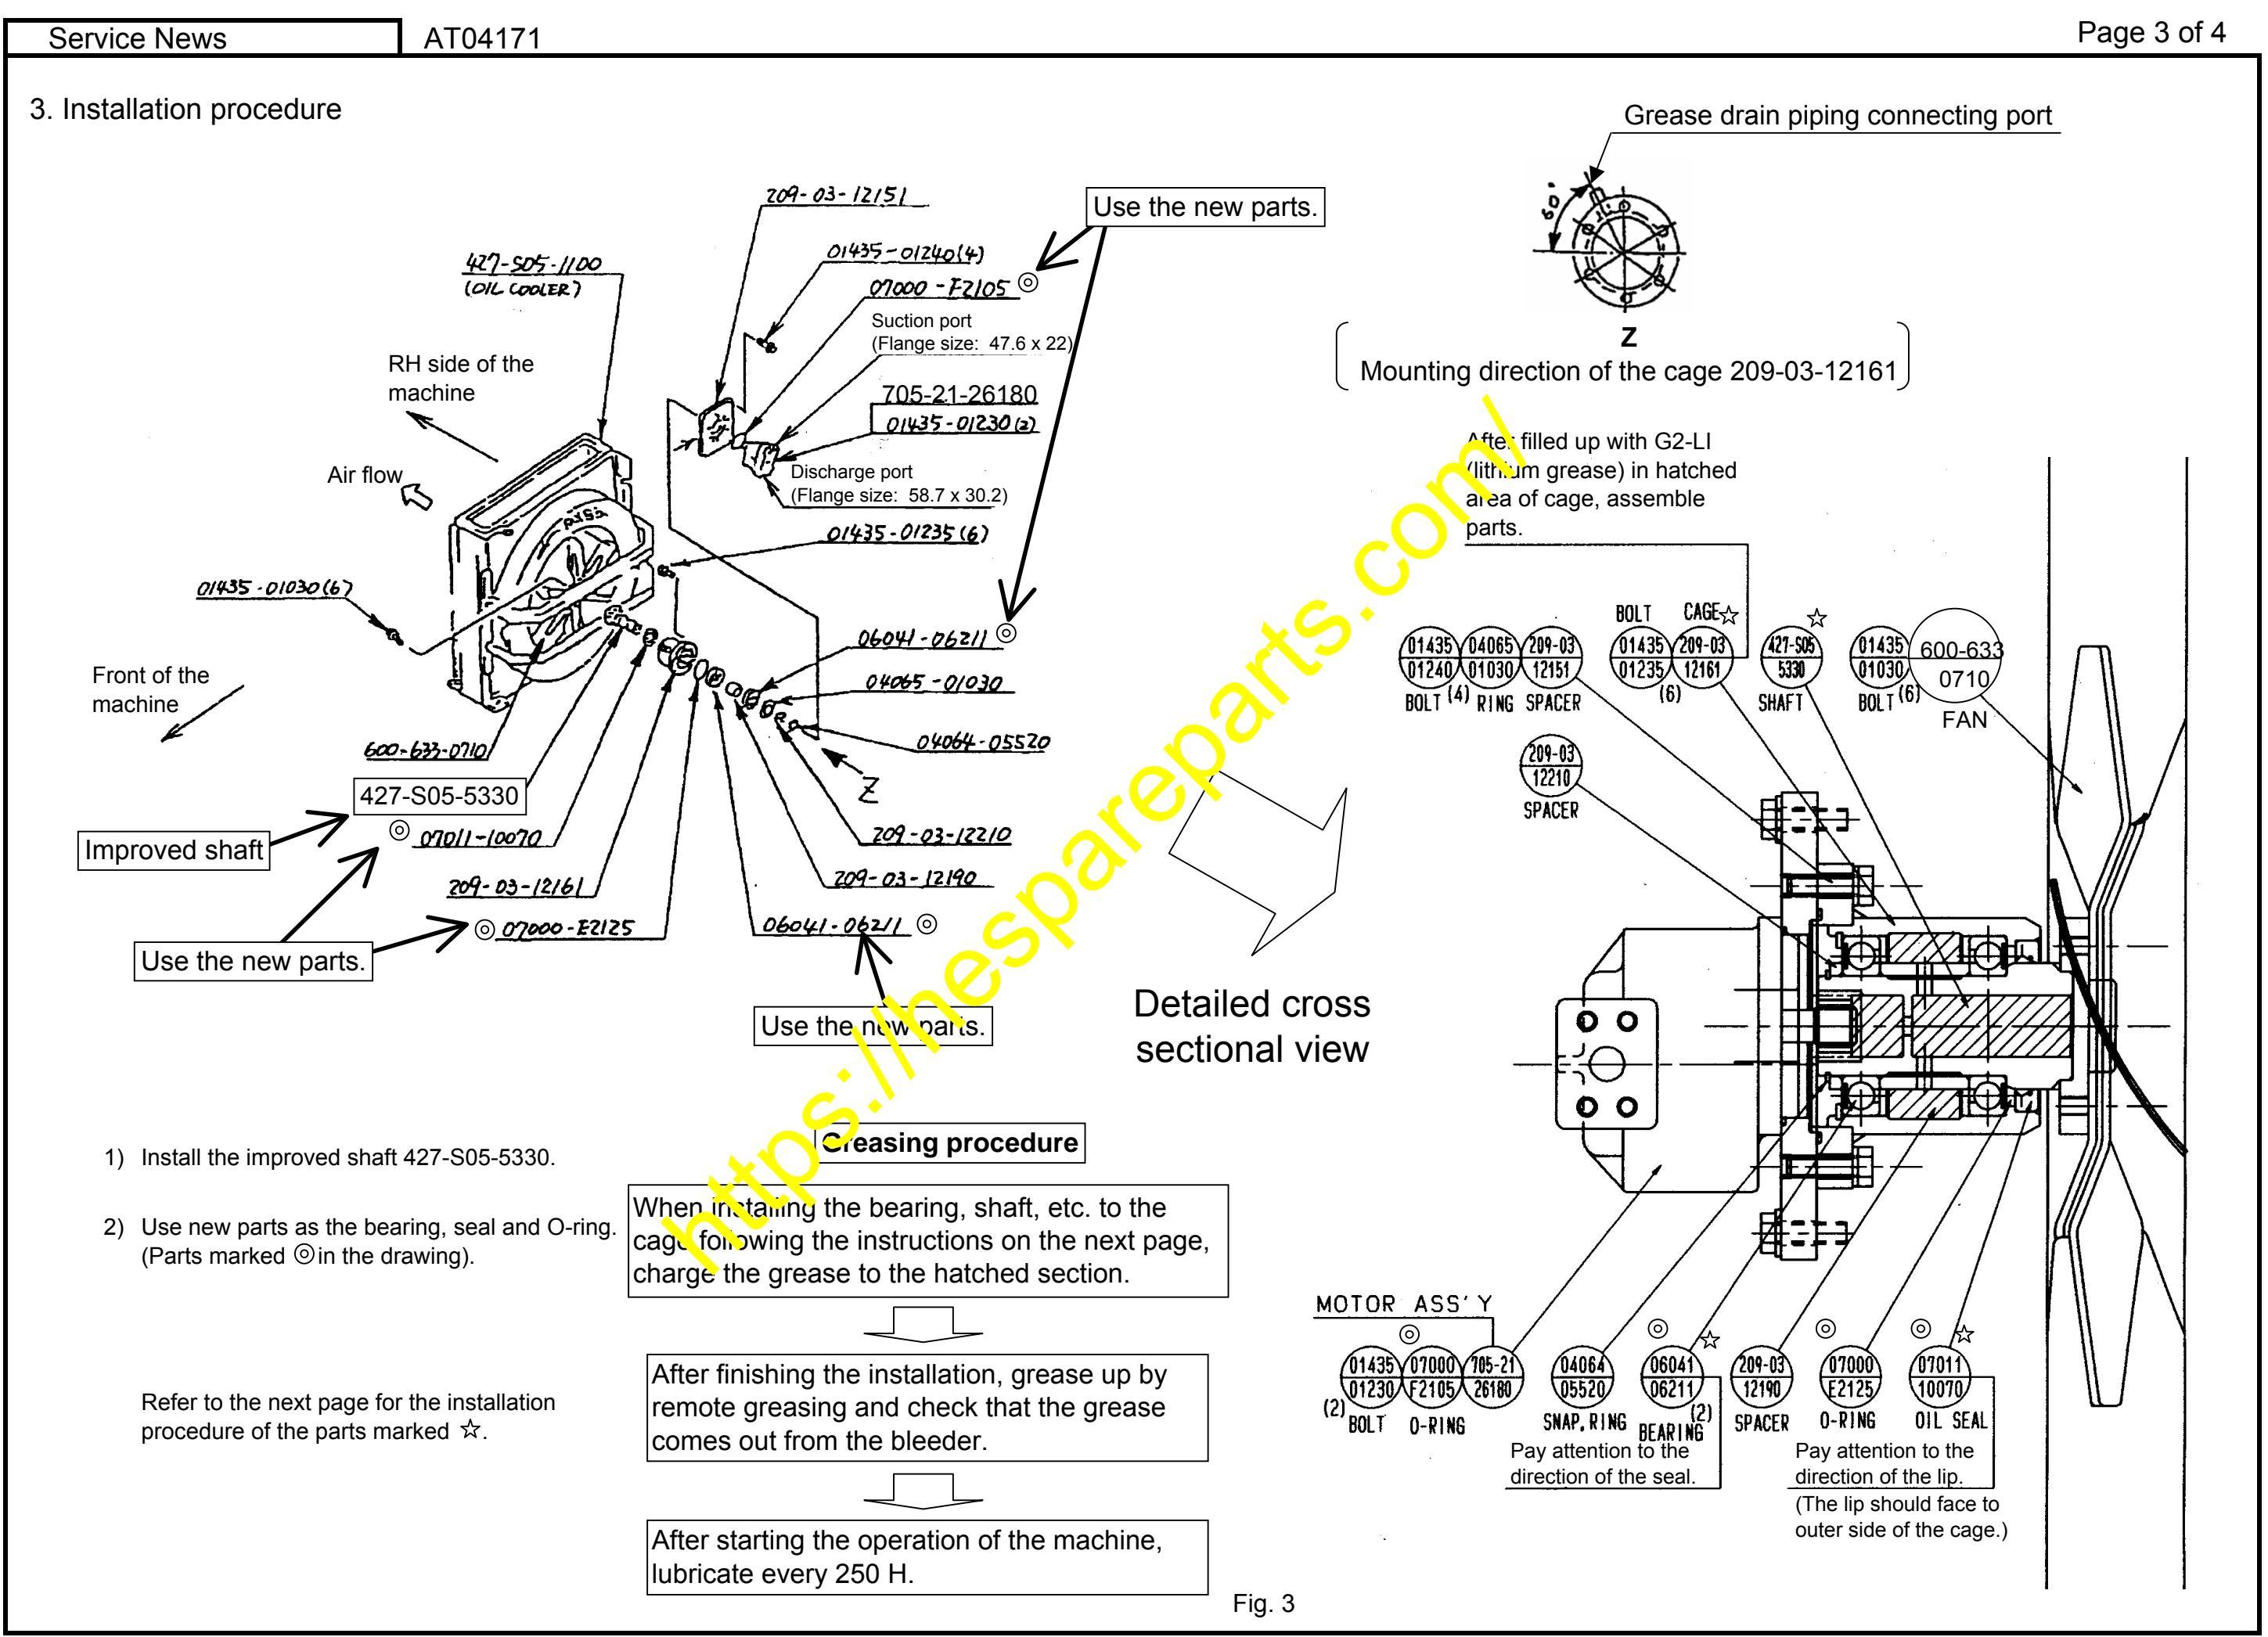
Improved shaft (427-S05-5330)

- <1> The grease to lubricate the spline section escapes to the outer circumferential section through the bearing where the immersion resistance is low and the grease is not supplied into the hollow section of the shaft.
- <2> The grease is dispersed to the outer circumferential section by the centrifugal force and grease film interruption occurs on the spline section.

Since abnormal wear may occur on the spline section of the additional cooler fan drive motor shaft, it becomes necessary to modify the shaft structure and make the inclification as outined in this **PARTS** & **SERVICE NEWS**.
