# PARTS & SERVICE NEWS

REF NO.	AT04802
DATE	May 14, 2004

**SUBJECT:** REPAIR PROCEDURE FOR GRAMMER'S SEAT WITH AJSS ON WA700-3, 800-3, 900-3 AND 1200-3

**PURPOSE:** To introduce modification procedure to repair GRAMMER's operator's seat on the AJSS spec. WA700-3, 800-3, 900-3 and 1200-3 wheel loaders

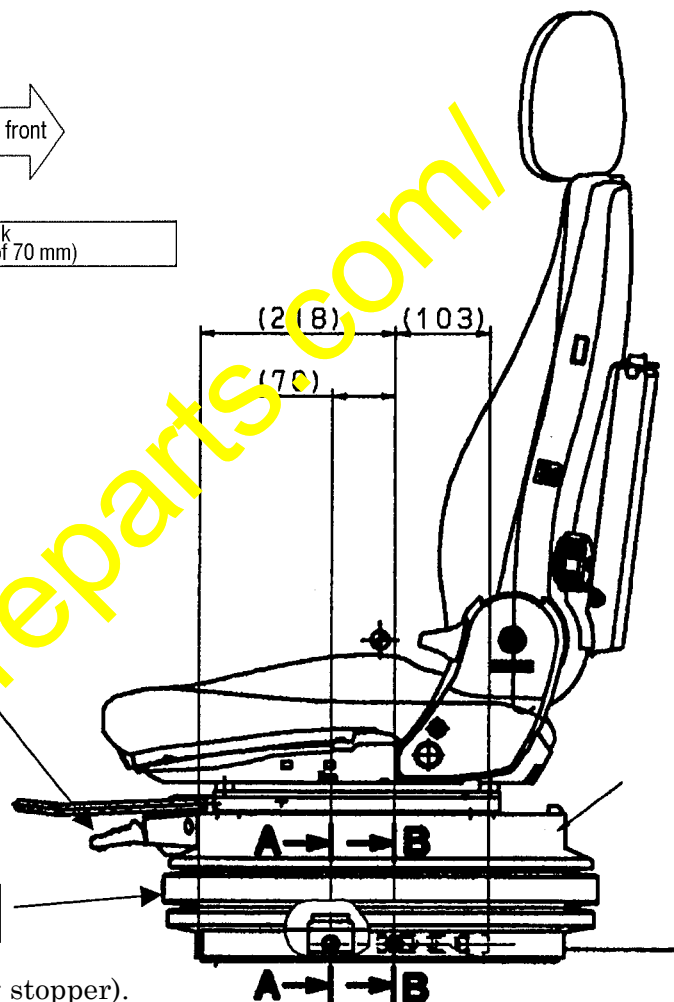
Fig. 4

Air adjust lever

Suspension boot

- Add the suspension stoppers (lowering stopper). (On both of the LH and RH sides)
