PARTS & SERVICE NEWS

REF NO. AA00142

SUBJECT: CORRECTION OF FUSE BOXES IN OPERATORS CAB

APPLICATION: HD325-6 Dump Trucks, S/N 5292
HD785-3 Dump Trucks, S/N 2269 thru 2276, 2278 thru 2283, 2290 and 2291
HD785-5 Dump Trucks, S/N A10228 and up
330M Dump Trucks, S/N Cf24120 and up

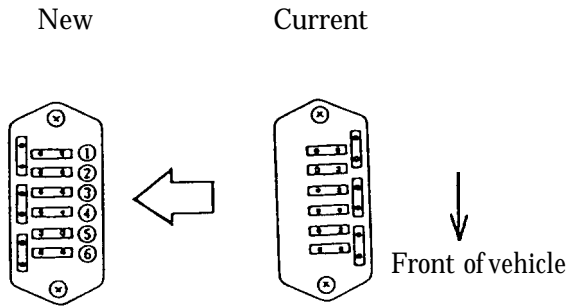
Fig. 1

The fuses in the fuse box in the operator's cab may be installed different from those indicated on the nameplate. In this case, rectify them according to this **PARTS & SERVICE NEWS**.

- (1) Open the rear cover in the operator's cab.
- (2) Remove the two mounting screws of fuse box A (BT3), and reinstall it inversely (Fig. 1 and Fig. 2).

- (3) After inverting fuse box A, exchange fuses ② and ⑤ with each other.

New	Current
② : 20A	10A
⑤ : 10A	20A

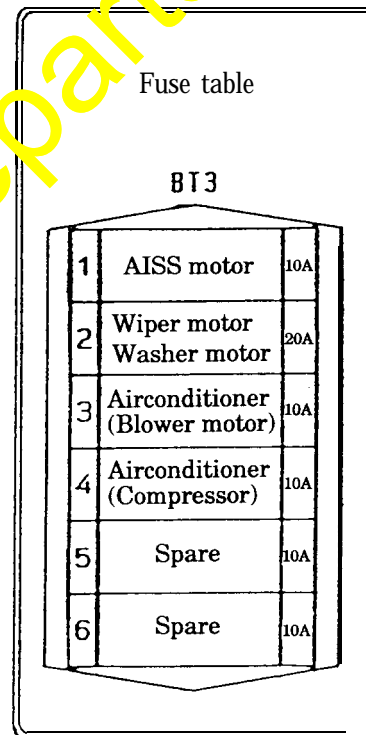
Fig. 3

Confirm that the capacity of each fuse in fuse box A now conforms to that on the fuse nameplate (Fig. 3) stuck to the back of the rear cover.
