PARTS & SERVICE NEWS

AA00204

SUBJECT: JOYSTICK STEERING WIRING HARNESS

APPLICATION: WA600-3L Wheel Loader Serial Numbers A52001 through A52155

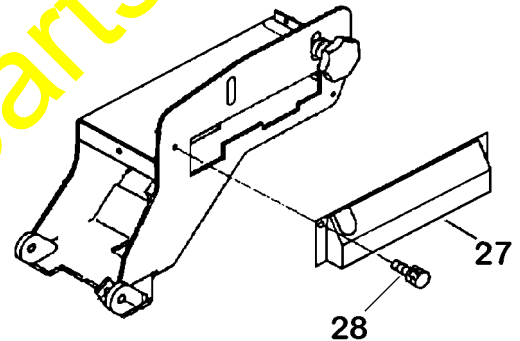
DESCRIPTION: The J/S wiring harness may get caught between the J/S assembly and the left console box, causing damage to the harness.

1. Slide J/S Console unit and operator seat forward as far as possible.
2. Remove screws 01023-20612 (#28) and take off cover 428-S33-2280 (#27) as shown.
