# PARTS & SERVICE NEWS

REF NO. AA02107

**SUBJECT:** AIR CONDITIONING COMPRESSOR BELT GUARDS

**APPLICATION:** Komatsu Mechanical Drive Dump Trucks:  
530M: AFP49-A thru Y, A30001 thru A30038;  
HD1500-5: A30039 thru A30067

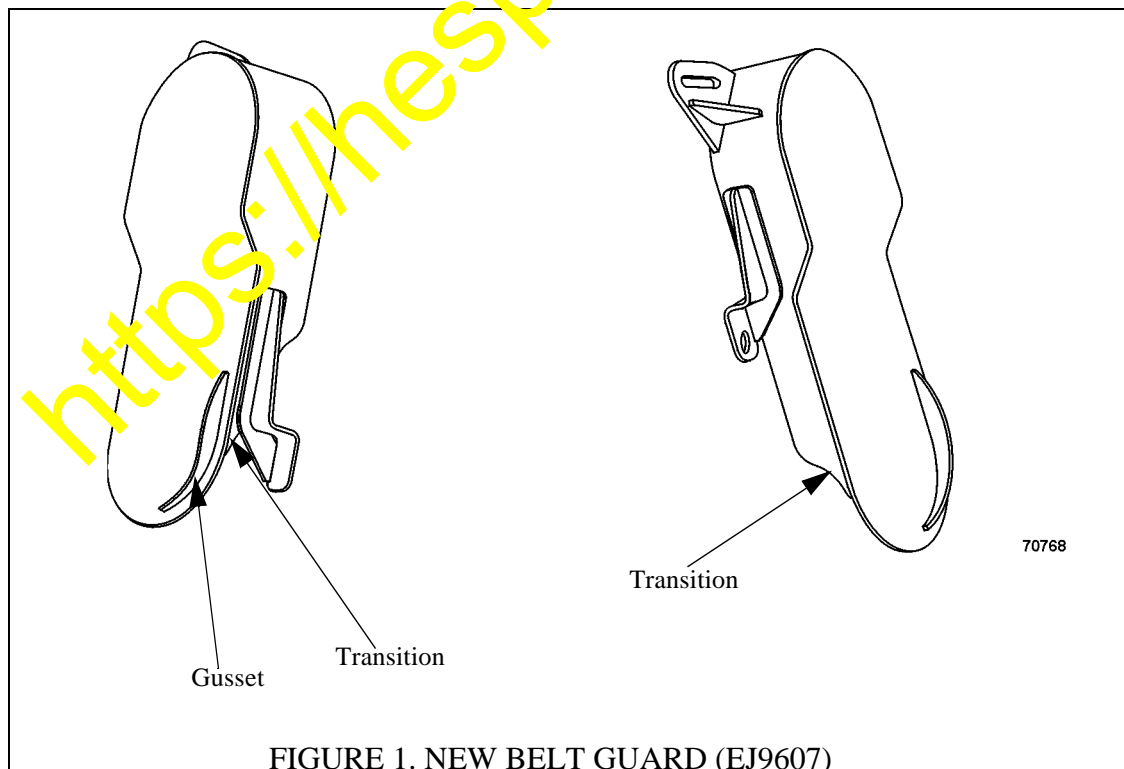
Differences in the new belt guard include transitions in the center wrap sheet and an added gusset. Refer to Figure 1.

FIGURE 1. NEW BELT GUARD (EJ9607)

Some trucks in the field may experience cracking at the air conditioning compressor belt guard. A new improved belt guard (EJ9607) has been developed to replace previous belt guard (EH8750), and to prevent this problem from occurring.

Truck units A30068 and above will be assembled with the new belt guard.
